South East New Territories (SENT) Landfill Extension

Monthly Environmental Monitoring & Audit Report No.56 for August 2023

February 2024

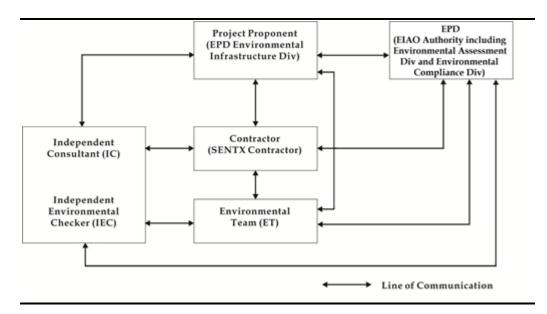
Figure 1.2 Organisation Chart

The organisation structure of the Project is presented in *Figure 1.2*.

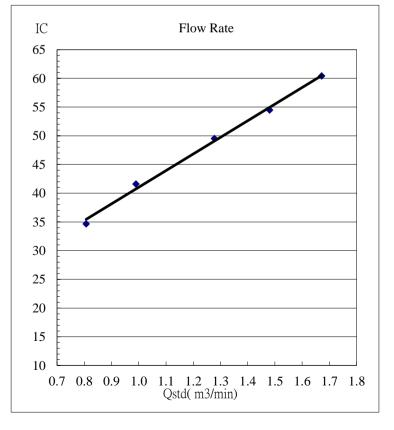
D 00.111		24.4.22
Location II						Date of Calib		24-Aug-23
Name and	Model:	TISCH	HVS Mode	1TE-5170		Next Calibrat	tion Date:	23-Oct-23
						Operator:		P.F.Yeung
				CONDITIO	SNC			
Sea Level Pressure (hpa) 1007 Temperature (°C) 29.0						Corrected Pressure (mm Hg) 755.3 Temperature (K) 302		
				CALIBRA	TION C	RIFICE		
Make: TISCH Model: TE-5025A Serial#: 2454						Qstd Slope Qstd Intercep	t	2.06918 -0.04220
				CALIBRA	TION			
Plate	H2O(L)	H20(R)	H2O	Qstd	Ι	IC		LINEAR
No.	(in)	(in)	(in)	(m3/min)	(chart)	(corrected)		REGRESSION
18	6.1	6.1	12.2	1.692	57	56.46	Slope=	= 31.858
13	4.5	4.5	9.0	1.457	52	51.51	Intercept=	= 3.629
10	3.6	3.6	7.2	1.305	45	44.57	Corr. Coeff.=	
7	2.2	2.2	4.4	1.025	38	37.64

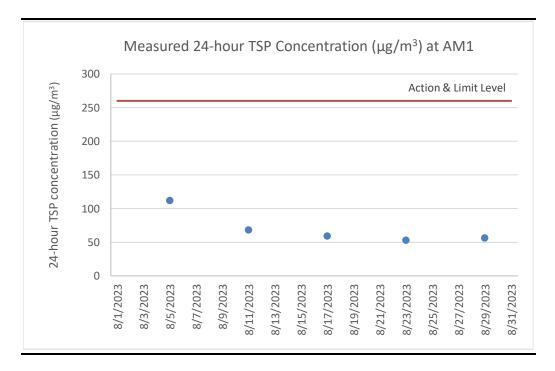
Figure D2.1 Graphical Presentation for 24-hr TSP Monitoring at AM1

Start Date	Start Time	Finish Date	Finish Time	Weather	24-hour TSP (μg/m³)
5 Aug 23	8:00	6 Aug 23	8:00	Sunny	112
11 Aug 23	8:00	12 Aug 23	8:00	Cloudy	68
17 Aug 23	8:00	18 Aug 23	8:00	Sunny	59
23 Aug 23	8:00	24 Aug 23	8:00	Fine	53
29 Aug 23	8:00	30 Aug 23	8:00	Cloudy	56
				Average	70
				Min	53
				Max	112

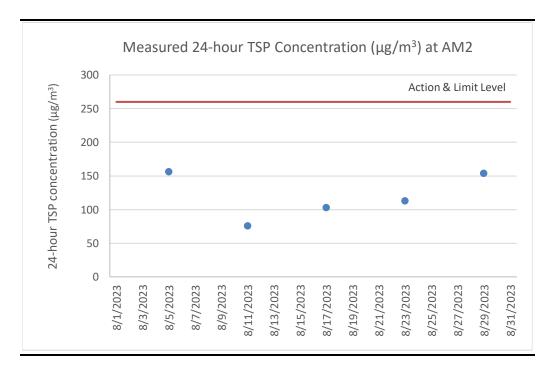
Figure D2.2 Graphical Presentation for 24-hr TSP Monitoring at AM2

Start Date	Start Time	Finish Date	Finish Time	Weather	24-hour TSP (μg/m³)
5 Aug 23	8:00	6 Aug 23	8:00	Sunny	156
11 Aug 23	8:00	12 Aug 23	8:00	Cloudy	76
17 Aug 23	8:00	18 Aug 23	8:00	Sunny	103
23 Aug 23	8:00	24 Aug 23	8:00	Fine	113
29 Aug 23	8:00	30 Aug 23	8:00	Cloudy	154
				Average	120
				Min	76
				Max	156

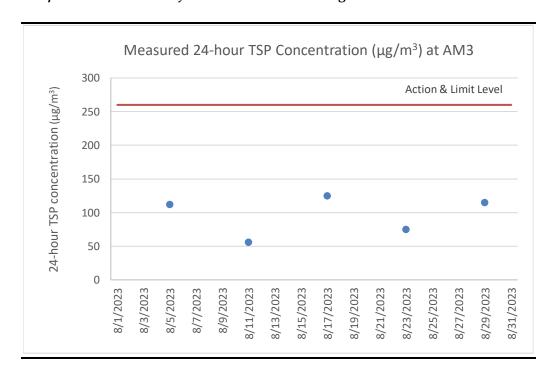
Figure D2.3 Graphical Presentation for 24-hr TSP Monitoring at AM3

Start Date	Start Time	Finish Date	Finish Time	Weather	24-hour TSP (μg/m³)
5 Aug 23	8:00	6 Aug 23	8:00	Sunny	112
11 Aug 23	8:00	12 Aug 23	8:00	Cloudy	56
17 Aug 23	8:00	18 Aug 23	8:00	Sunny	125
23 Aug 23	8:00	24 Aug 23	8:00	Fine	75
29 Aug 23	8:00	30 Aug 23	8:00	Cloudy	115
				Average	97
				Min	56
				Max	125

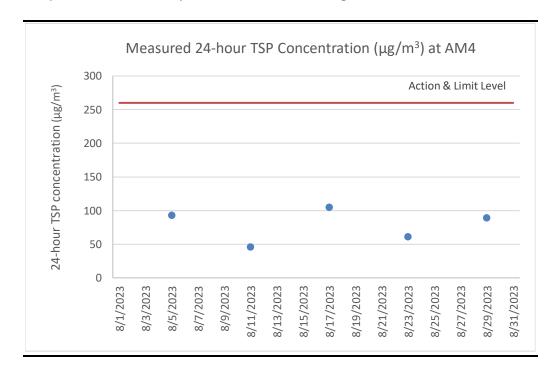
Figure D2.4 Graphical Presentation for 24-hr TSP Monitoring at AM4

Start Date	Start Time	Finish Date	Finish Time	Weather	24-hour TSP (μg/m³)
5 Aug 23	8:00	6 Aug 23	8:00	Sunny	93
11 Aug 23	8:00	12 Aug 23	8:00	Cloudy	46
17 Aug 23	8:00	18 Aug 23	8:00	Sunny	105
23 Aug 23	8:00	24 Aug 23	8:00	Fine	61
29 Aug 23	8:00	30 Aug 23	8:00	Cloudy	89
				Average	79
				Min	46
				Max	105

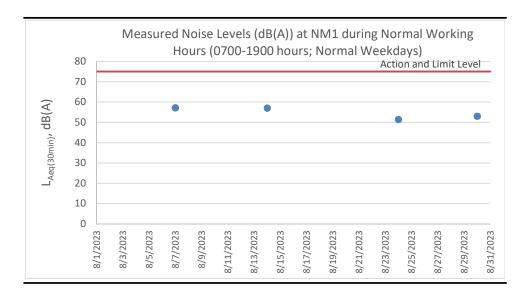
Figure E2.1 Graphical Presentation for Noise Monitoring at NM1

Date	Start Time	Finish Time	Weather	L _{10 (30min)}	L _{90 (30min)}	Leq (30min)
7 Aug 23	10:32	11:02	Sunny	59.7	53.3	57.2
14 Aug 23	10:42	11:12	Cloudy	58.3	54.2	57.0
24 Aug 23	10:51	11:21	Cloudy	52.5	49.2	51.4
30 Aug 23	10:53	11:23	Sunny	55.1	50.0	53.0
					Average	e 54.7
					Mir	n 51.4
					Max	x 57.2

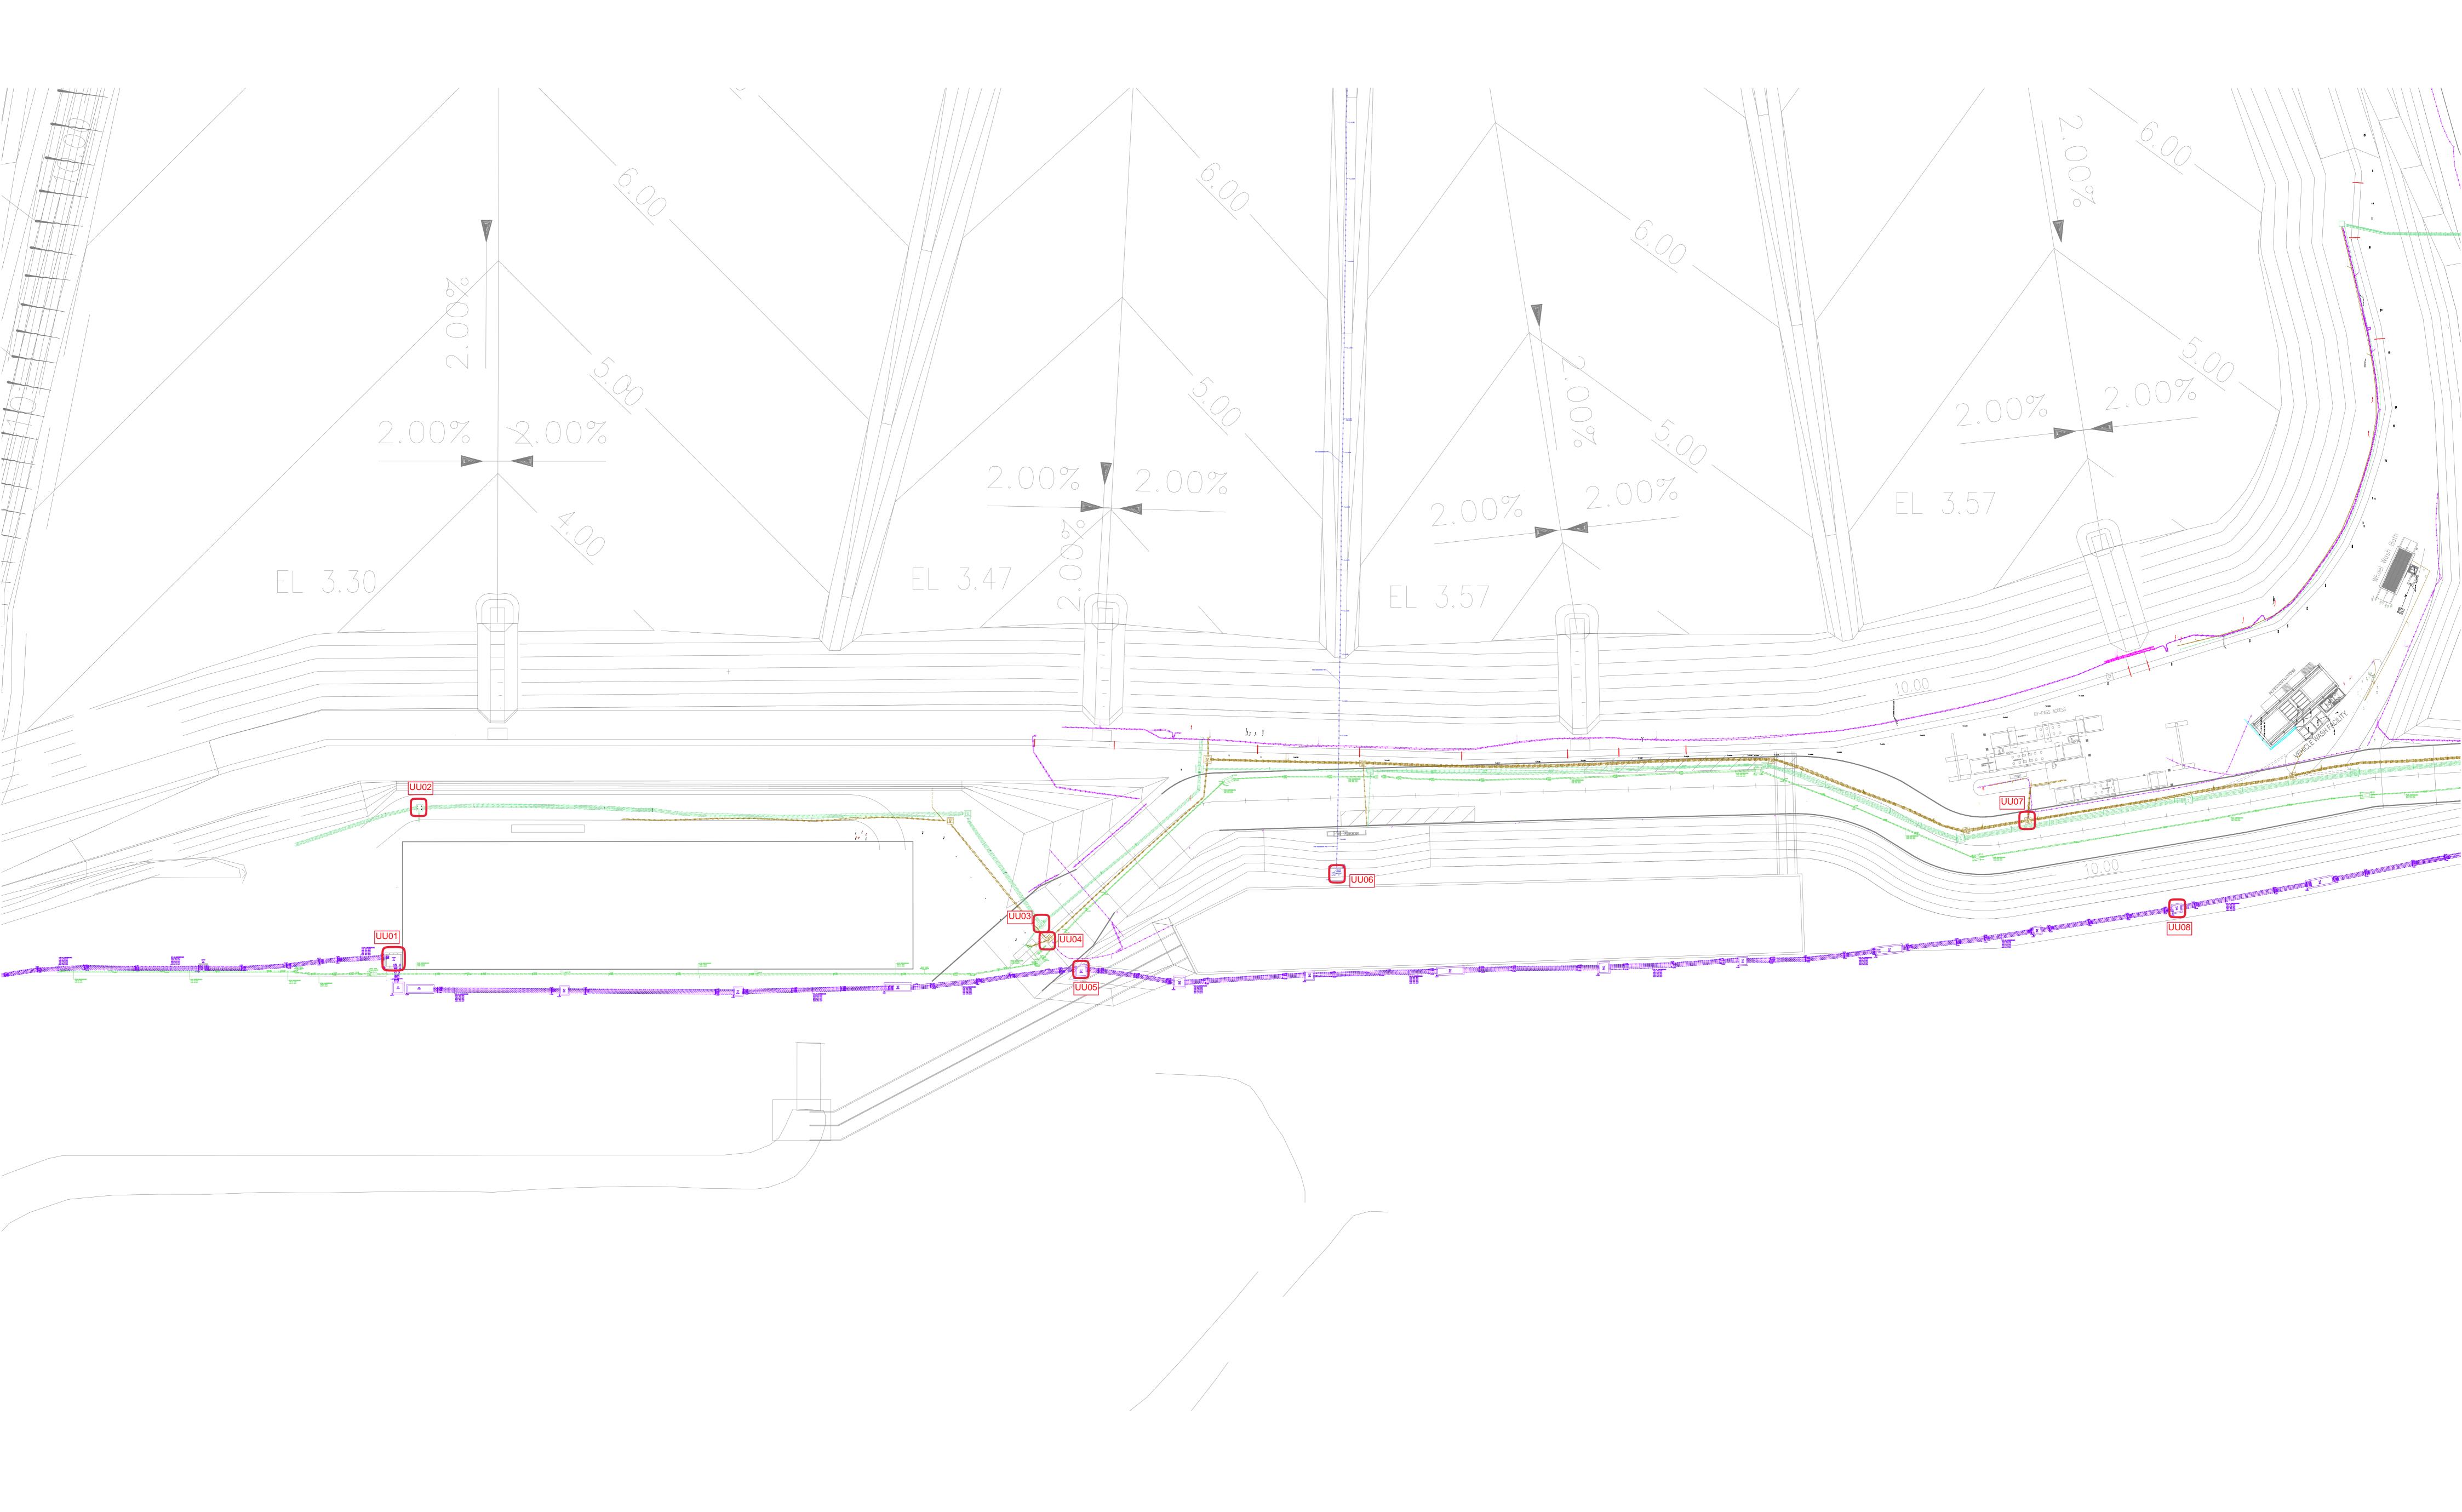
Landfill Gas Monitoring
Locations for Service Voids,
Utilities and Manholes
along the Site Boundary and
Within the SENTX Site
