## South East New Territories (SENT) Landfill Extension

Monthly Environmental Monitoring & Audit Report No.59  
for November 2023

# South East New Territories (SENT) Landfill Extension

## Monthly Environmental Monitoring & Audit Report for November 2023

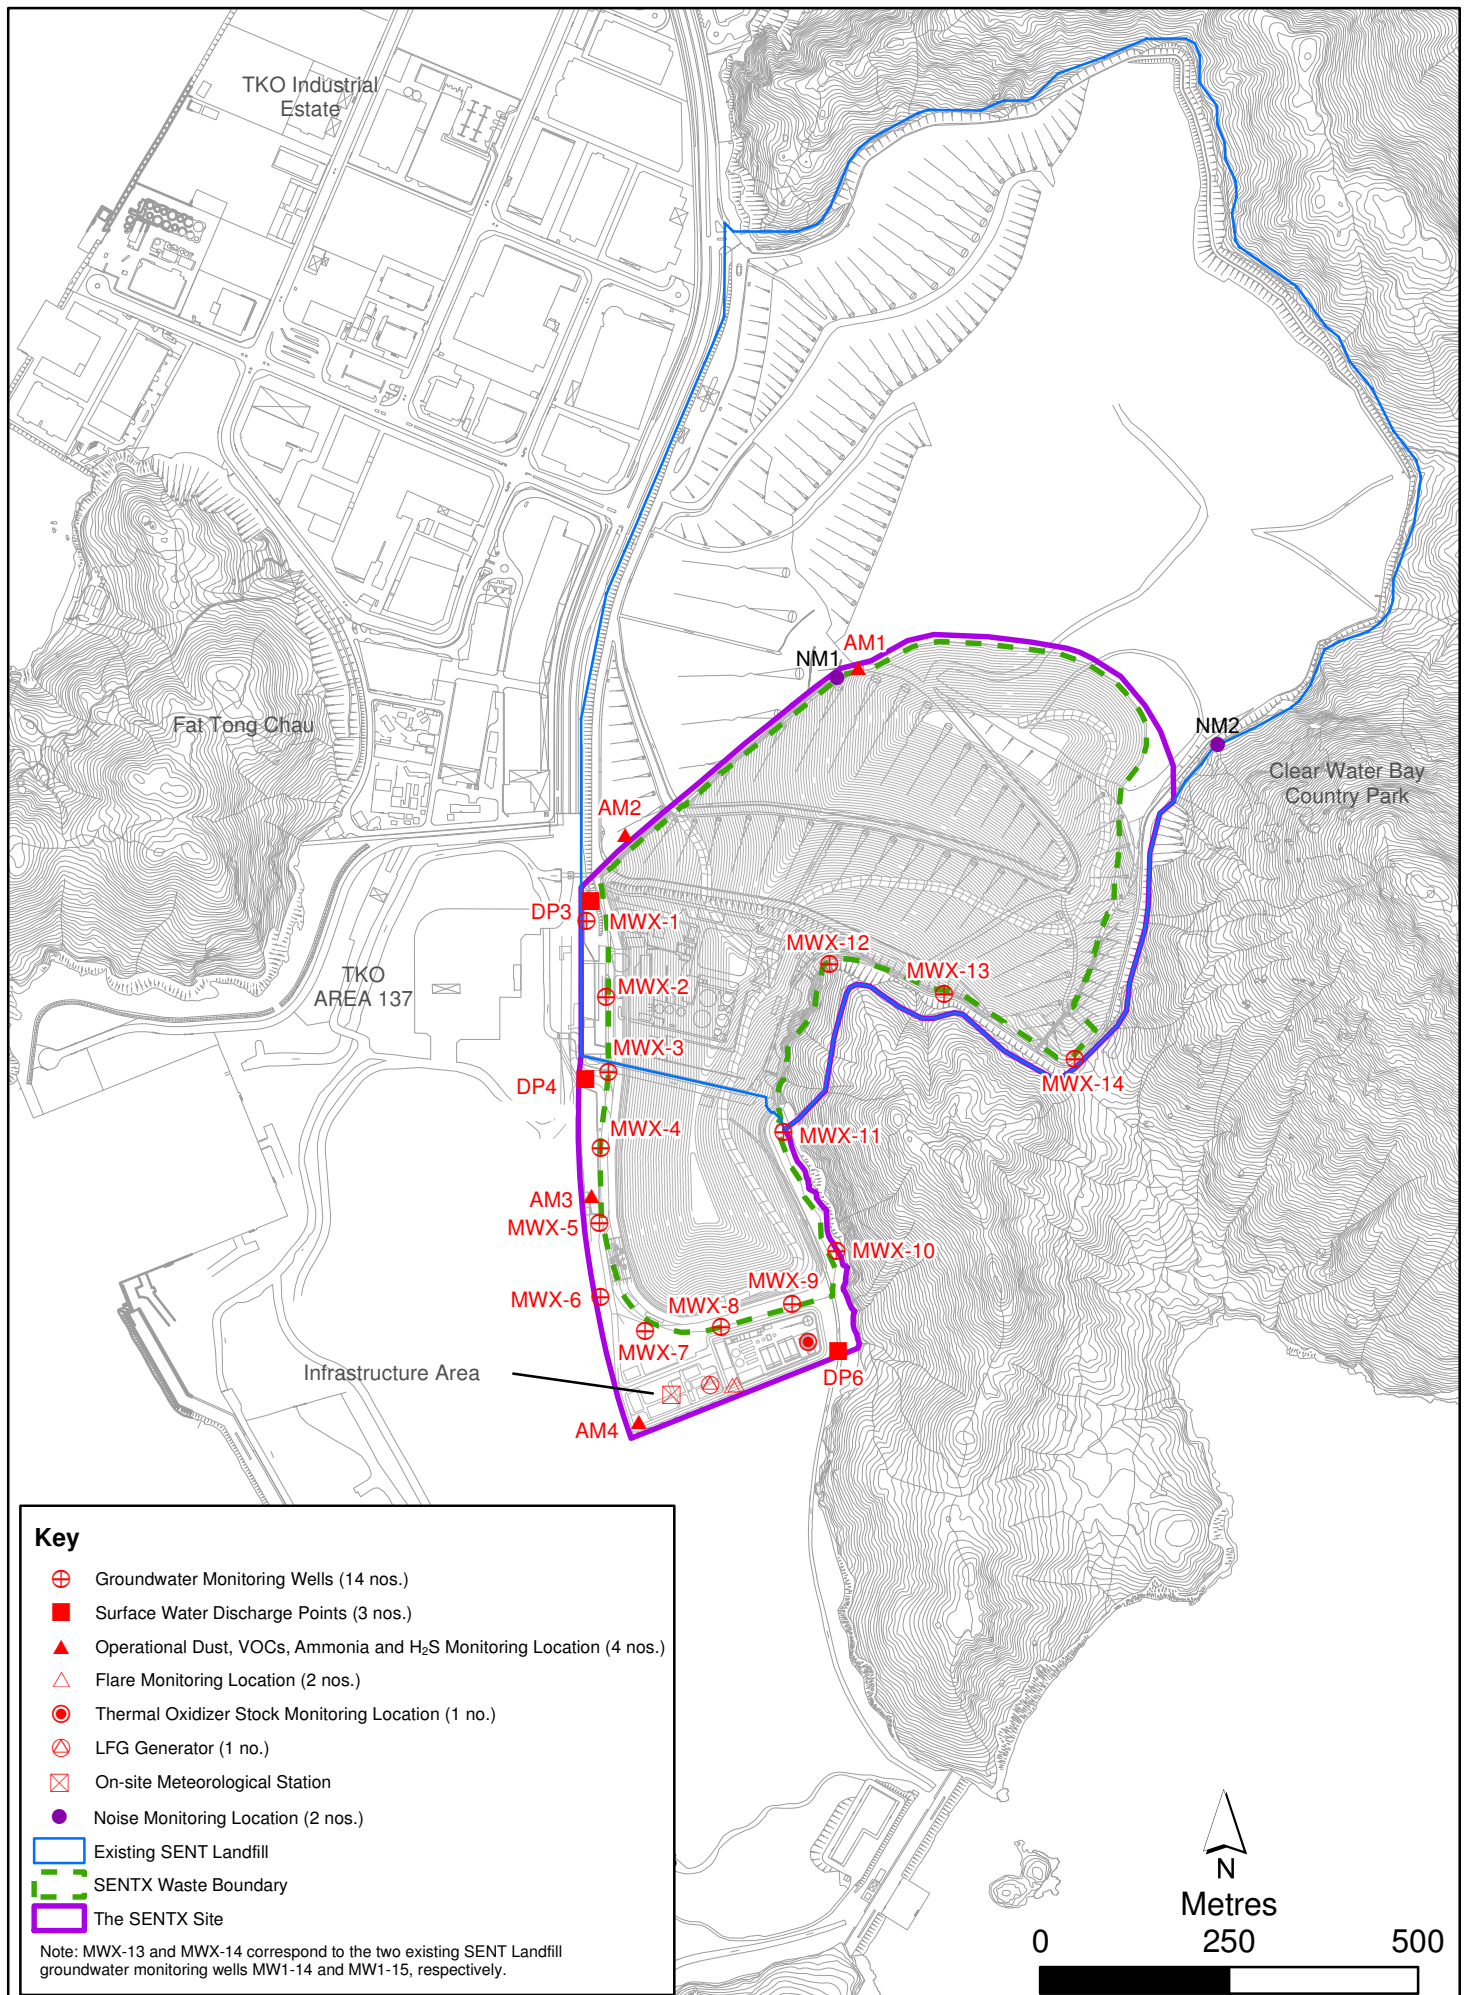
Figure 2.1

Environmental Monitoring Locations

The equipment used in the impact dust monitoring programme and monitoring locations are summarised in *Table 2.2* and illustrated in *Figure 2.1*, respectively. Copies of the calibration certificates for the equipment are presented in *Annex D1*.
