Agreement No. CE 5/2019 (EP)
Independent Environmental Checker for First Stage of
Tseung Kwan O Desalination Plant – Investigation
Verification of Monthly EM&A Report No.22 (December 2021)

### Contract No. 13/WSD/17

## Design, Build and Operate First Stage of Tseung Kwan O Desalination Plant

Design, Build and Operate First Stage of Tseung Kwan O Desalination Plant Monthly EM&A Report No.22

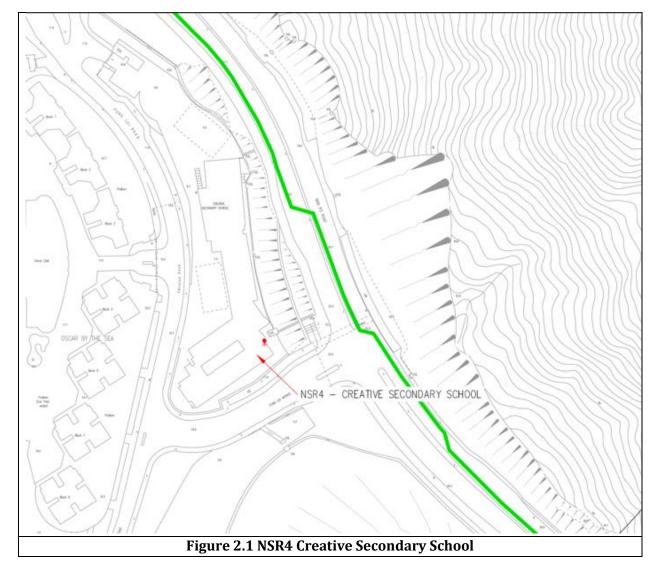
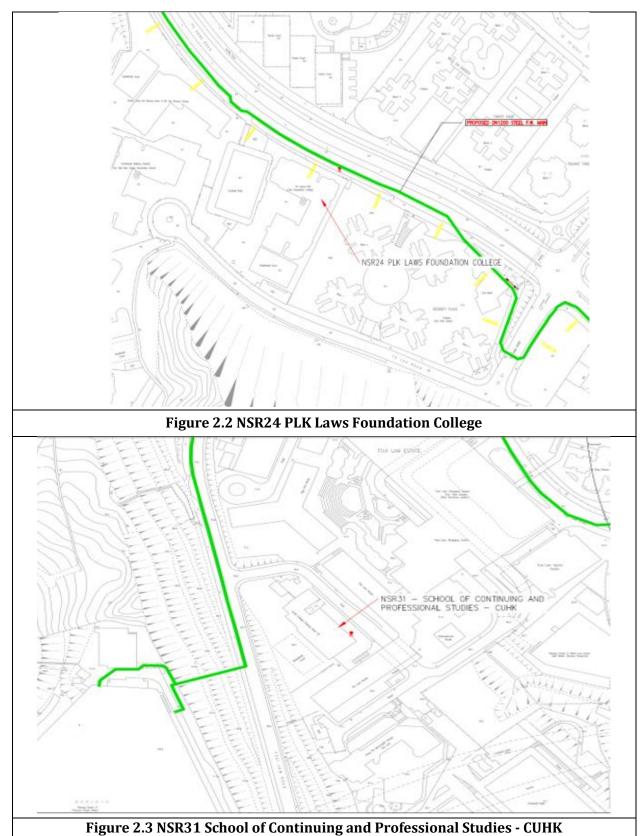
Three noise monitoring locations for impact monitoring at the nearby sensitive receivers are shown in **Figure 2.1-2.3**.

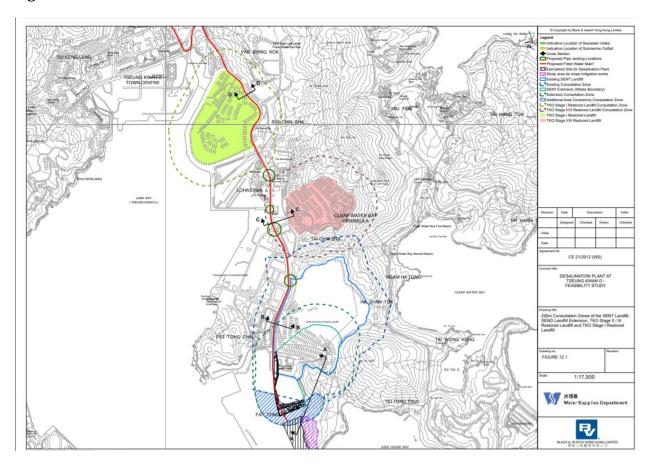
Figure 5.1 Overview of the SENT Extension Consultation Zone and the Contract Site Area

The area required to be monitored for landfill gas in the reporting period is shown in **Figure 5.2**.

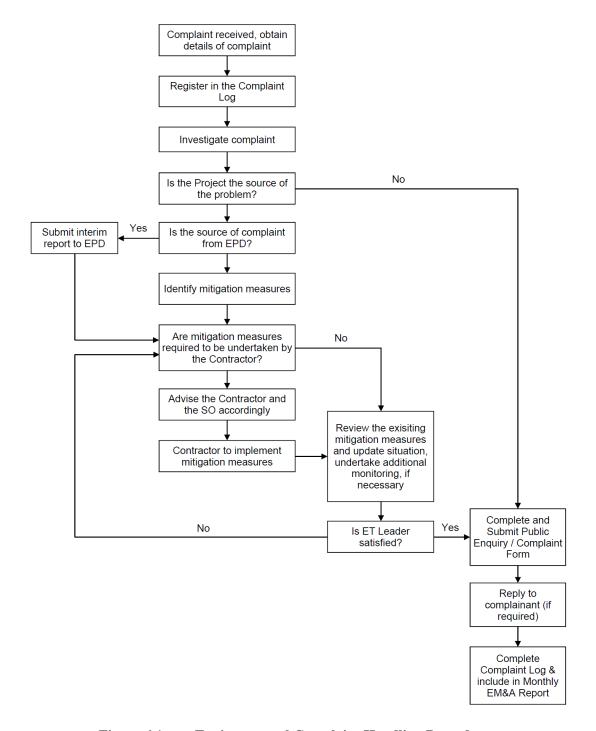
Figure 6.1 Environmental Complaint Handling Procedures

The Environmental Complaint Handling Procedure is shown in below **Figure 6.1**:

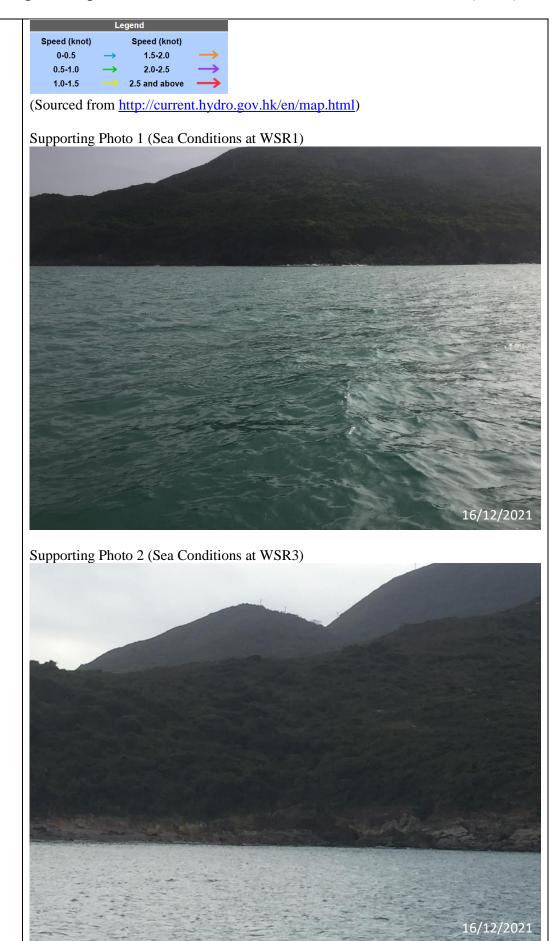
Dominating sea current direction was found to be from Southeast to Northwest at waters to the west side of Tit Cham Chau; and from Northeast to Southwest at waters to the east side of Tit Cham Chau.

Current direction during mid-flood sampling on 16 December 2021:
