WSD Contract No.: 3/WSD/20 -

Reclaimed Water Supply to Sheung Shui and Fanling

MONTHLY ENVIRONMENTAL MONITORING & AUDIT Report (No.4) – March 2022

PREPARED FOR WATER SUPPLIES DEPARTMENT

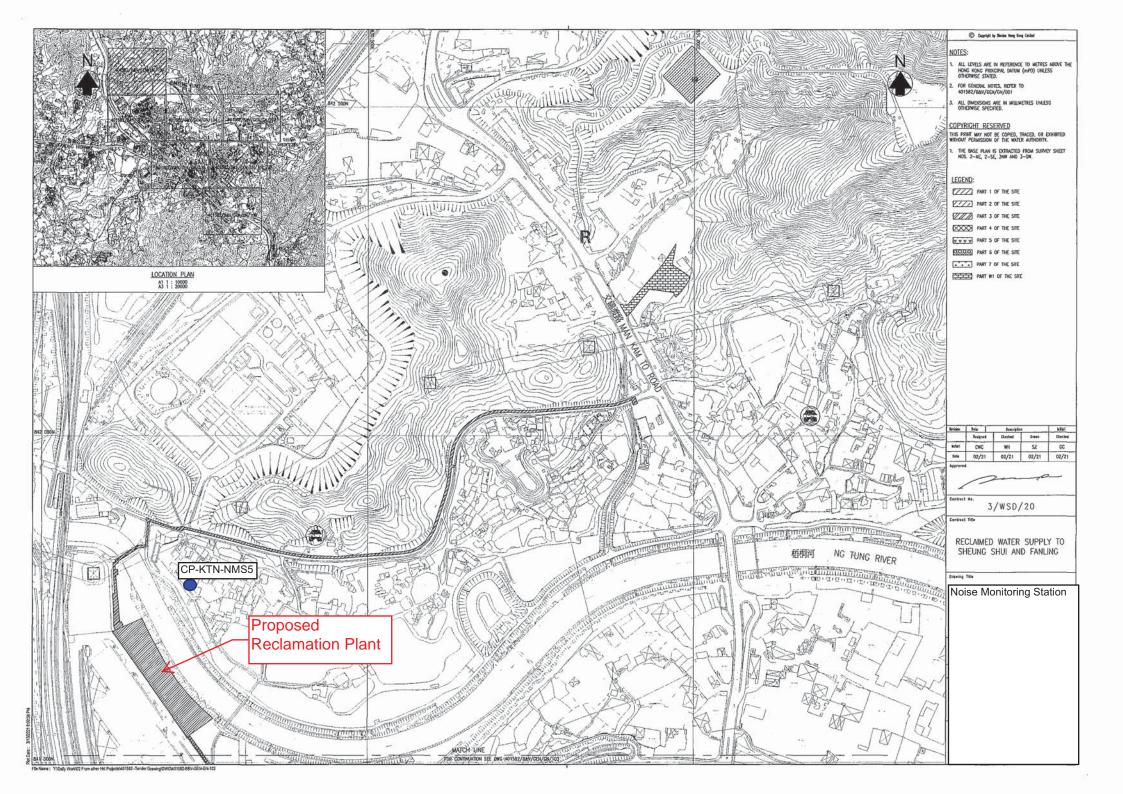
Location of Designated Noise Monitoring Station CP-KTN-NMS5

- 3.3.2 According to the geographic location of proposed Shek Wu Hui Water Reclamation Plant and all the recommended designated construction noise monitoring stations, only the designated noise monitoring station CP-KTN-NMS5 (prior named "CP-NMS7") shown in *Appendix D*, is located near the proposed Shek Wu Hui Water Reclamation Plant within 300m (distance about 110m). Therefore, the designated noise monitoring station CP-KTN-NMS5 is recommended for the Contract Works to undertake construction noise monitoring. If the recommended noise monitoring location CP-KTN-NMS5 not available, the ET shall propose alternative monitoring locations/additional monitoring location is proposed, the monitoring location shall be chosen based on the following criteria:

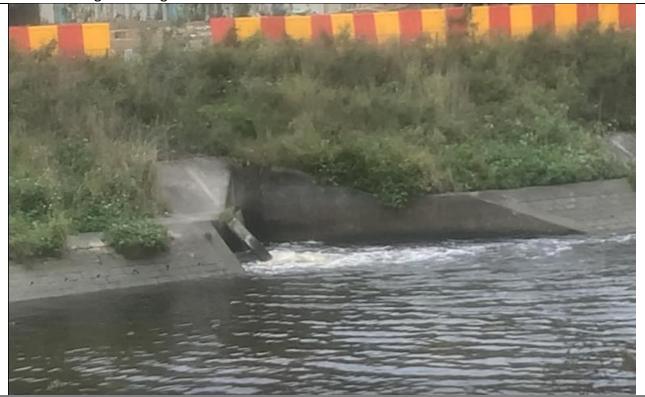
Photo 1 Sewage discharge at P3

- 5.8 Once again, with observations on site and knowledge available, it is suggested that cumulative effects of increased disturbances (a photo of the sewage discharge at P3 is provided in **Appendix D**) at the study area and more attractive wetland habitats at LVNP may have caused waterbirds to deprioritize activities within the study area. The surveyor also reported no specific instances of noise or activities that has scared away waterbirds from the construction site during March.

- 5.9 As the current monitoring findings have triggered the action and/or limit levels, it is suggested that the construction site should continue keeping the best site practice in noise control to minimize disturbance caused to waterbirds. Surveyors would also pay special attention to the
