Provision of Environmental Team consultancy for Design and Construction of Kong Nga Po Police Training Facilities (Programme no. 279LP) Quotation No. PMB202/8480/2022/A01/A Submission of monthly EM&A report in June 2023 v4

Provision of Independent Environmental Checker Consultancy for Design and Construction of Kong Nga Po Police Training Facilities **Verification of Monthly EM&A Report (June 2023)**

Design and Construction of Kong Nga Po Police Training Facilities <u>Proactive Environmental Protection Proforma</u>

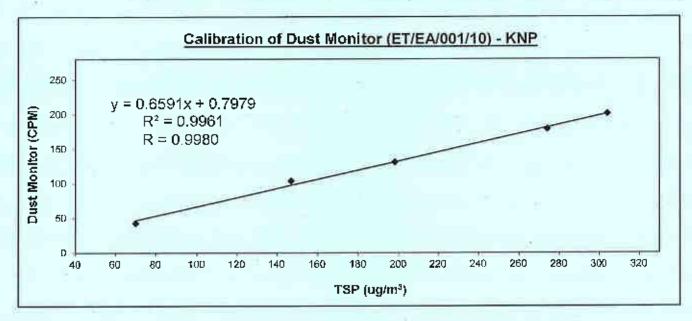
*	Dust Monitor (CPM)	43	104	131	179	201
	TSP (ug/m³)	70	147	198	274	304
High Volume Air Sampler Serail No.: 1180 Calibration Due Date: 27 April 2023

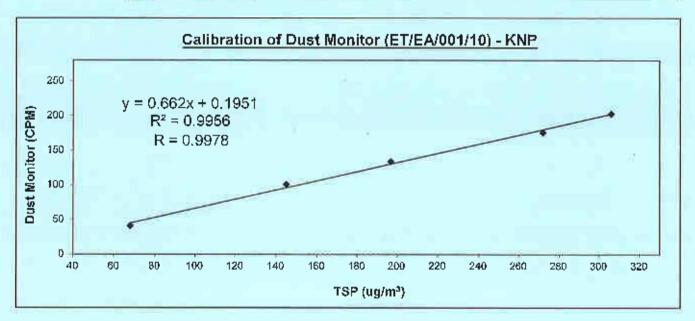
Dust Monitor (CPM)	41	101	134	176	203	
TSP (ug/m³)	68	145	197	272	306	
High Volume Air Sampler Serail No.: 1180	Calibration Due Date: 25 June 2023

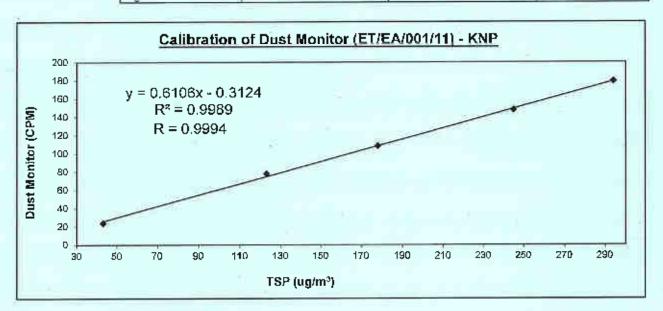
Dust Monitor (CPM)	24	78	108	148	179
TSP (ug/m³)	43	123	178	245	294
High Volume Air Sampler Serail No.:1180	No.:1180 Calibration Due Date: 27 April 2023

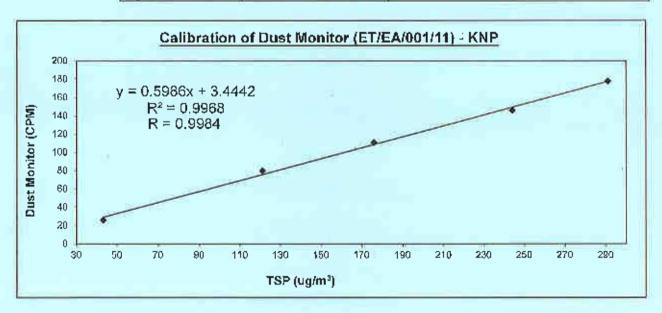
Dust Monitor (CPM)	26	80	111	146	178
TSP (ug/m³)	43	121	176	244	291
High Volume Air Sampler Serail No :1180	Calibration Due Date: 25 June 2023

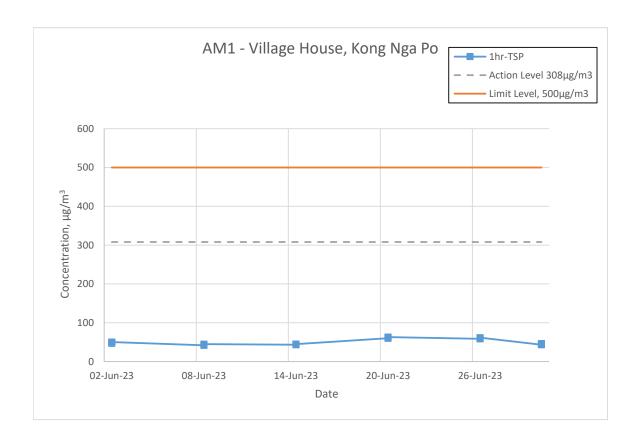
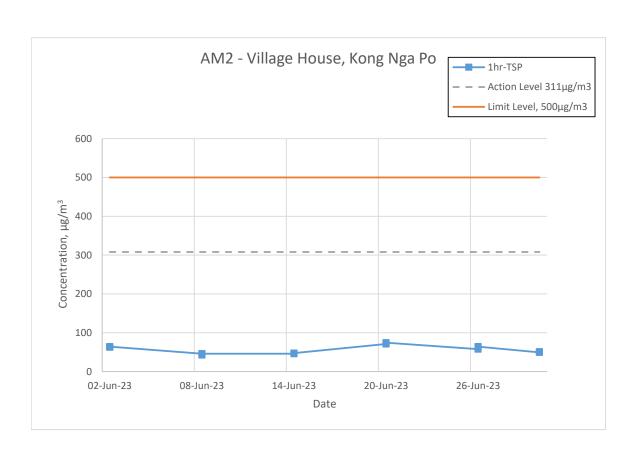
1-hr TSP Concentration Levels

Date	Time	Weather	Particulate Concentration (µg/m³)
	10:00		63
02-Jun-23	11:00	Cloudy	64
	13:00		64
	10:00	_	46
08-Jun-23	11:00	Drizzle	43
	13:00		46
	9:00	_	46
14-Jun-23	10:00	Cloudy	48
	11:00		48
	10:00	_	71
20-Jun-23	11:00	Cloudy	73
	13:00		74
	10:00	_	58
26-Jun-23	11:00	Cloudy	64
	13:00		64
	10:00	_	49
30-Jun-23	11:00	Fine	51
	13:00		51
		Minimum	43
		Maximum	74
		Average	57

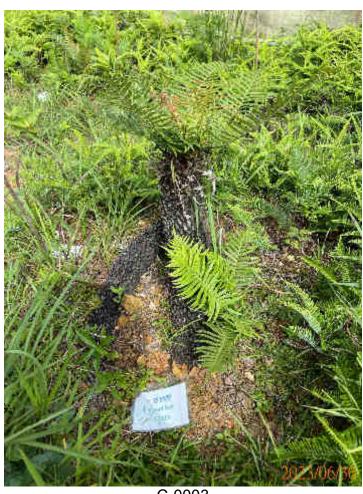
Tree/Plant/	Number of		Form	Health	D 1
Colony No.	Individuals	Species Name	(Good/Fair/Poor)	(Good/Fair/Poor)	Remark
j	01	Brainea insignis	F	F	Young leaves observed
	02	Brainea insignis	F	F	Young leaves observed
	03	Brainea insignis	F	F	Young leaves observed
~ ~ ~ ~ .	04	Brainea insignis	F	F	Young leaves observed
C-0001	05	Brainea insignis	F	F	Young leaves observed
	06	Brainea insignis	F	F	Young leaves observed
	07	Brainea insignis	F	F	Young leaves observed
	08	Brainea insignis	F	F	Young leaves observed
	01	Brainea insignis	F	F	Young leaves observed
	02	Brainea insignis	F	F	Young leaves observed
	03	Brainea insignis	F	P	Young leaves observed
	04		F	P	Young leaves observed
C-0002	05	Brainea insignis	F	F	Young leaves observed
		Brainea insignis			Č
	06	Brainea insignis	F	F	Young leaves observed
	07	Brainea insignis	F	F	Young leaves observed
	08	Brainea insignis	F	F	Young leaves observed
C-0003	01	Brainea insignis	F	F	Young leaves observed

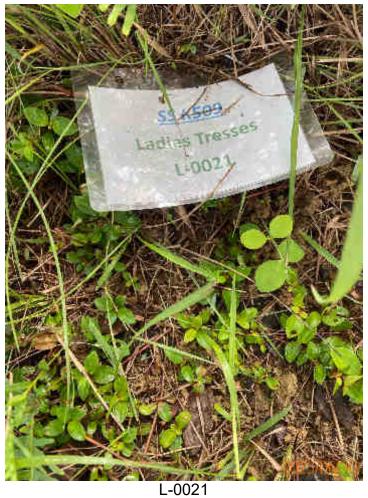
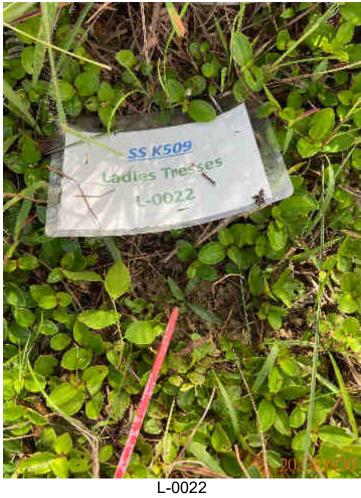
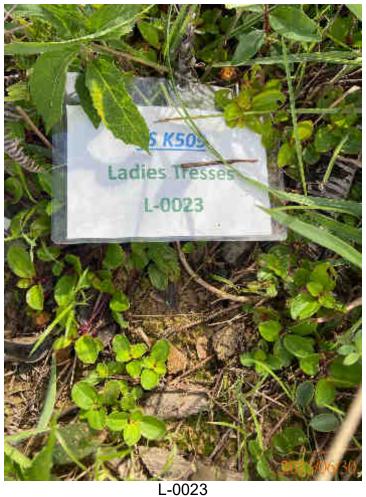
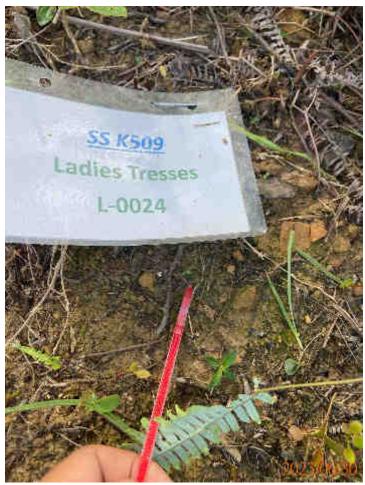
Tree/Plant/ Colony No.	Species Name	Form (Good/Fair/Poor)	Health (Good/Fair/Poor)	30/6/2023
L-0001	Spiranthes sinensis	-	-	Not observed
L-0002	Spiranthes sinensis	P	P	Leaf observed
L-0003	Spiranthes sinensis	P	P	Leaf observed
L-0004	Spiranthes sinensis	-	-	Not observed
L-0005	Spiranthes sinensis	-	-	Not observed
L-0006	Spiranthes sinensis	-	-	Not observed
L-0007	Spiranthes sinensis	-	-	Not observed
L-0008	Spiranthes sinensis	P	P	Leaf observed
L-0009	Spiranthes sinensis	-	-	Not observed
L-0010	Spiranthes sinensis	-	-	Not observed
L-0011	Spiranthes sinensis	-	-	Not observed
L-0012	Spiranthes sinensis	-	-	Not observed
L-0013	Spiranthes sinensis	-	-	Not observed
L-0014	Spiranthes sinensis	P	P	Leaf observed
L-0015	Spiranthes sinensis	P	P	Leaf observed
L-0016	Spiranthes sinensis	-	-	Not observed
L-0018	Spiranthes sinensis	F	F	Leaf observed
L-0019	Spiranthes sinensis	_	_	Not observed
L-0020	Spiranthes sinensis	_	_	Not observed

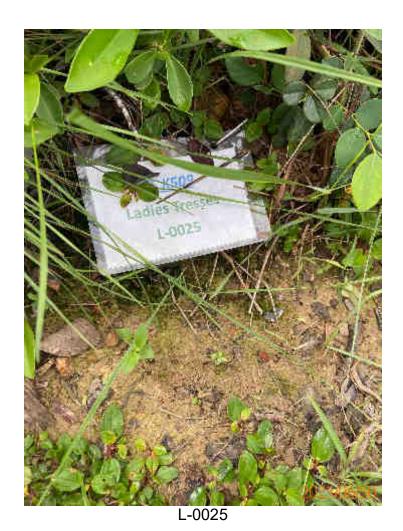
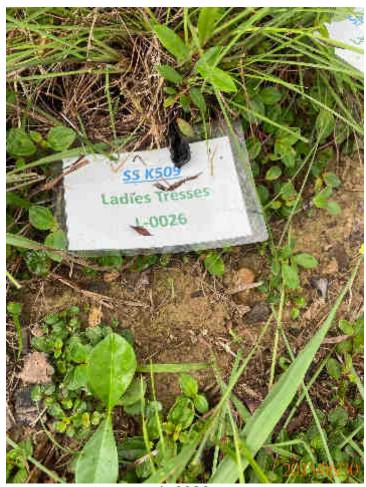
L-0021	Spiranthes sinensis	-	-	Not observed
L-0022	Spiranthes sinensis	F	F	Leaf observed
L-0023	Spiranthes sinensis	-	-	Not observed
L-0024	Spiranthes sinensis	P	P	Leaf observed
L-0025	Spiranthes sinensis	-	-	Not observed
L-0026	Spiranthes sinensis	-	-	Not observed
L-0027	Spiranthes sinensis	-	_	Not observed
L-0028	Spiranthes sinensis	-	-	Not observed
L-0029	Spiranthes sinensis	-	-	Not observed
L-0030	Spiranthes sinensis	-	_	Not observed
L-0031	Spiranthes sinensis	F	F	Leaf observed
L-0032	Spiranthes sinensis	-	-	Not observed
L-0033	Spiranthes sinensis	-	-	Not observed
L-0034	Spiranthes sinensis	-	-	Not observed
L-0035	Spiranthes sinensis	-	-	Not observed
L-0036	Spiranthes sinensis	-	-	Not observed
L-0037	Spiranthes sinensis	F	F	Leaf observed
L-0038	Spiranthes sinensis	-	-	Not observed
L-0039	Spiranthes sinensis	-	-	Not observed
L-0040	Spiranthes sinensis	P	P	Leaf observed
L-0041	Spiranthes sinensis	-	-	Not observed

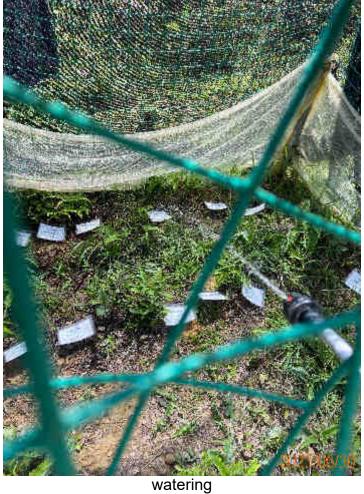
Check fence

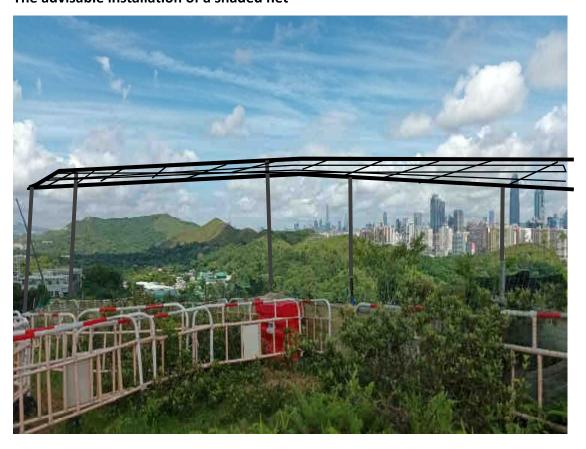
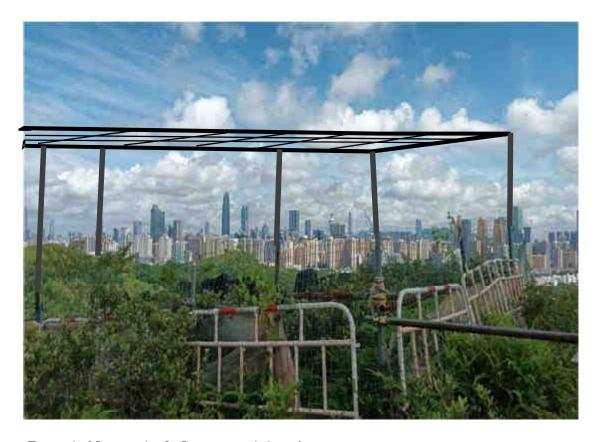
The advisable installation of a shaded net

Remark: Non scale & Conceptual drawing
