Provision of Environmental Team consultancy for Design and Construction of Kong Nga Po Police Training Facilities (Programme no. 279LP) Quotation No. PMB202/8480/2022/A01/A Submission of monthly EM&A report in September 2023

Provision of Independent Environmental Checker Consultancy for Design and Construction of Kong Nga Po Police Training Facilities Verification of Monthly EM&A Report (September 2023)

Monitoring and Maintenance Works for Flora Species of Conservation Interest

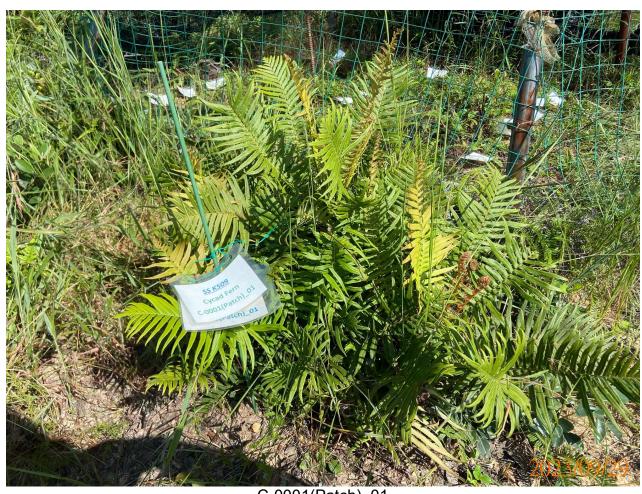
C-0001(Patch)_01

Tree/Plant/	Number of		Form	Health	
Colony No.	Individuals	Species Name	(Good/Fair/Poor)	(Good/Fair/Poor)	Remark
	01	Brainea insignis	F	F	Young leaves observed
	02	Brainea insignis	F	F	Young leaves observed
	03	Brainea insignis	F	F	Young leaves observed
C-0001	04	Brainea insignis	F	F	Young leaves observed
C-0001	05	Brainea insignis	F	F	Young leaves observed
	06	Brainea insignis	F	F	Young leaves observed
	07	Brainea insignis	F	F	Young leaves observed
	08	Brainea insignis	F	F	Young leaves observed
	01	Brainea insignis	F	F	Young leaves observed
	02	Brainea insignis	F	F	Young leaves observed
	03	Brainea insignis	F	P	Young leaves observed
C 0002	04	Brainea insignis	F	P	Young leaves observed
C-0002	05	Brainea insignis	F	F	Young leaves observed
	06	Brainea insignis	F	F	Young leaves observed
	07	Brainea insignis	F	F	Young leaves observed
	08	Brainea insignis	F	F	Young leaves observed
C-0003	01	Brainea insignis	F	F	Young leaves observed

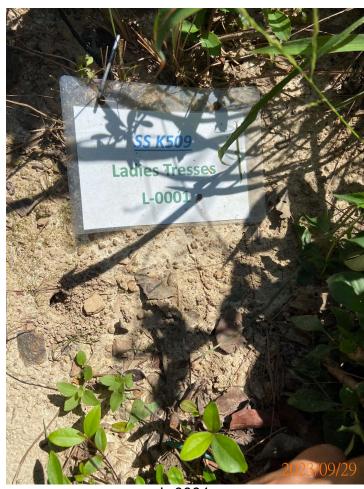
L-0001

L-0021	Spiranthes sinensis	-	-	Not observed
L-0022	Spiranthes sinensis	F	F	Leaf observed
L-0023	Spiranthes sinensis	-	-	Not observed
L-0024	Spiranthes sinensis	-	-	Not observed
L-0025	Spiranthes sinensis	-	-	Not observed
L-0026	Spiranthes sinensis	-	-	Not observed
L-0027	Spiranthes sinensis	-	-	Not observed
L-0028	Spiranthes sinensis	-	-	Not observed
L-0029	Spiranthes sinensis	-	-	Not observed
L-0030	Spiranthes sinensis	-	-	Not observed
L-0031	Spiranthes sinensis	F	F	Leaf observed
L-0032	Spiranthes sinensis	-	-	Not observed
L-0033	Spiranthes sinensis	-	-	Not observed
L-0034	Spiranthes sinensis	-	-	Not observed
L-0035	Spiranthes sinensis	-	-	Not observed
L-0036	Spiranthes sinensis	-	-	Not observed
L-0037	Spiranthes sinensis	F	F	Leaf observed
L-0038	Spiranthes sinensis	P	P	Leaf observed
L-0039	Spiranthes sinensis	-	-	Not observed
L-0040	Spiranthes sinensis	F	F	Leaf observed
L-0041	Spiranthes sinensis	-	-	Not observed

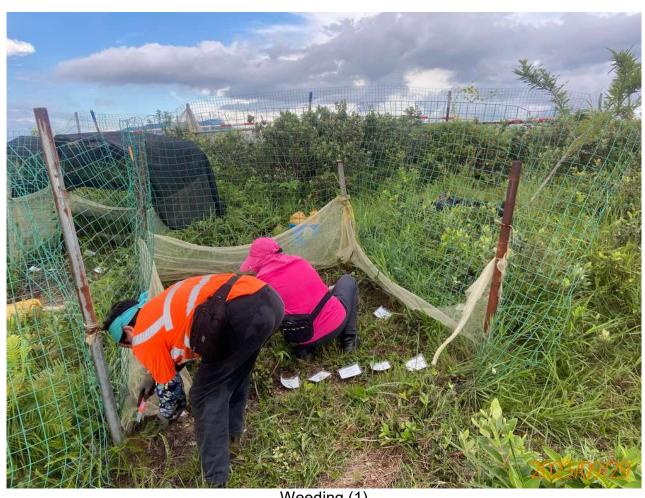
Weeding (1)

Description of Work																Date														
Description of Work	1	2	3	4	5	6	7	8	9	10	11	12	13	14	15	16	17	18	19	20	21	22	23	24	25	26	27	28	29	30
Watering																				Y										
Weeding																													Y	
Fertilization																														
Pest/Disease Control																														
Firming up of fence																													Y	
Installation of shaded net																														
Mulching																														
Inspection				Y					Y																				Y	
Checking of Protection Zone																													Y	
Remarks	R,MH	R, RH		МН	R,MH	МН	R,MH	R, RH	R, RH		R, RH	R,MH	R,MH	R, RH	R,MH	R,MH		МН	МН	МН	МН	МН	МН		R,MH	МН	R,MH	МН	МН	МН
	Publ	ic Hol	iday		Н-Но	ot	D-Dr	izzle		R-Ra	iny		W-W	indy		RH-F	ligh H	Iumid	ity	MH-l	Mediu	m Hu	midity	/	LH-L	ow H	umidi	ty
