**Sai Sha Road Widening
between Kam Ying Road and
Future Trunk Road T7 Junction**

**QUARTERLY ENVIRONMENTAL
MONITORING & AUDIT REPORT
REPORT NO. 10**

(JAN – MAR 2005)

**R/2563/042 Issue 1
April 2005**

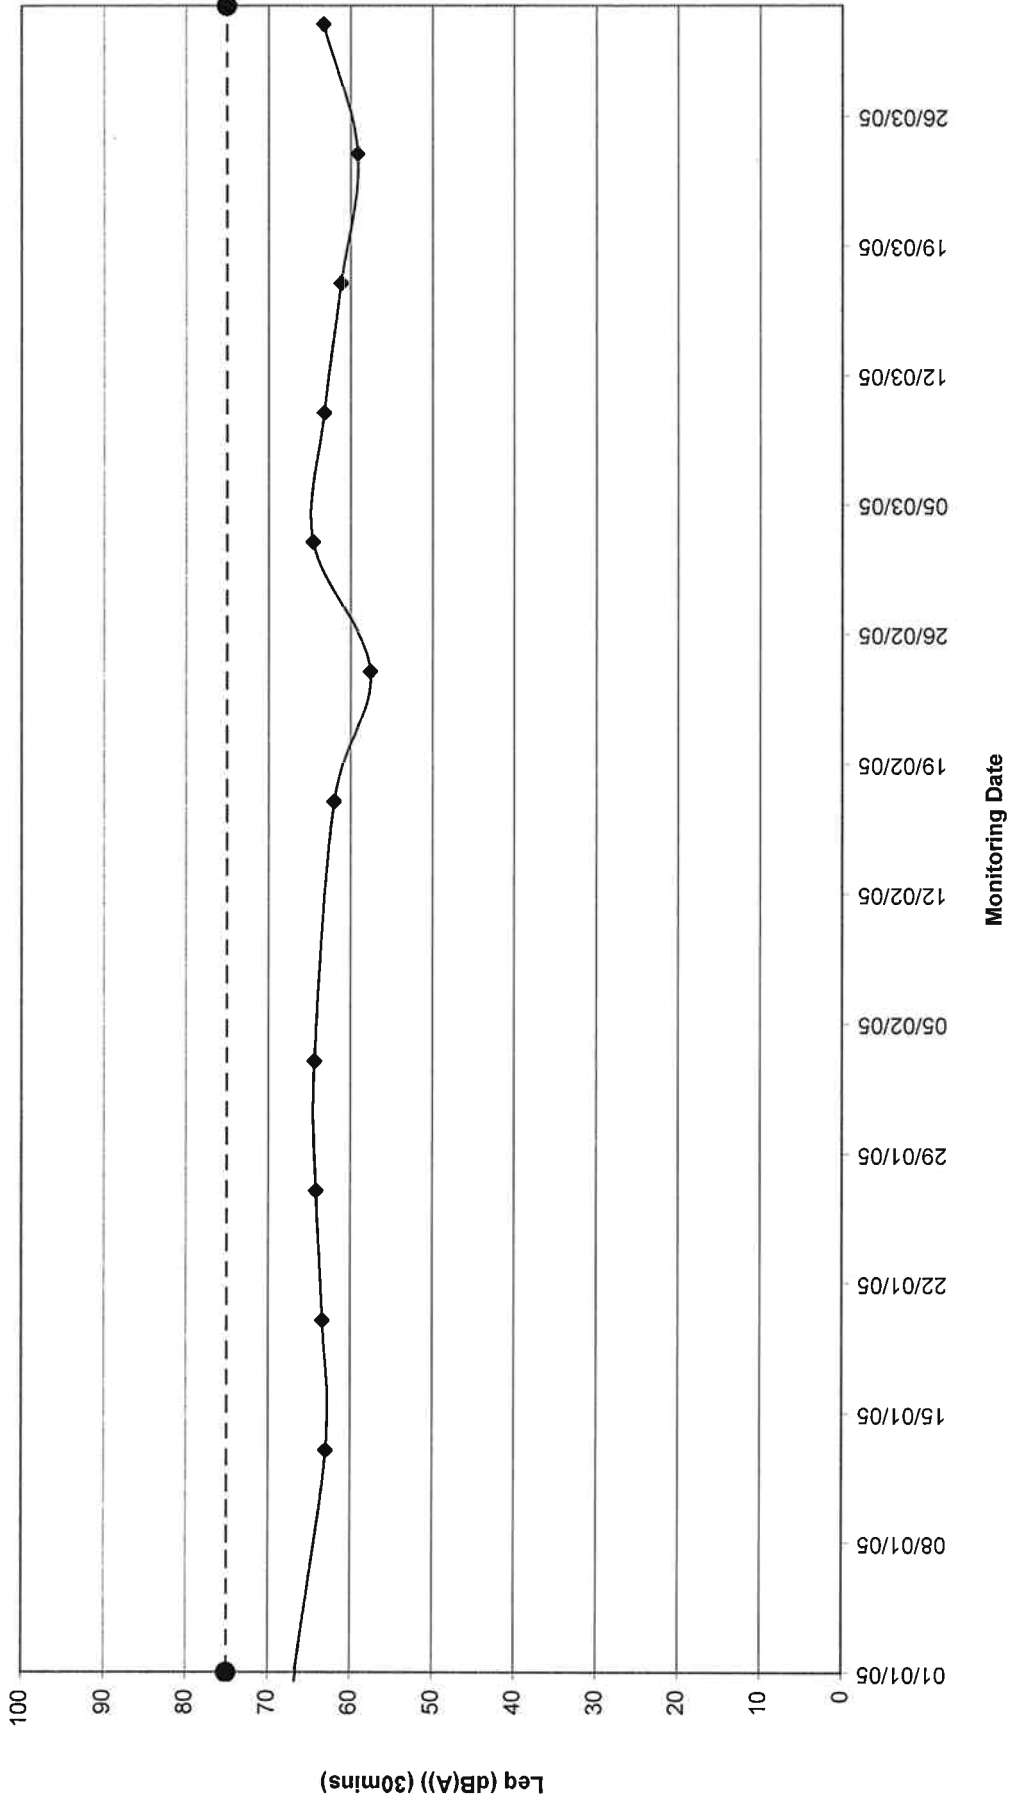
Graphical Noise Parameters for Kam Lung Court (CNM 2) (Jan 05 - Mar 05)

The construction works of the ASD site area near Lee On Estate slightly affected the noise monitoring results especially for CNM 2. The traffic noise from Sai Sha Road significantly contributed to the noise pollution.

● - - - - - Limit Level
◆ - - - - - Record Level

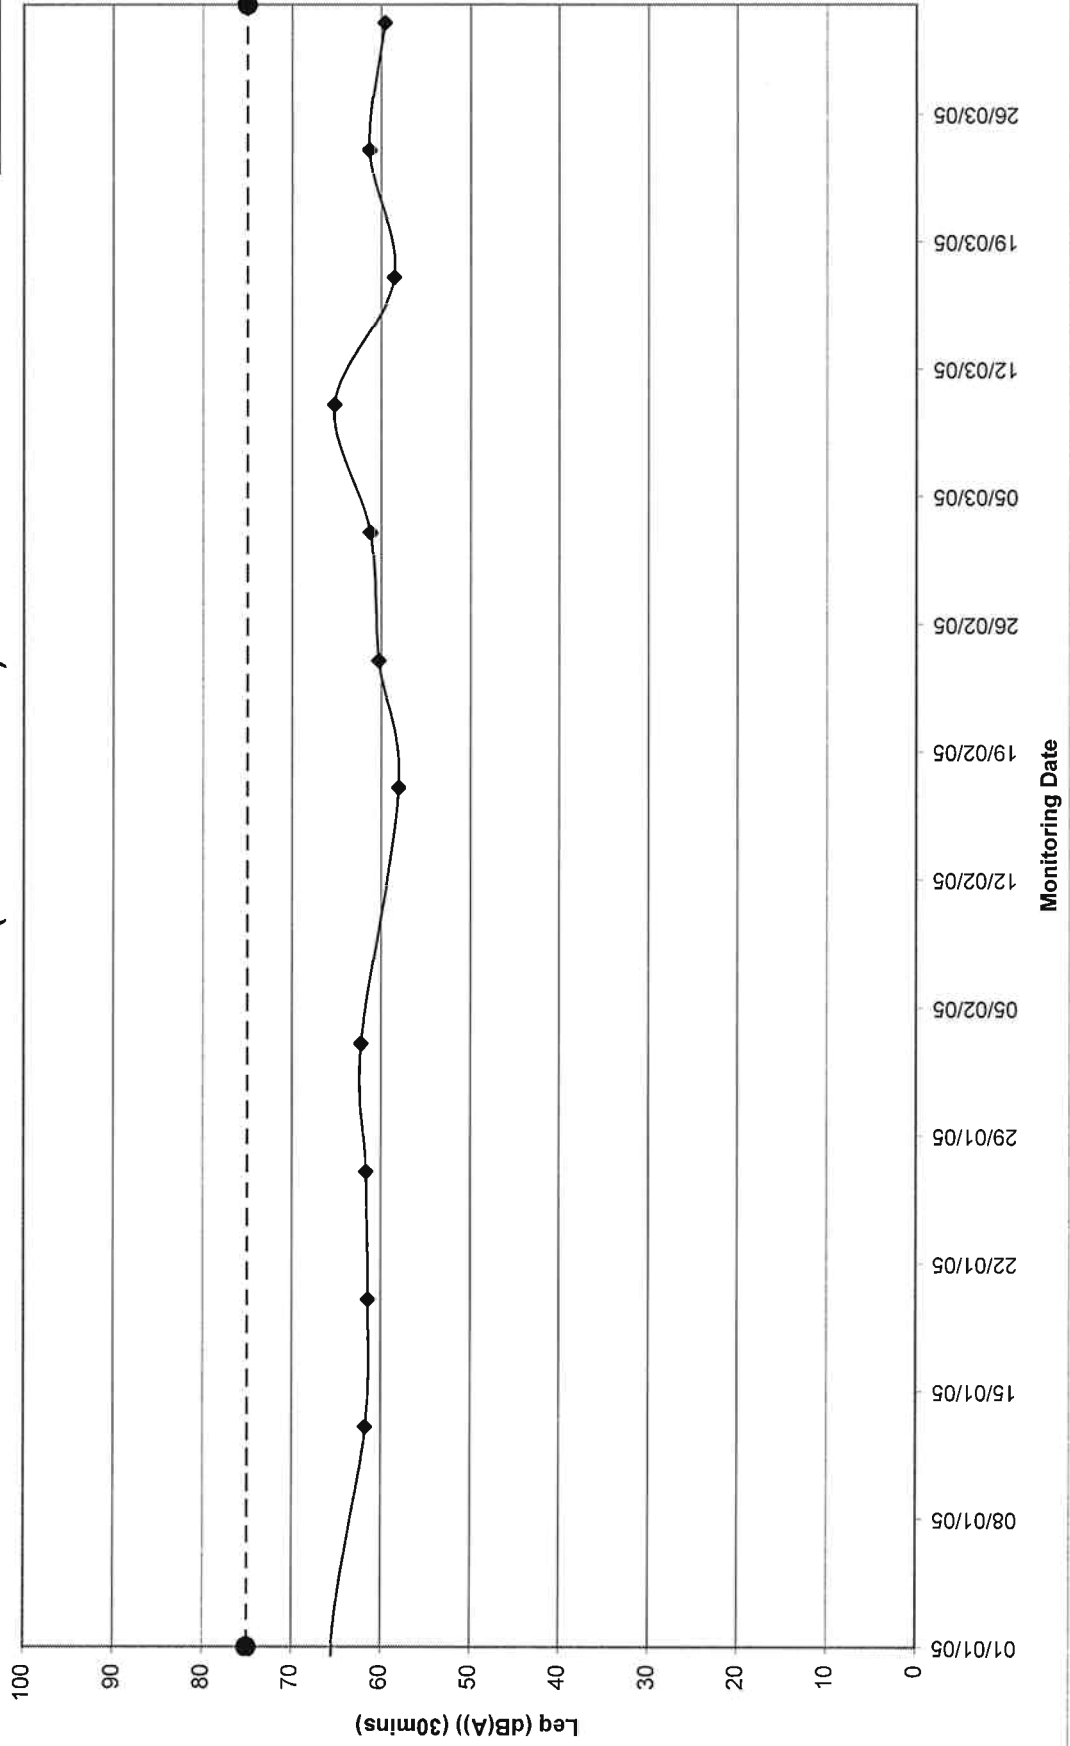
Graphical Noise Parameters for Wu Kwai Sha New Village (CNM 1) (Jan 05 - Mar 05)

During the reporting period, no noise limit exceedance was found.
