**Contract No. ST 89/02**

**Sha Tin Heights Tunnel and Approaches**

**Monthly EM&A Report**  
**(Version 1.0)**

January 2007

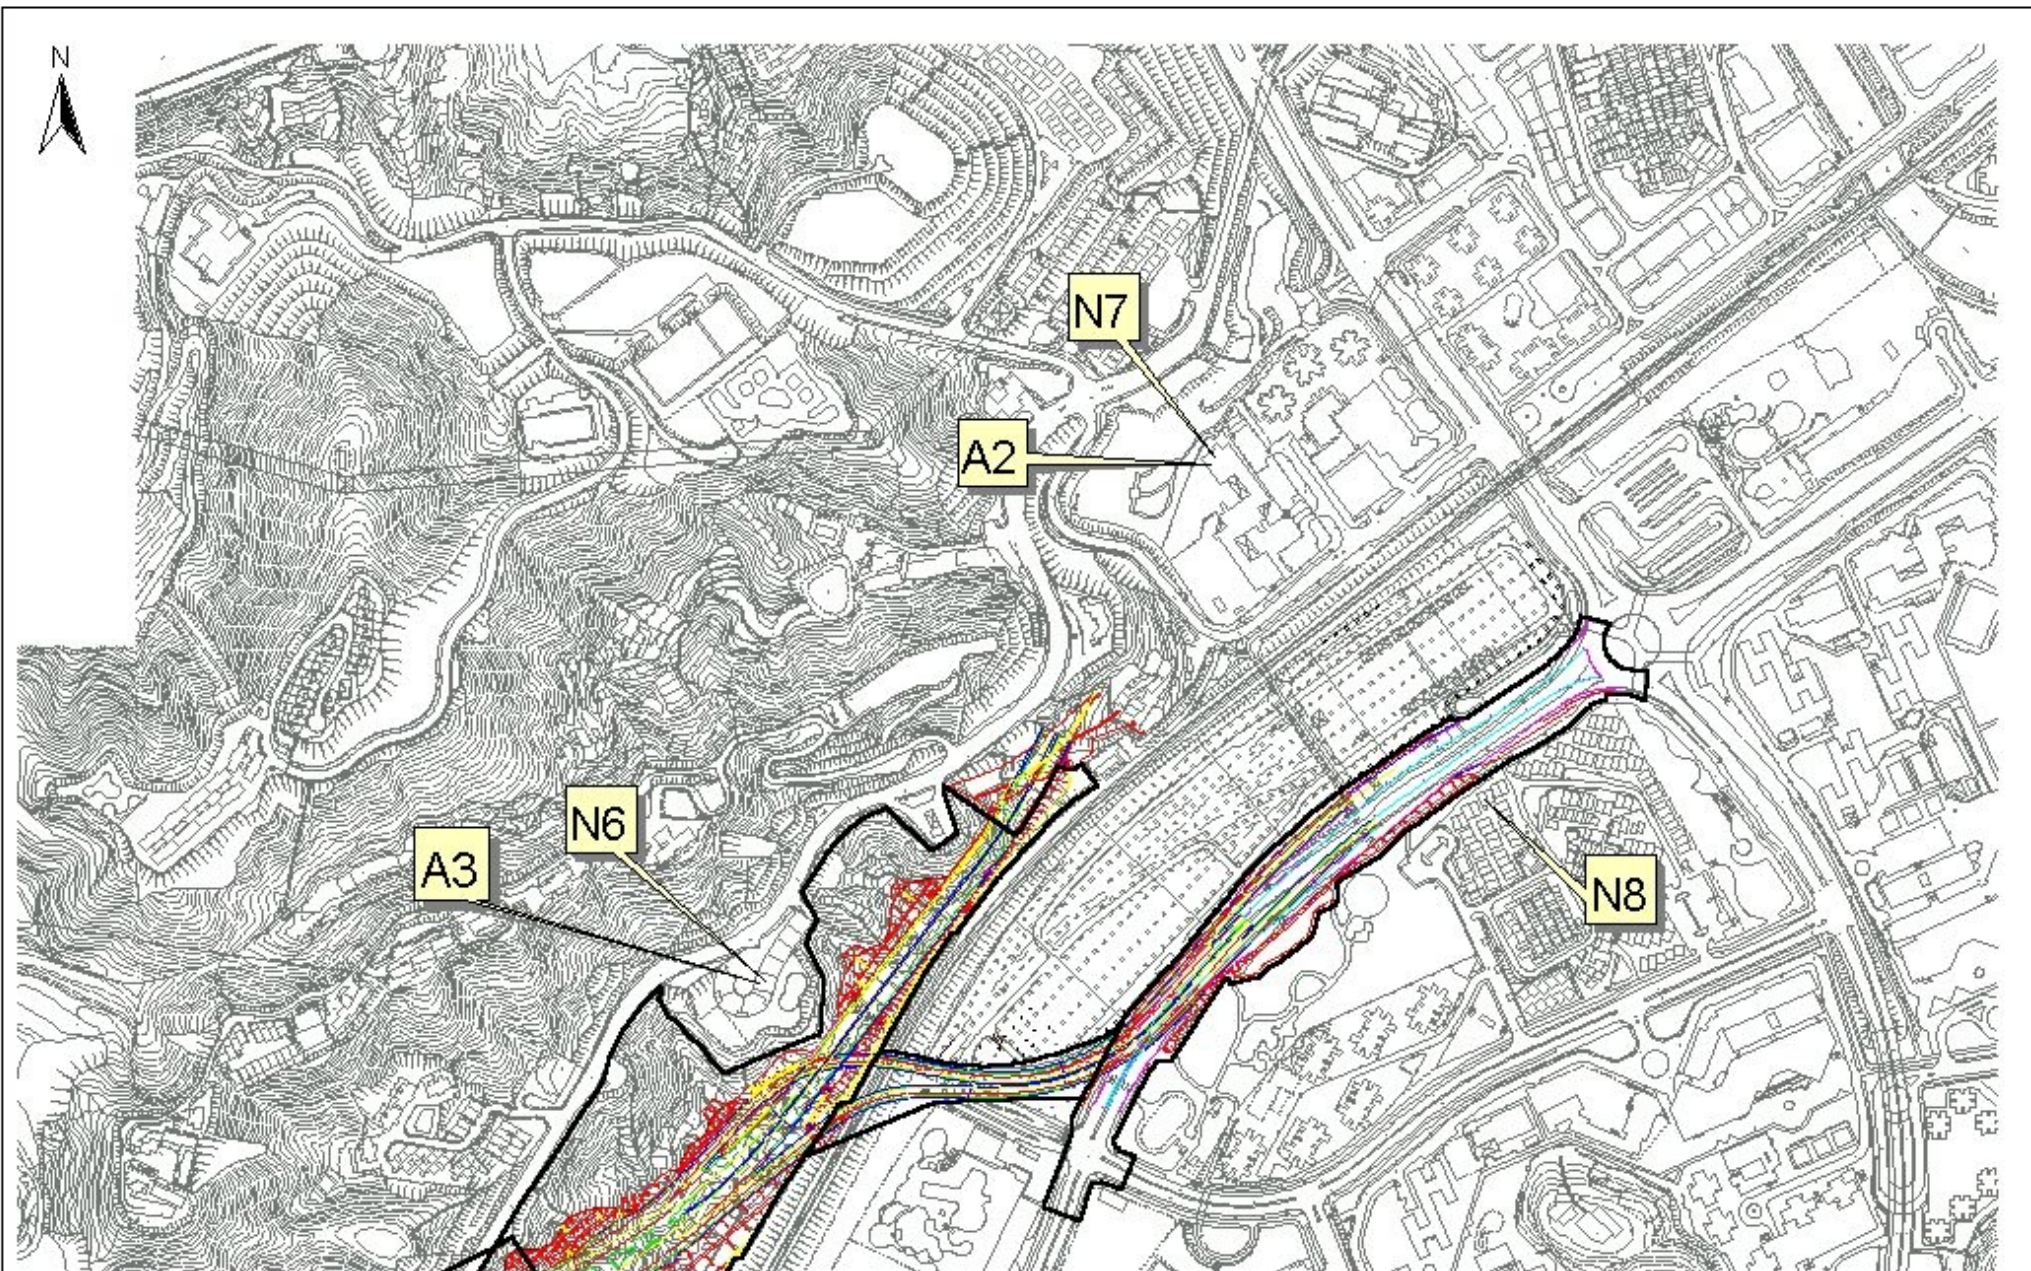
2a

Contract No. 92/02  
Environmental Team For Sha Tin Heights Tunnel & Approaches  
Locations of Monitoring Stations

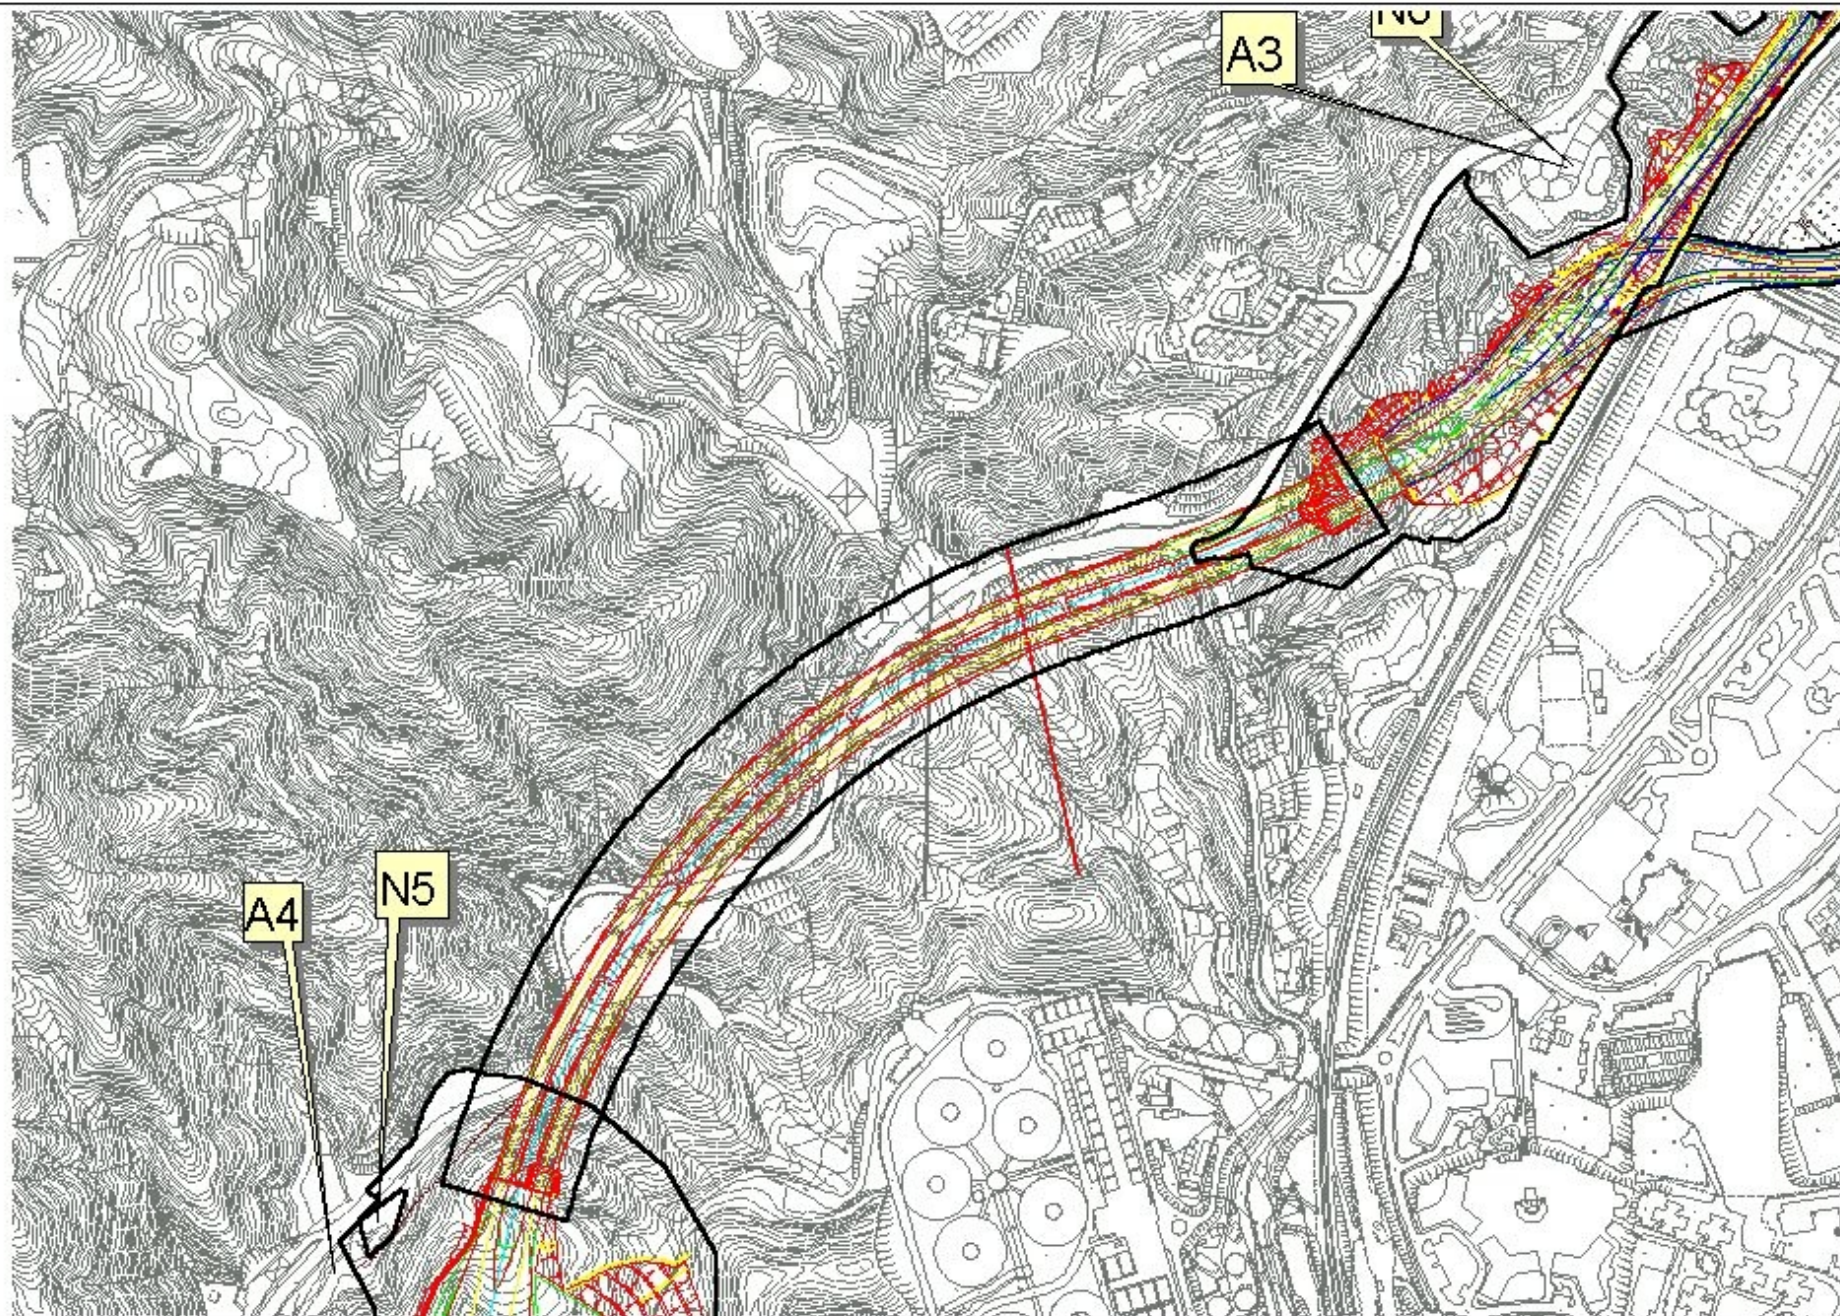
No. 2b

Contract No. 92/02  
Environmental Team For Sha Tin Heights Tunnel & Approaches

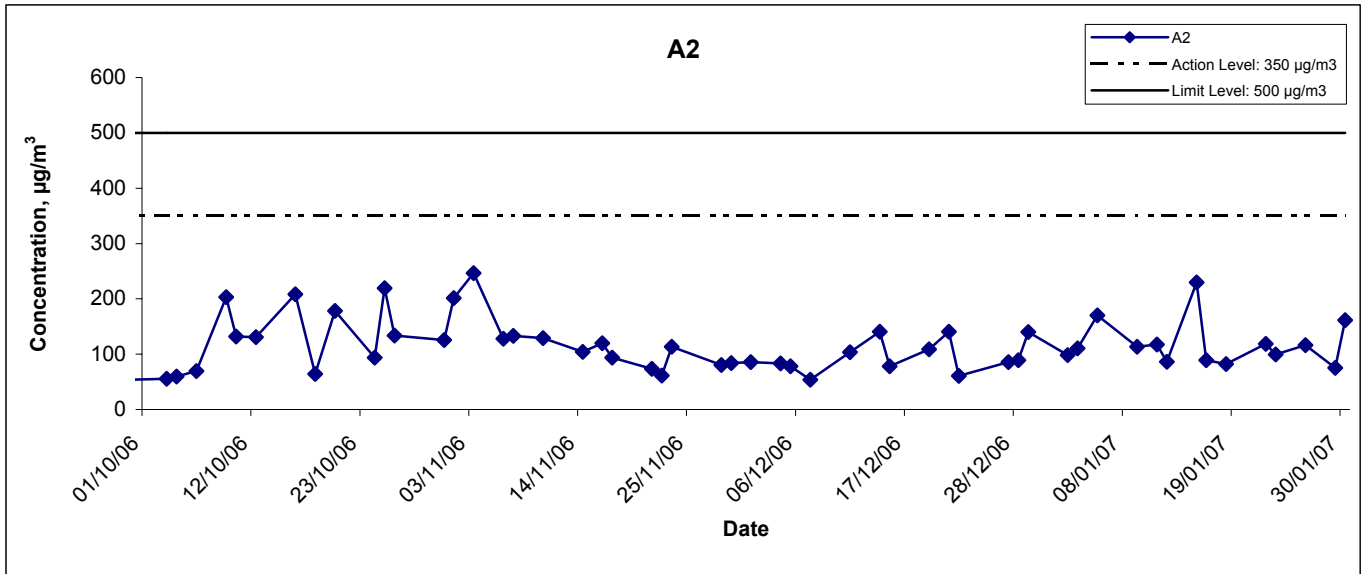
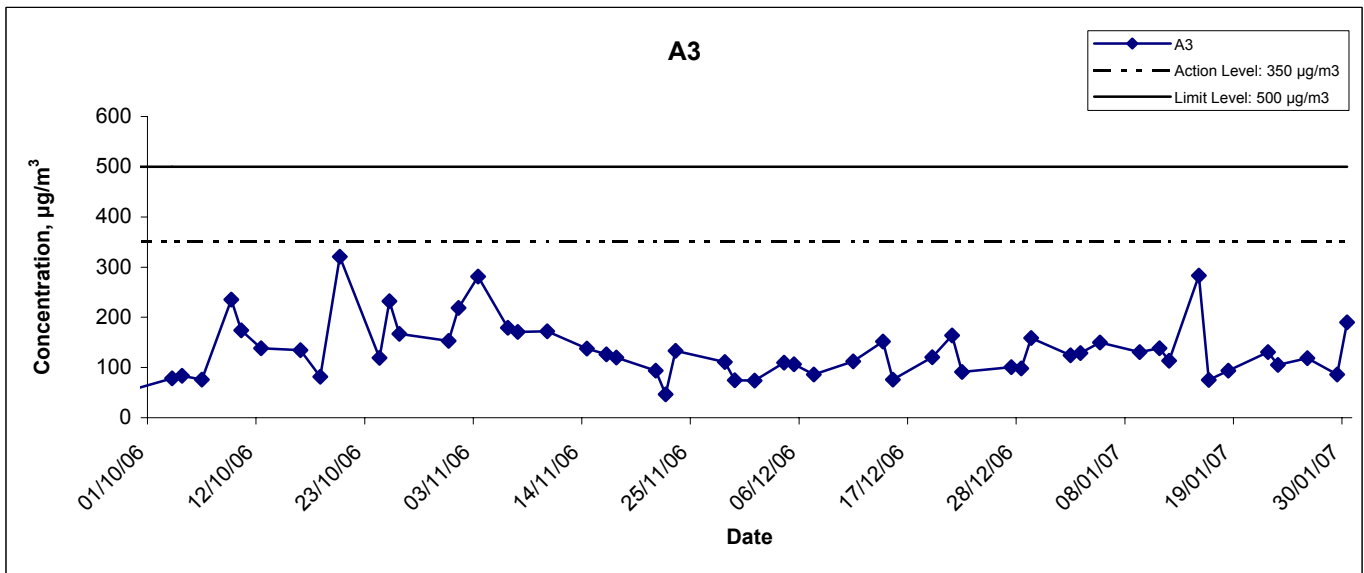
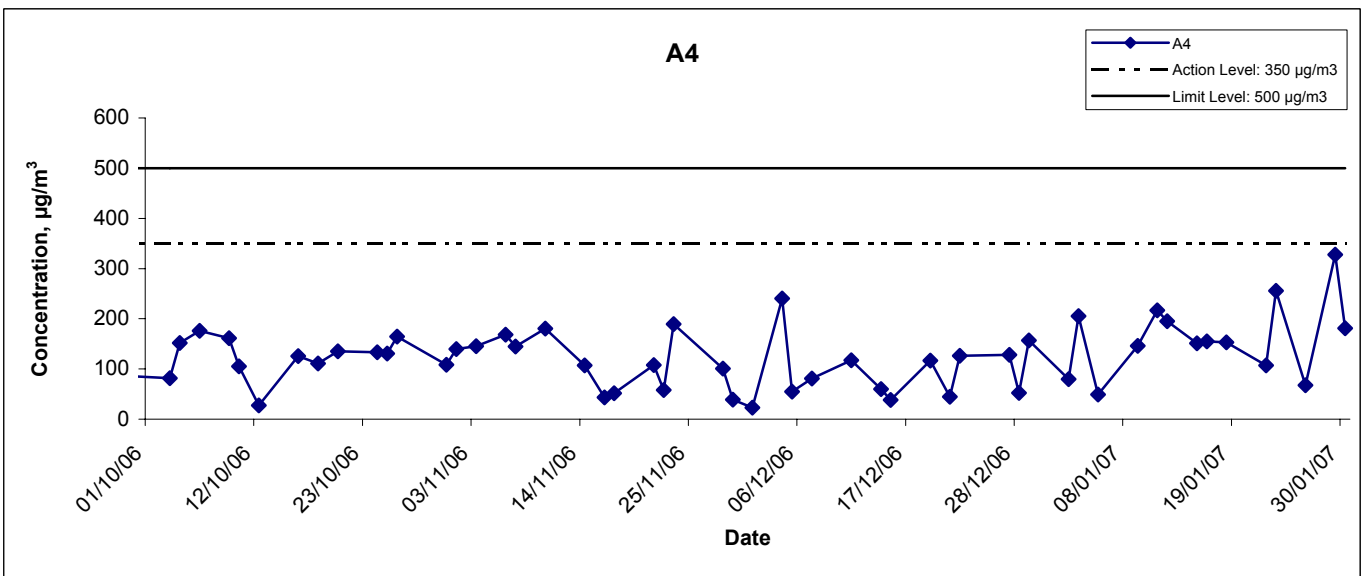
## 1-hr TSP Levels

<b>Title</b> Environmental Team for Sha Tin Heights Tunnel & Approaches Graphical Presentation of 1-hour TSP Monitoring Results	<b>Scale</b> N.T.S	<b>Project No.</b> MA2027

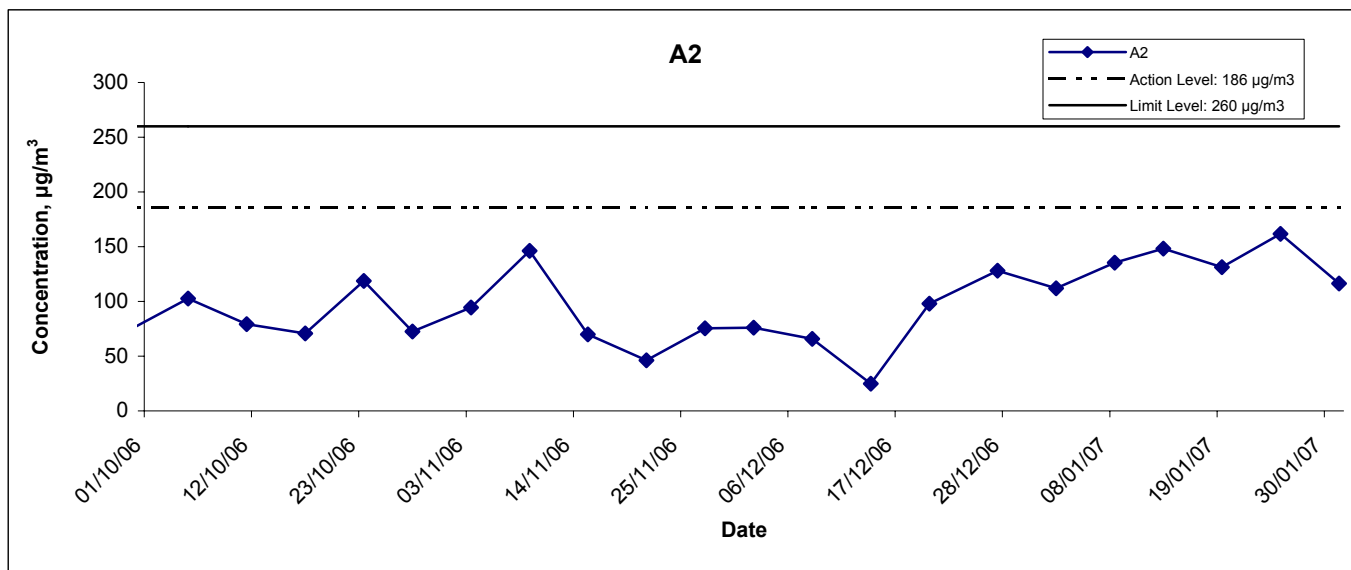
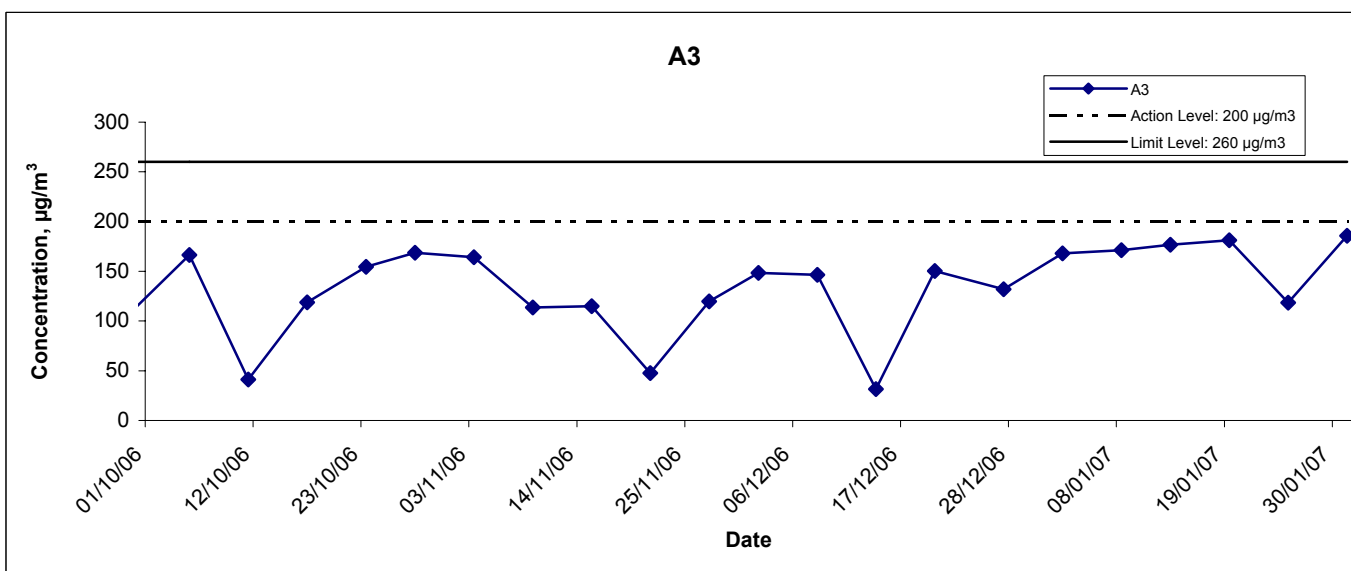
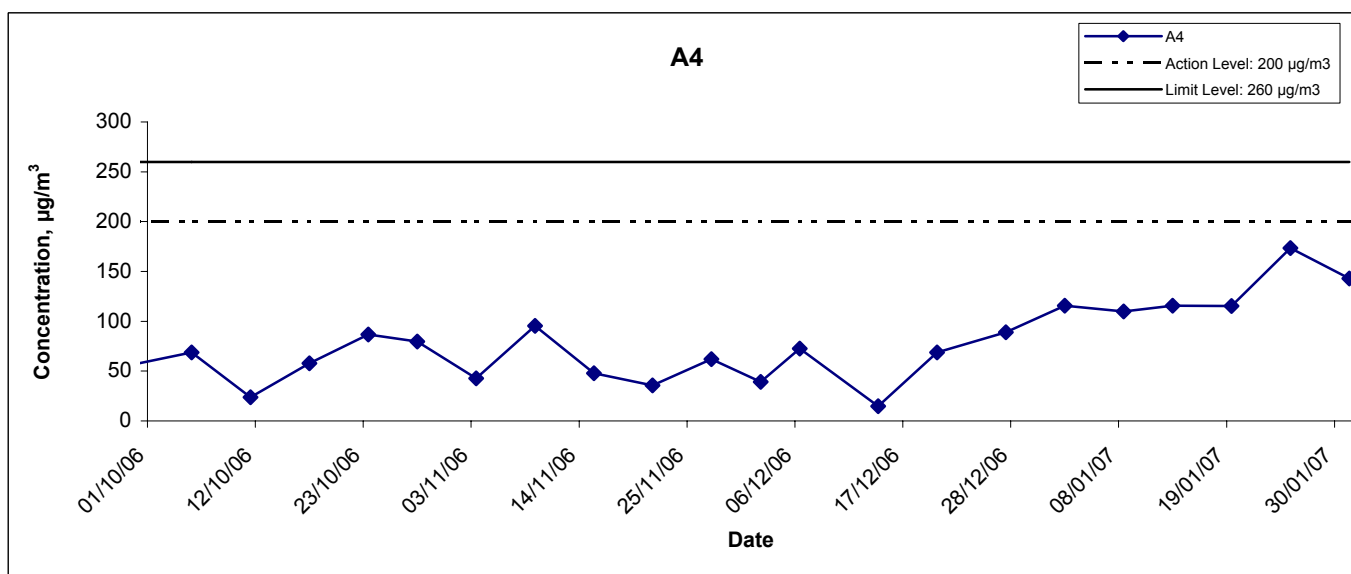
## 24-hr TSP Levels

<b>Title</b> Environmental Team for Sha Tin Heights Tunnel & Approaches Graphical Presentation of 24-hour TSP Monitoring Results	<b>Scale</b> N.T.S	<b>Project No.</b> MA2027	
	<b>Date</b> Jan 07	<b>Appendix</b> E

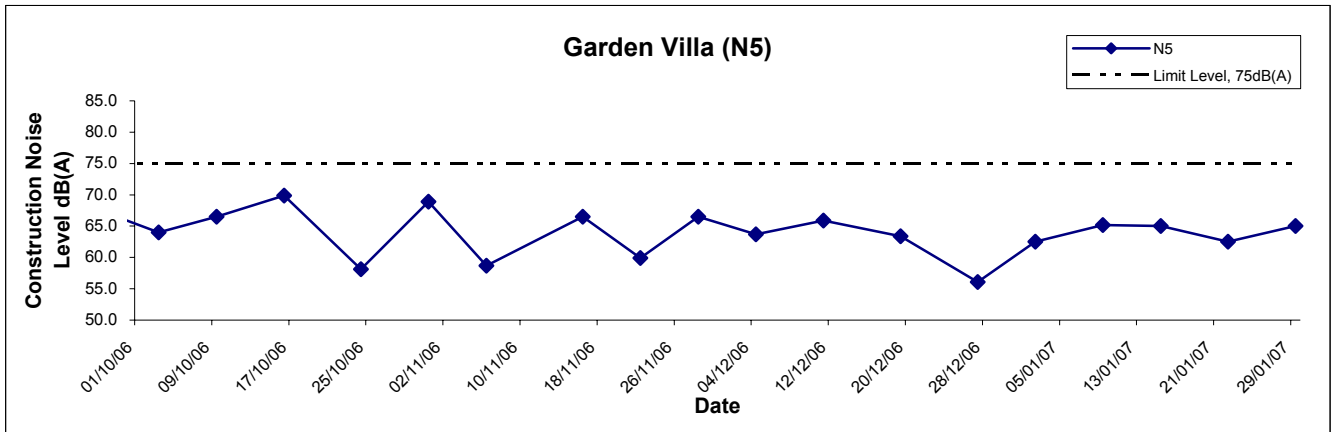
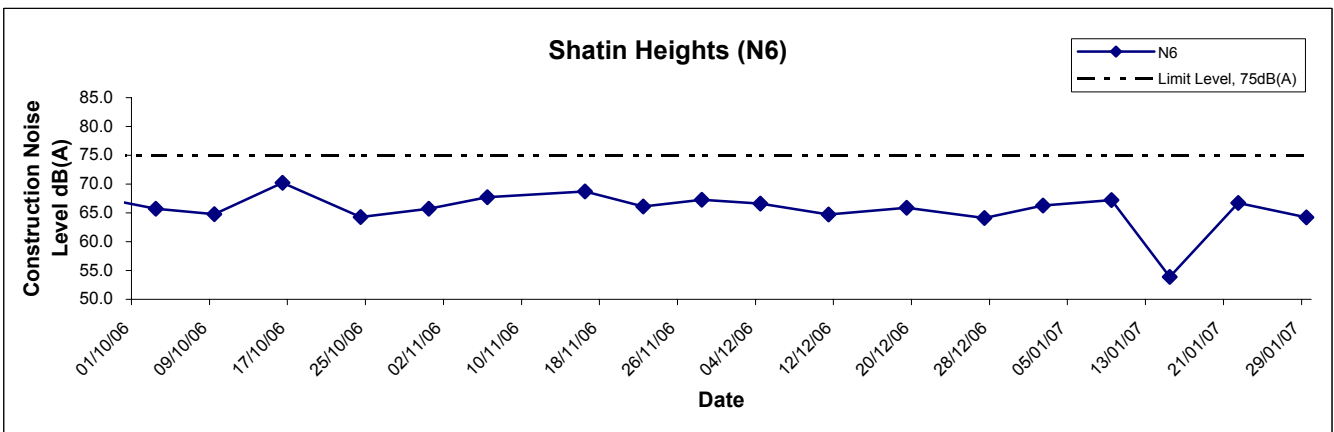
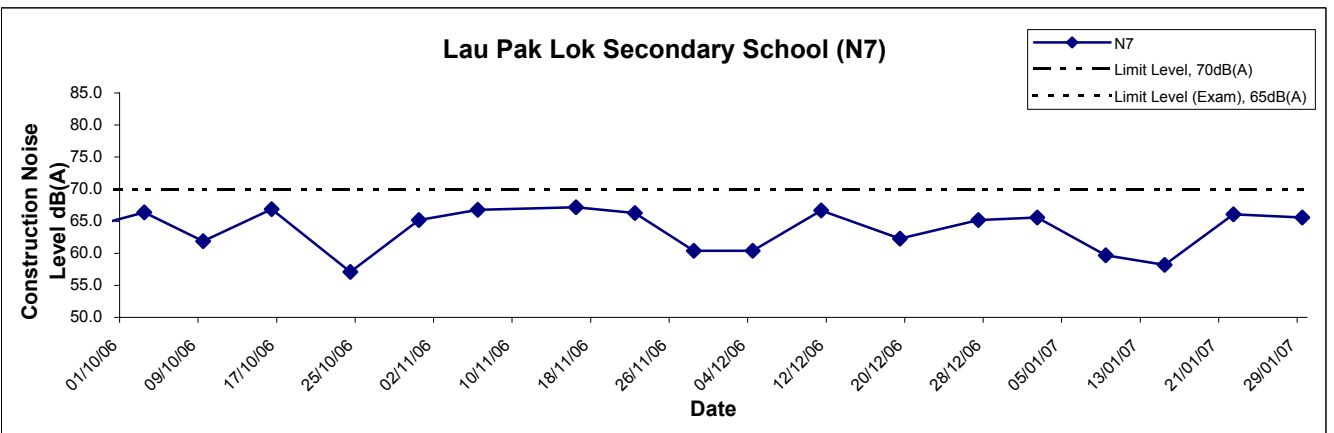
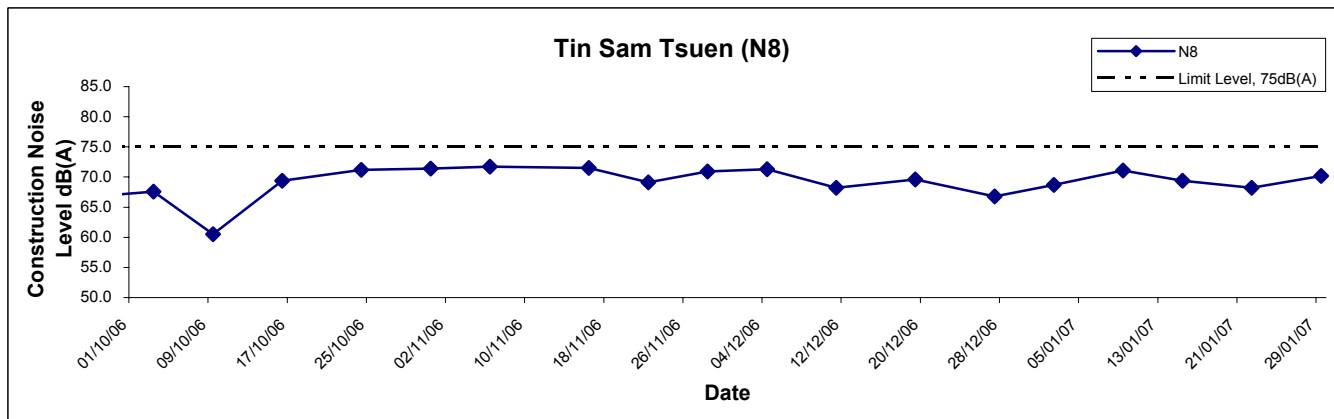
## Noise Levels

-The noise monitoring results are well within the range of Baseline Monitoring Level and there is no evidence showing that the dominant noise was generated from the construction activities.

Title Environmental Team for Sha Tin Heights Tunnel & Approaches Graphical Presentation of Construction Noise Monitoring Results	Scale N.T.S	Project No. MA2027

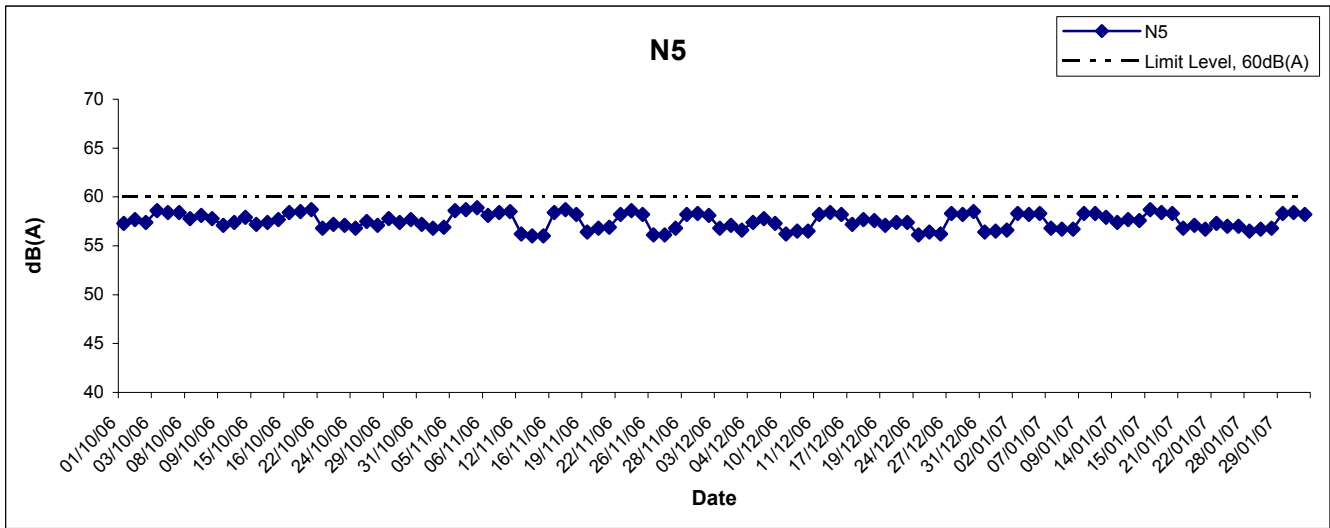
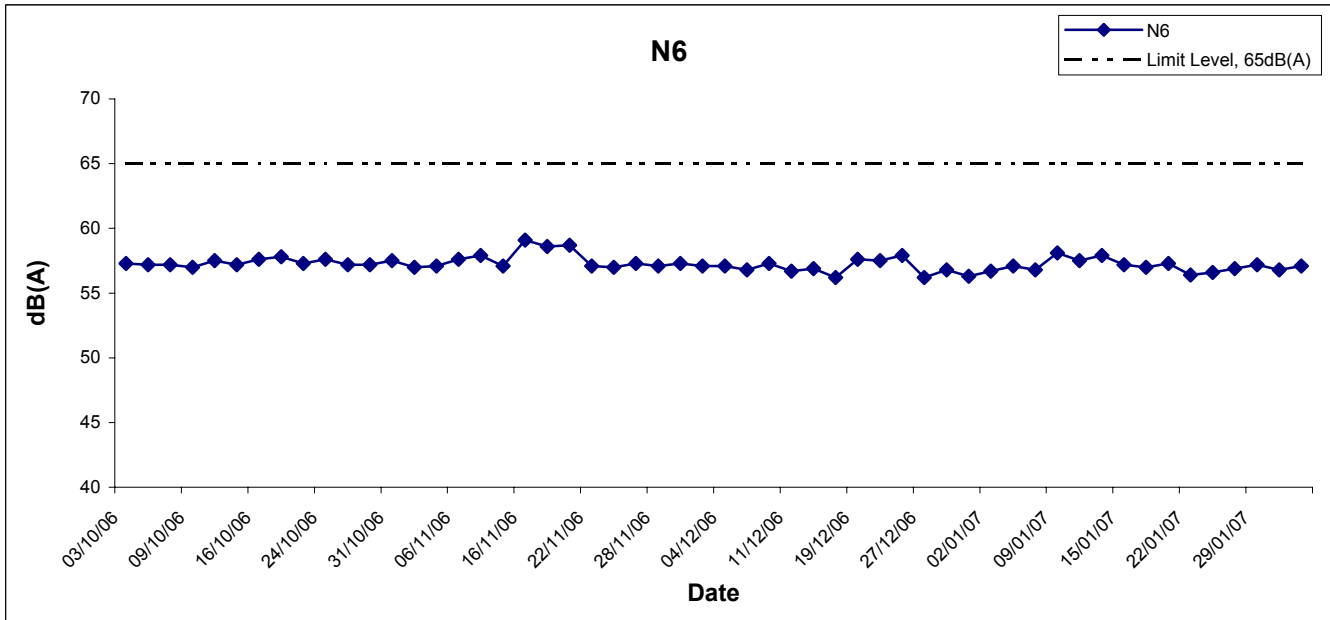
## Restricted Hours<sup>#</sup> - Noise Levels

<sup>#</sup> Remarks: - 19:00 to 23:00 on normal weekdays  
 - 07:00 to 23:00 on Holidays

Title Environmental Team for Sha Tin Heights Tunnel & Approaches Graphical Presentation of Construction Noise Monitoring Results	Scale N.T.S	Project No. MA2027	<b>CINOTECH</b>
	Date Jan 07	Appendix G

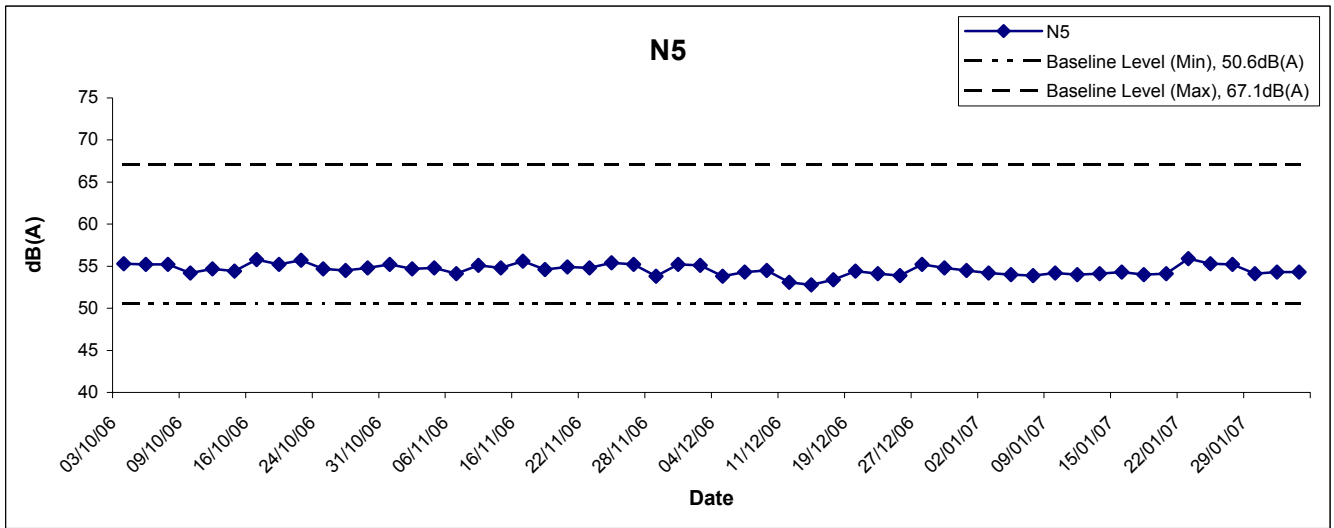
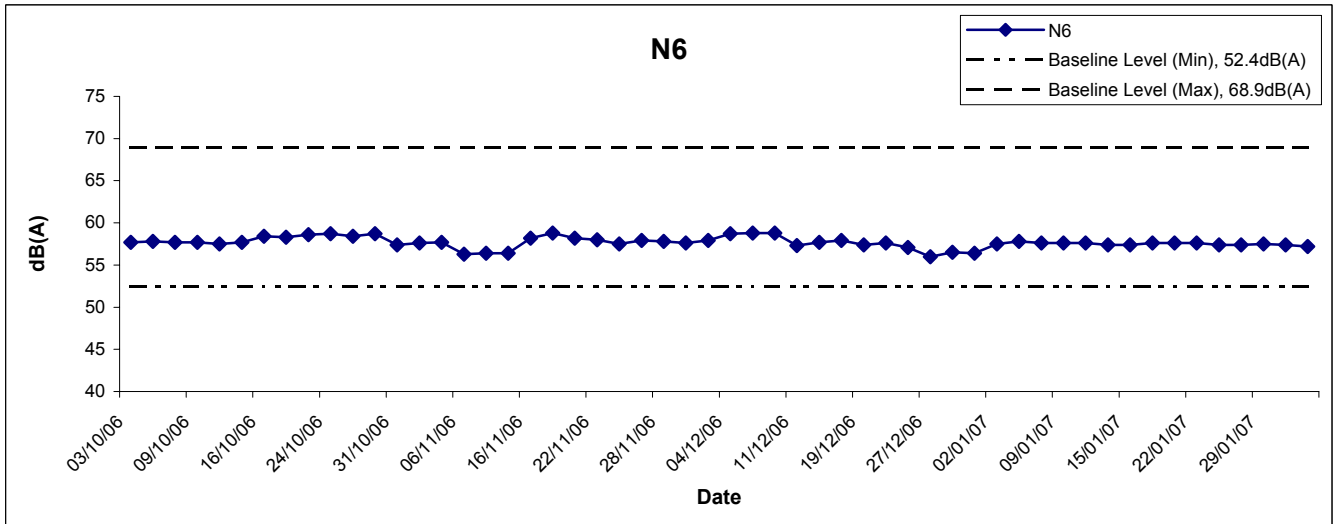
## Restricted Hours<sup>#</sup> - Noise Levels

<sup>#</sup> Remarks: - 23:00 to 07:00 on normal weekdays

Title Environmental Team for Sha Tin Heights Tunnel & Approaches Graphical Presentation of Construction Noise Monitoring Results	Scale	N.T.S	Project No.	MA2027	
	Date	Jan 07	Appendix	G
