Route 8 (previously known as Route 9) between Cheung Sha Wan & Sha Tin

Contract No. HY/2003/10 - Environmental Team for
Lai Chi Kok Viaduct and Eagle's Nest Tunnel

Monthly EM&A Report
Part II – Eagle's Nest Tunnel & Associated Works
(Version 1.0)

February 2008

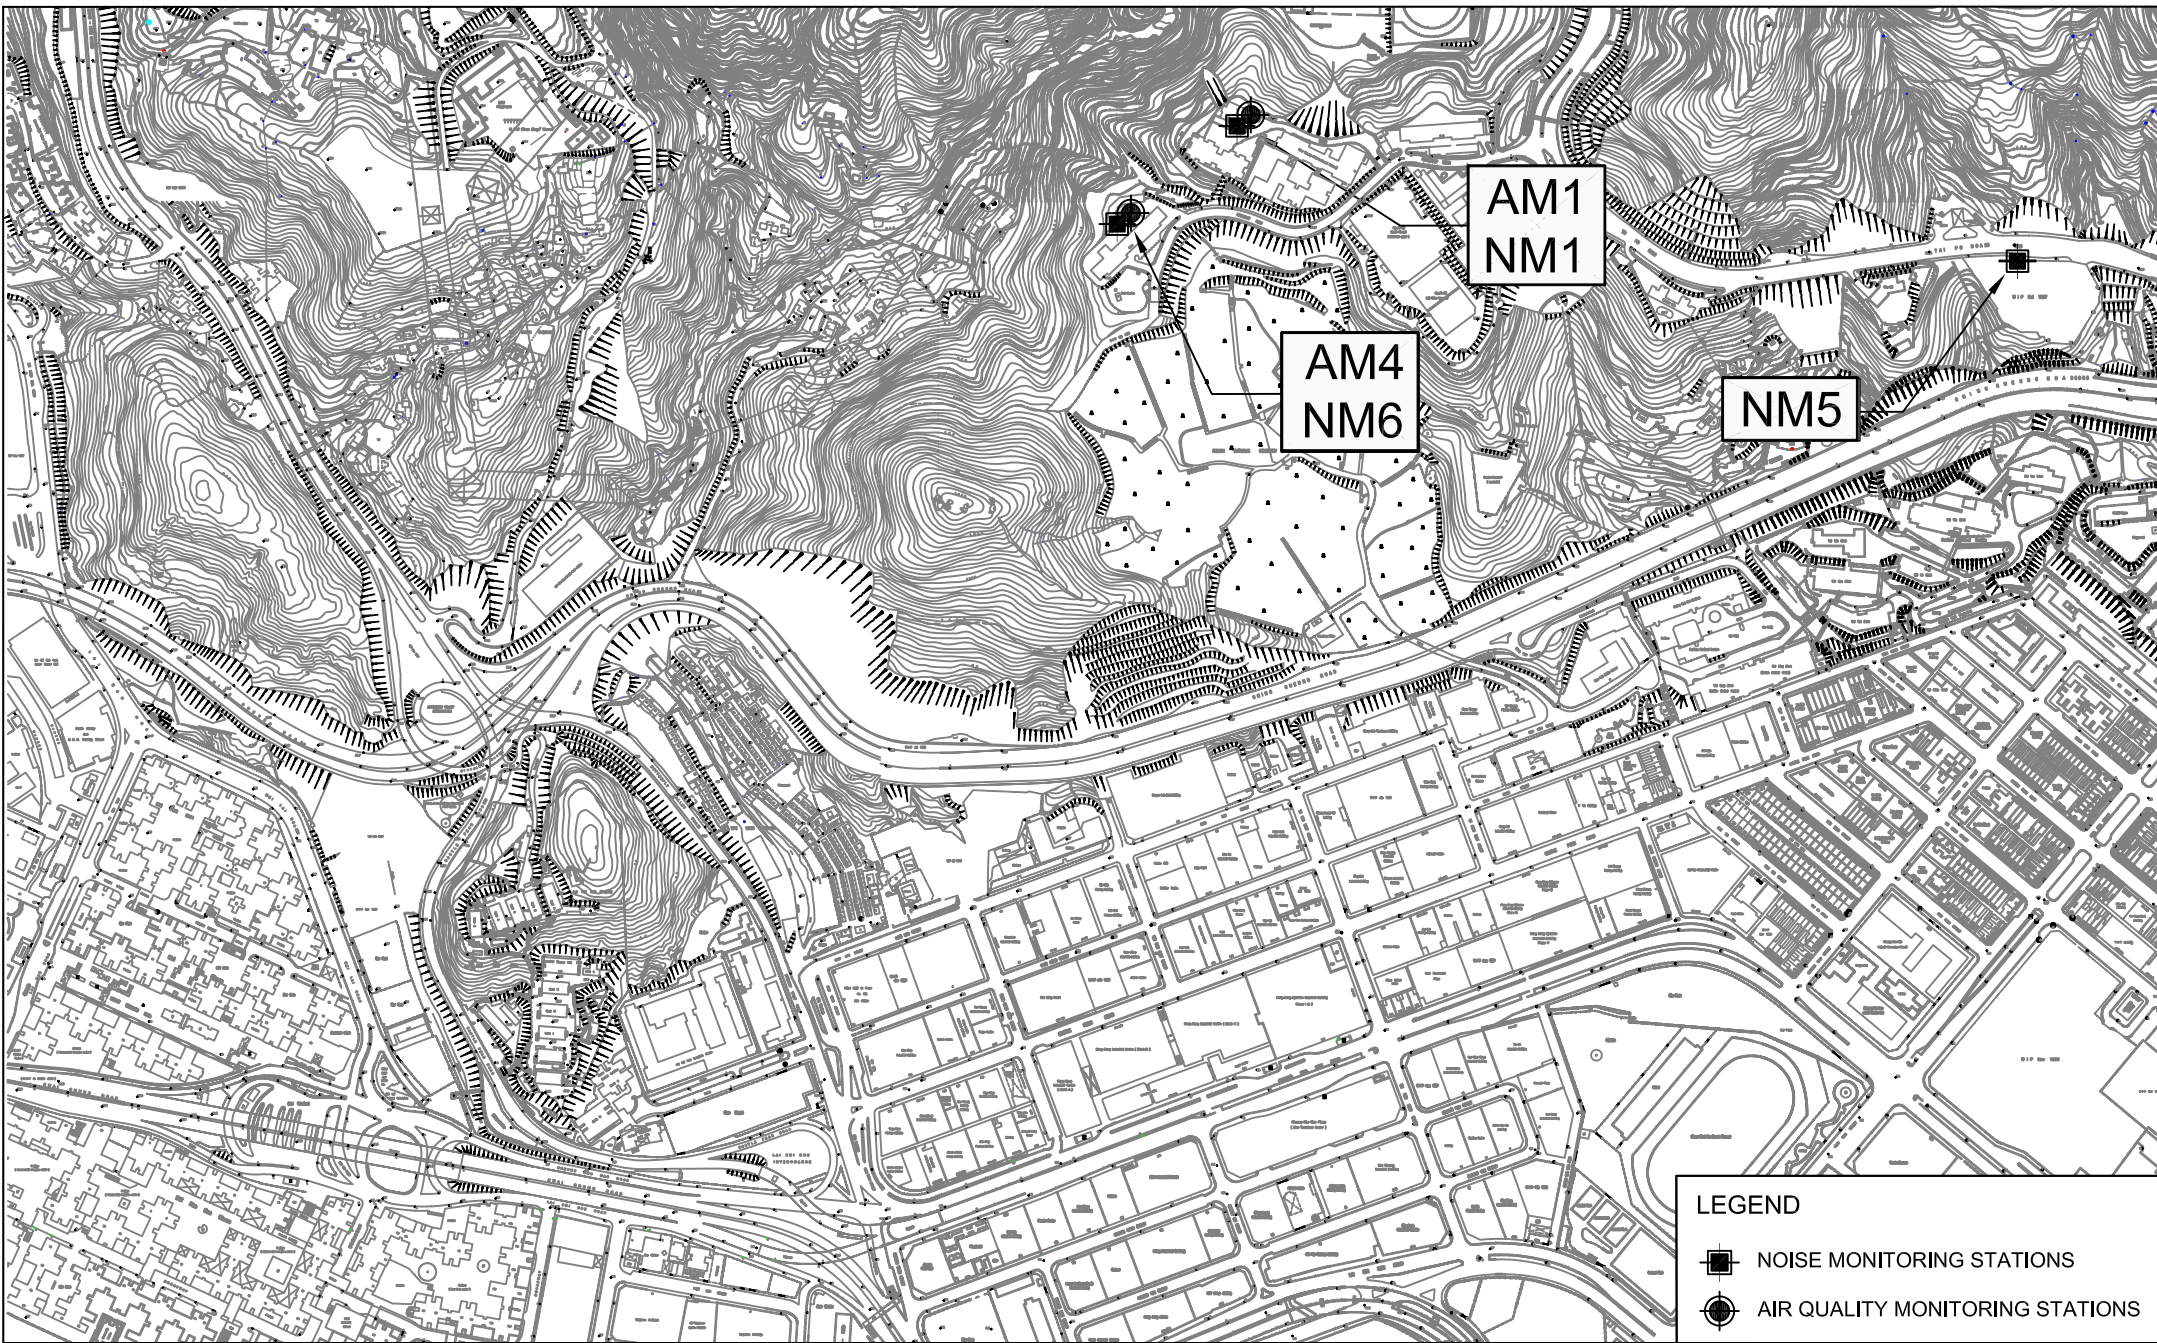
Figure No.
1a

LEGEND	
	NOISE MONITORING STATIONS
	AIR QUALITY MONITORING STATIONS

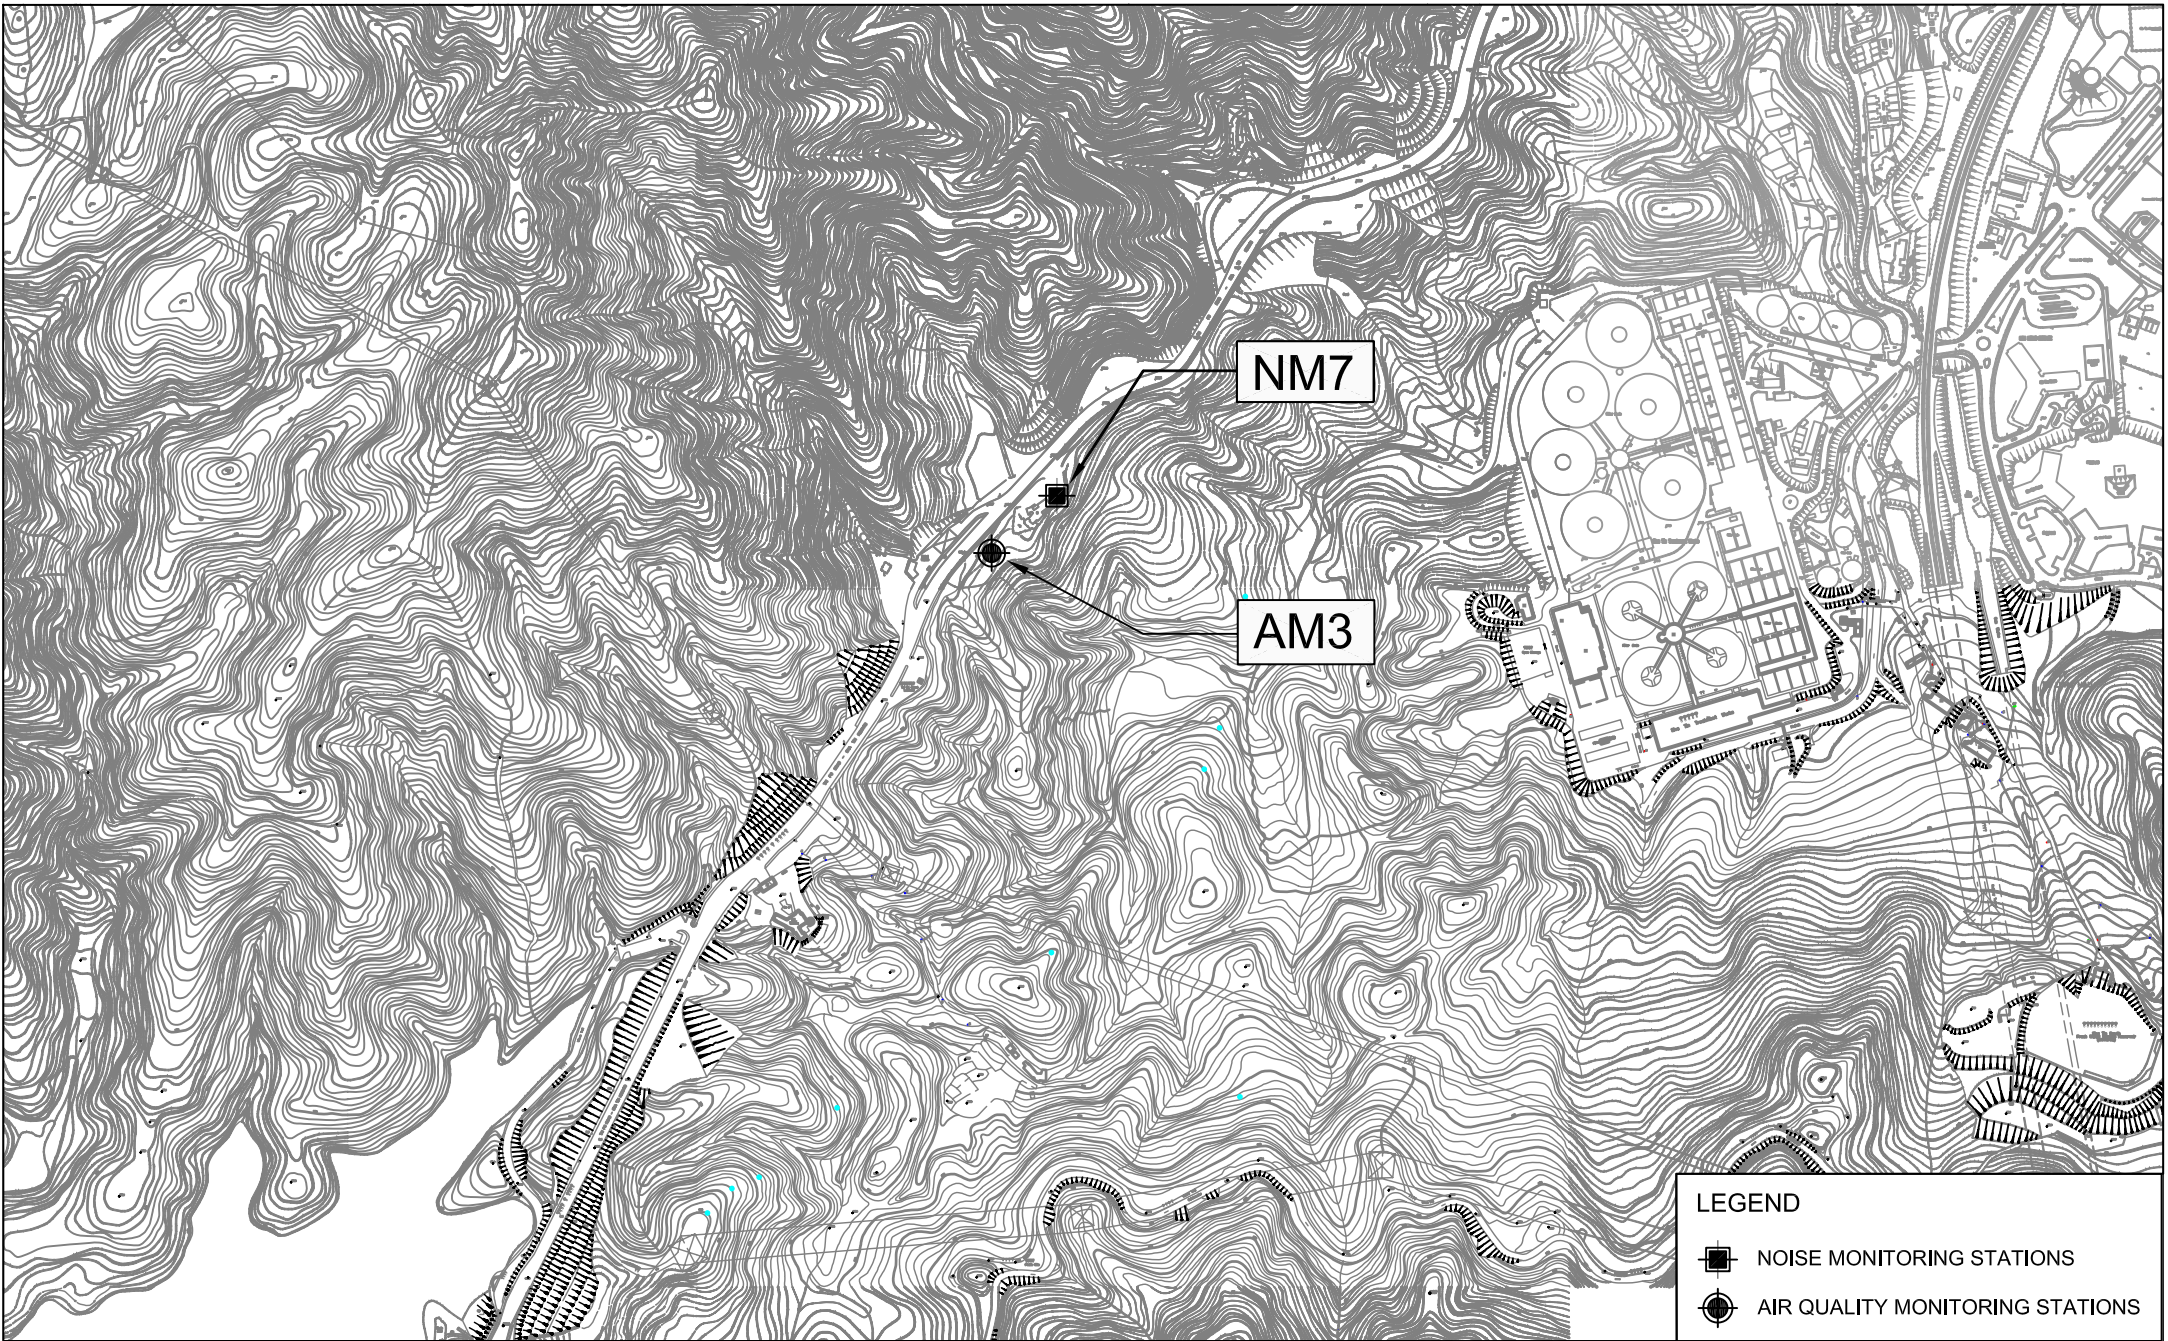
LEGEND	
	NOISE MONITORING STATIONS
	AIR QUALITY MONITORING STATIONS

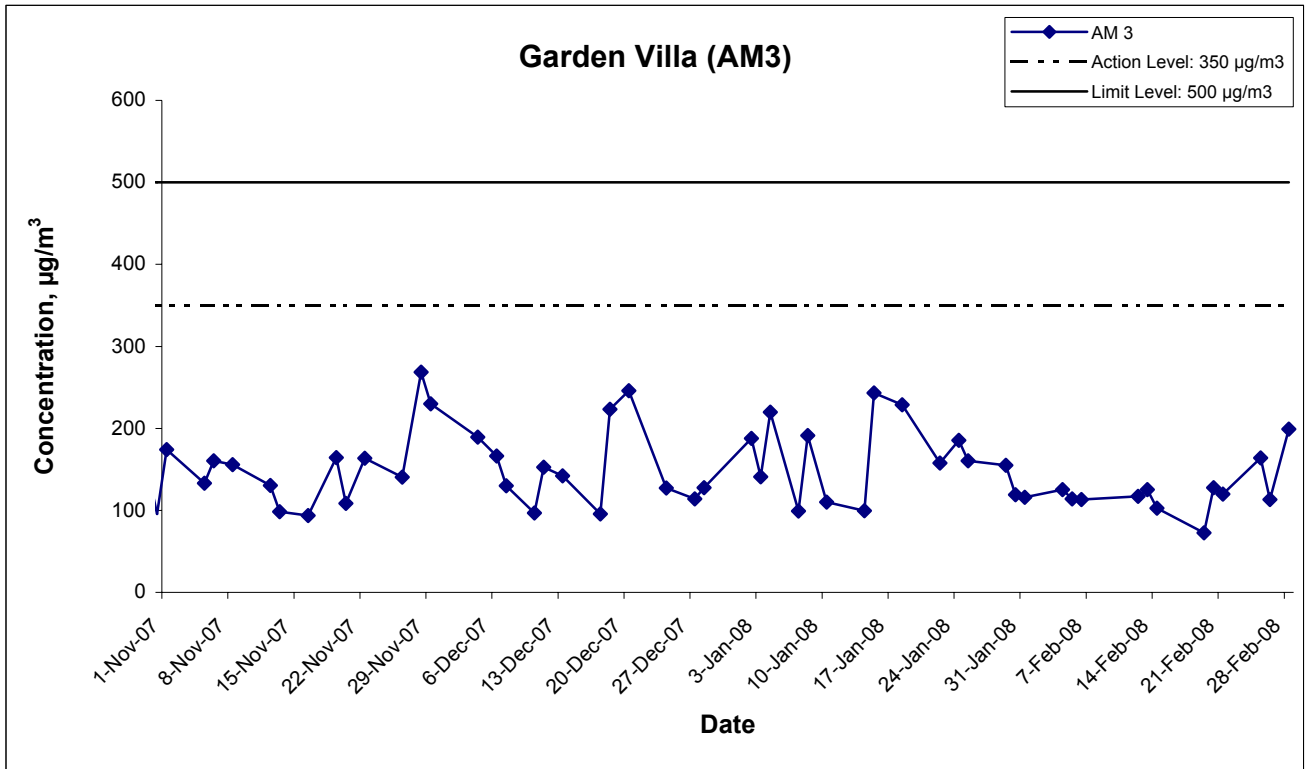
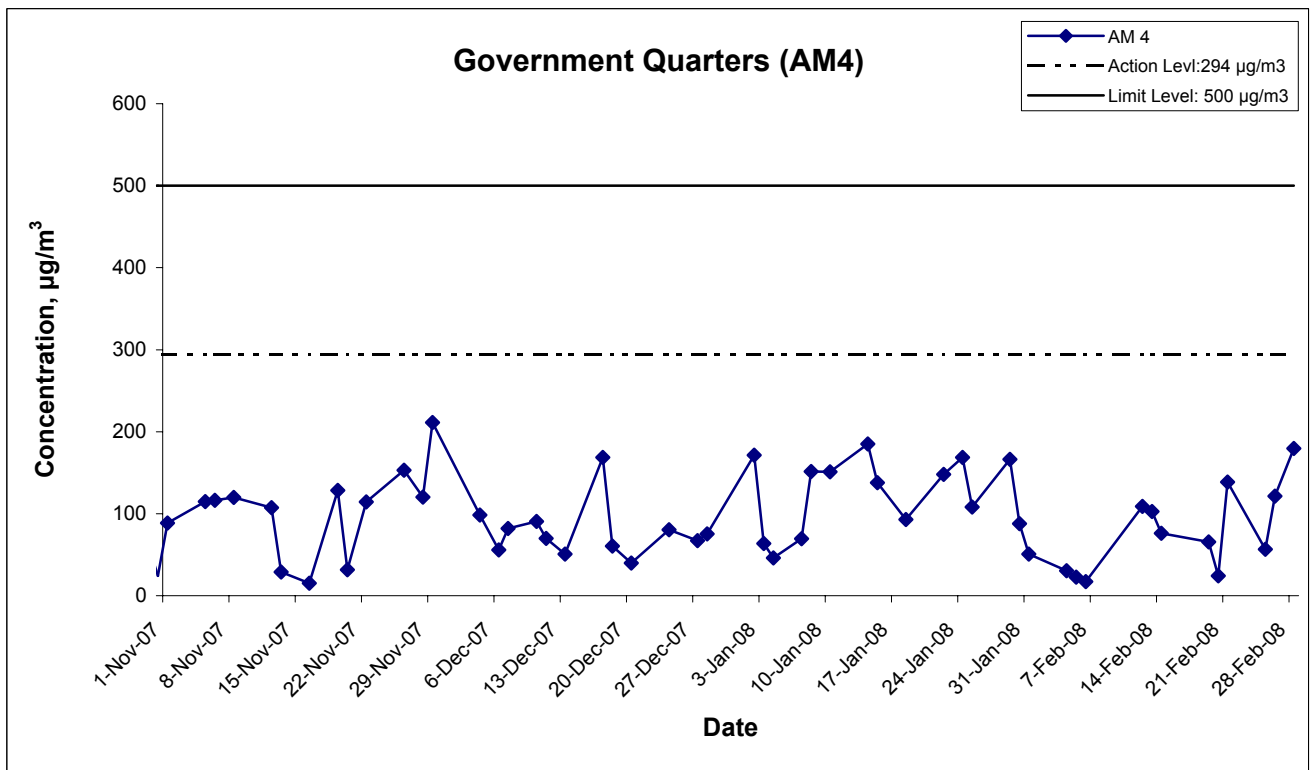
1-hr TSP Levels

Title Route 8 (previously known as Route 9) between Cheung Sha Wan & Sha Tin Contract HY/2003/02 - Eagle's Nest Tunnel and Associated Works Graphical Presentation of 1-hour TSP Impact Monitoring Results	Scale N.T.S	Project No. MA3024	
	Date Feb 08	Appendix E

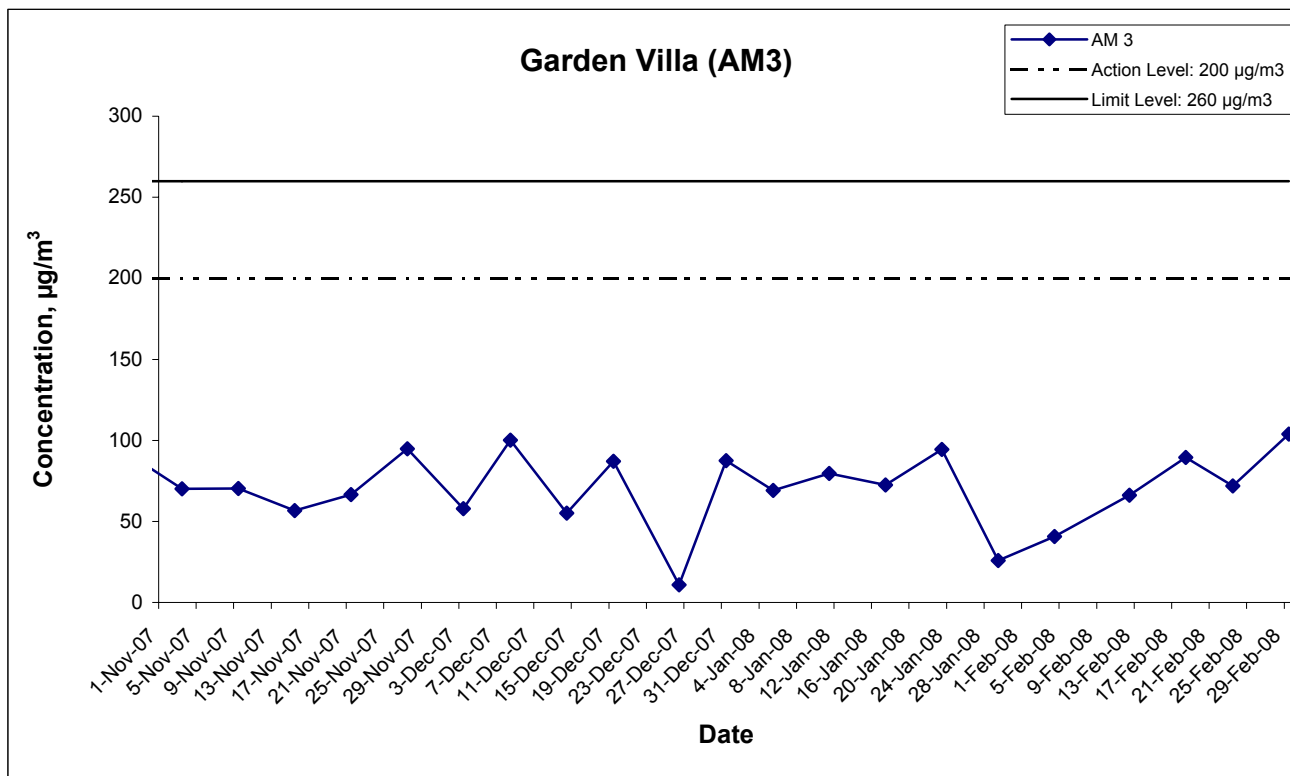
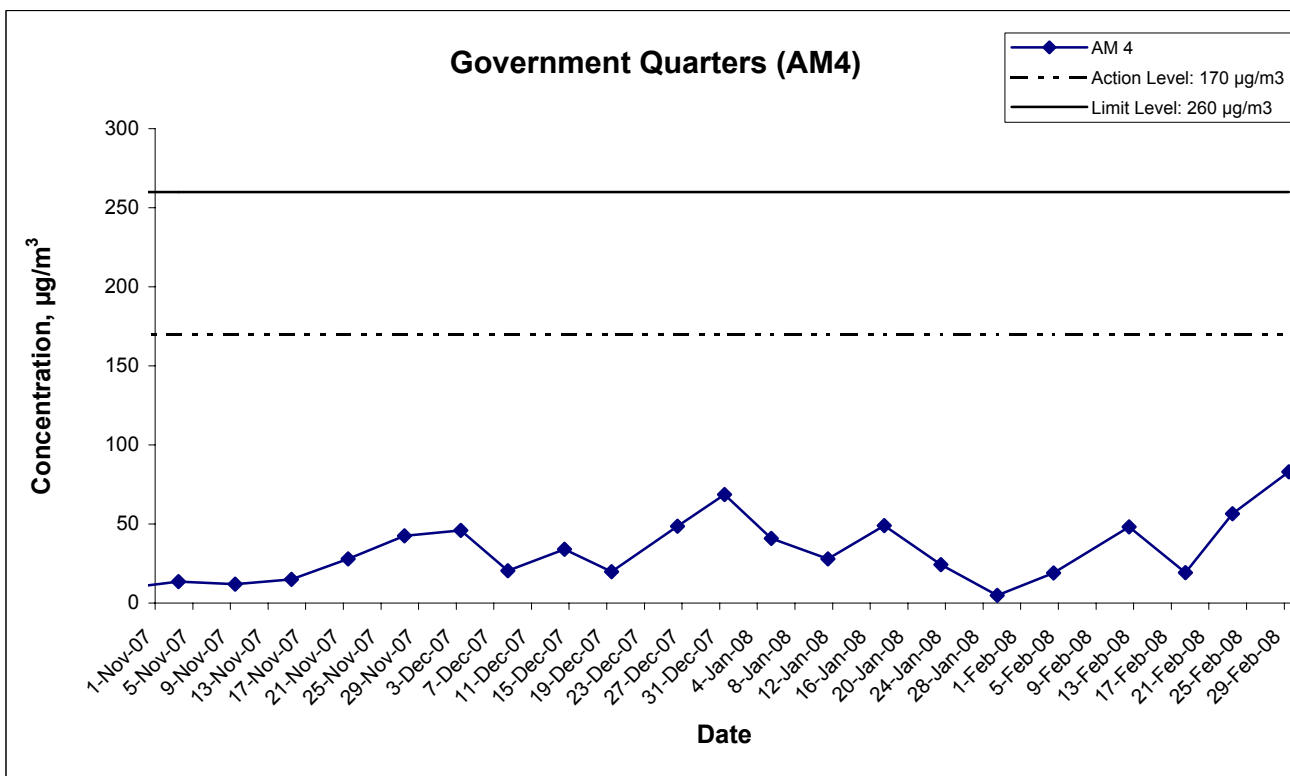
24-hr TSP Levels

Title Route 8 (previously known as Route 9) between Cheung Sha Wan & Sha Tin Contract HY/2003/02 - Eagle's Nest Tunnel and Associated Works Graphical Presentation of 24-hour TSP Impact Monitoring Results	Scale N.T.S	Project No. MA3024	
	Date Feb 08	Appendix F

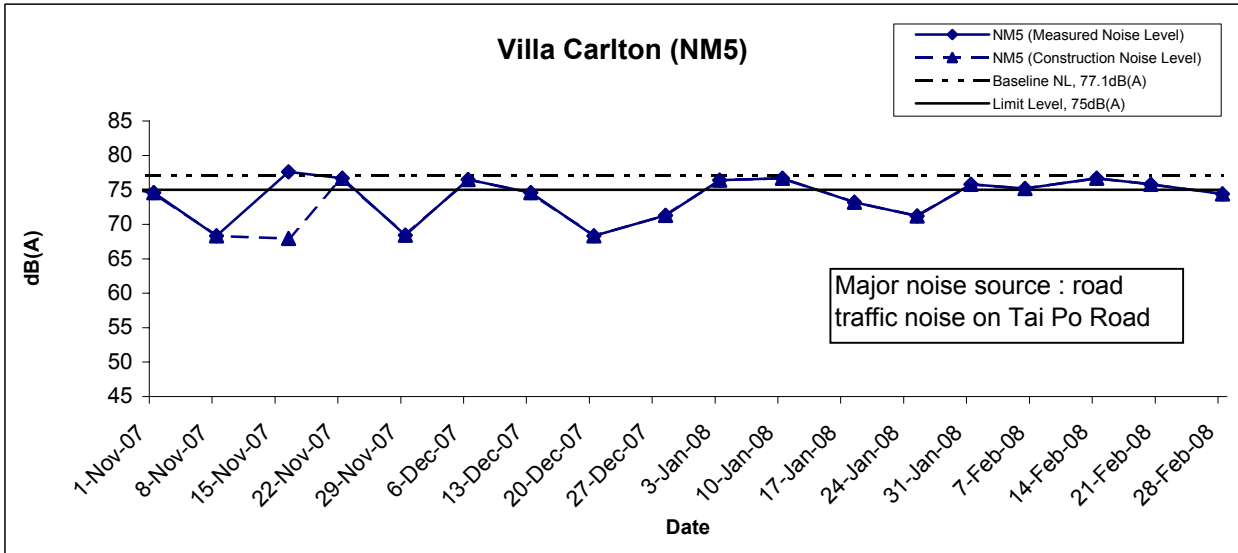
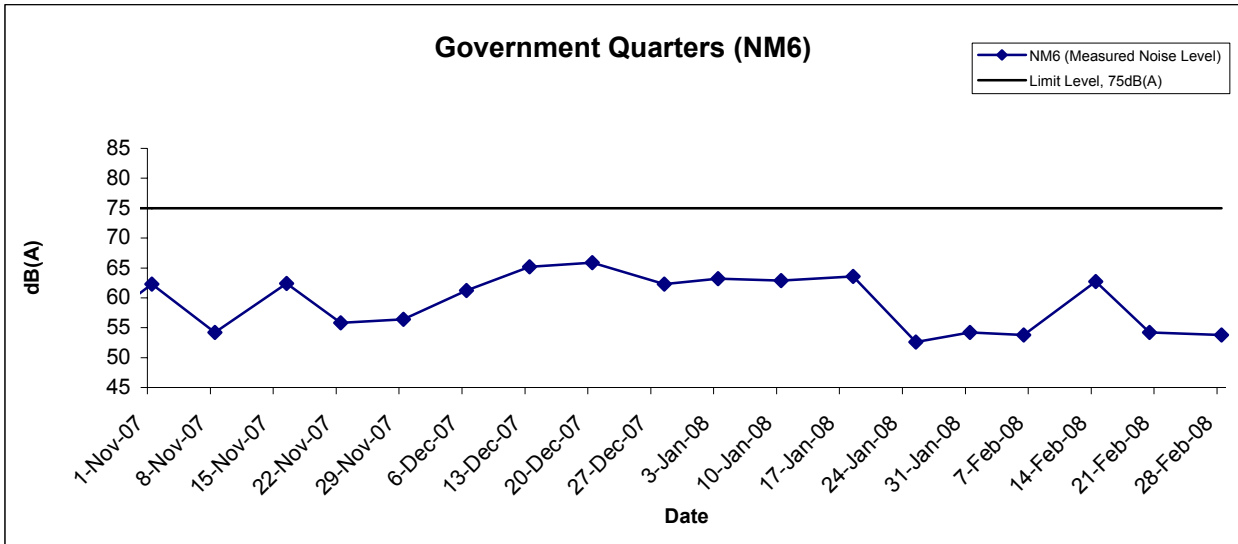
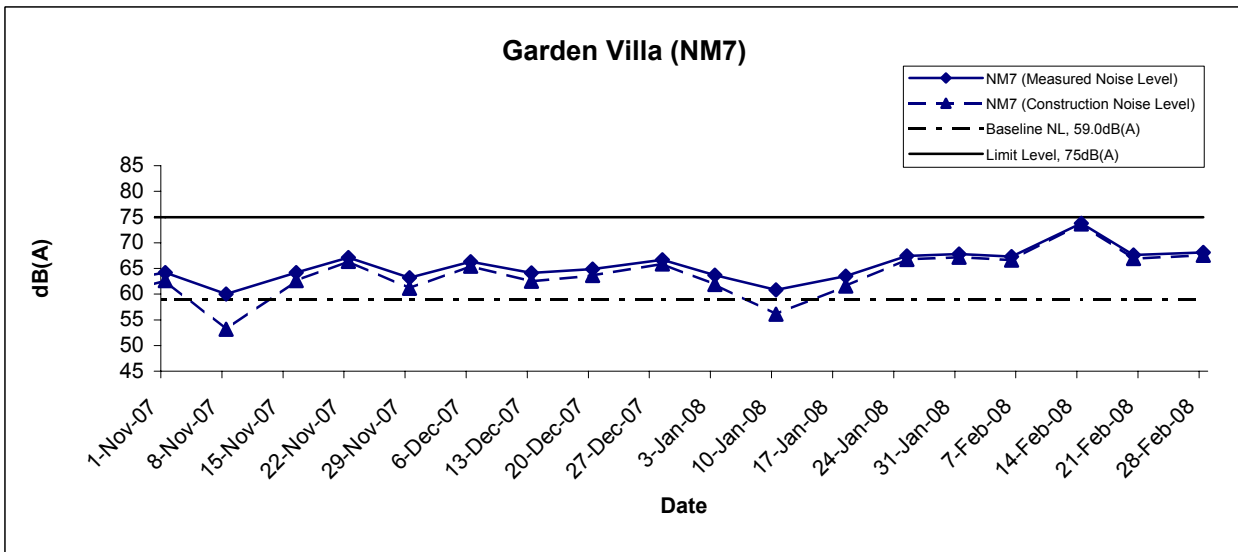
Noise Levels

* Construction Noise Level = Measured Noise Level - Baseline Level
 (If the measured noise level is lower than the baseline level, the construction noise level will be taken as the measured one)

Title Route 8 (previously known as Route 9) between Cheung Sha Wan & Sha Tin Contract HY/2003/02 - Eagle's Nest Tunnel and Associated Works Graphical Presentation of Construction Noise Monitoring Results	Scale N.T.S	Project No. MA3024	CINOTECH
	Date Feb 08	Appendix G

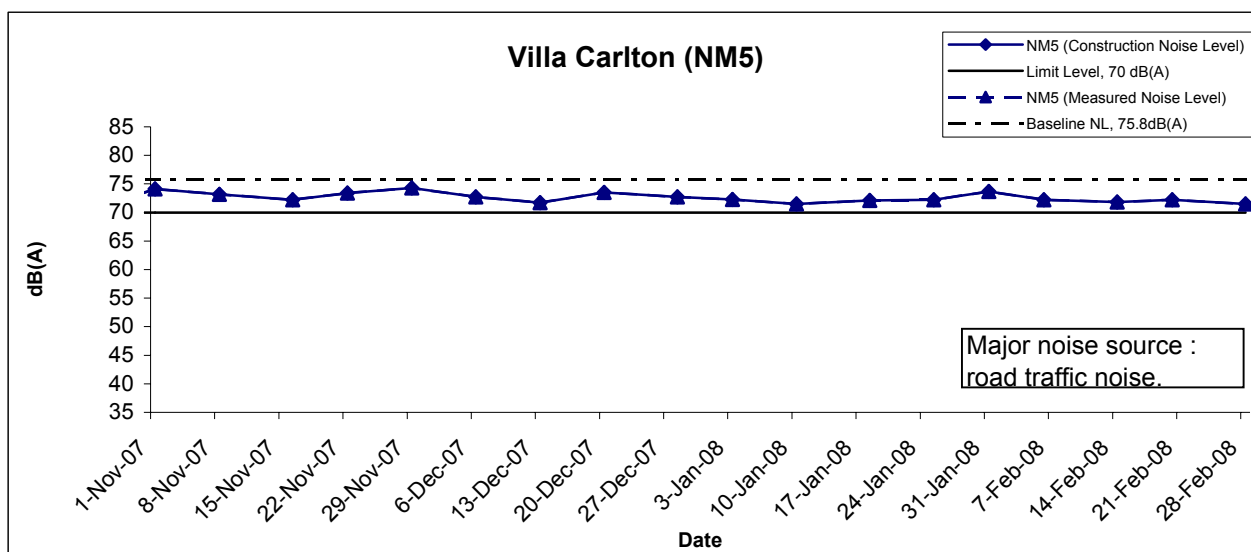
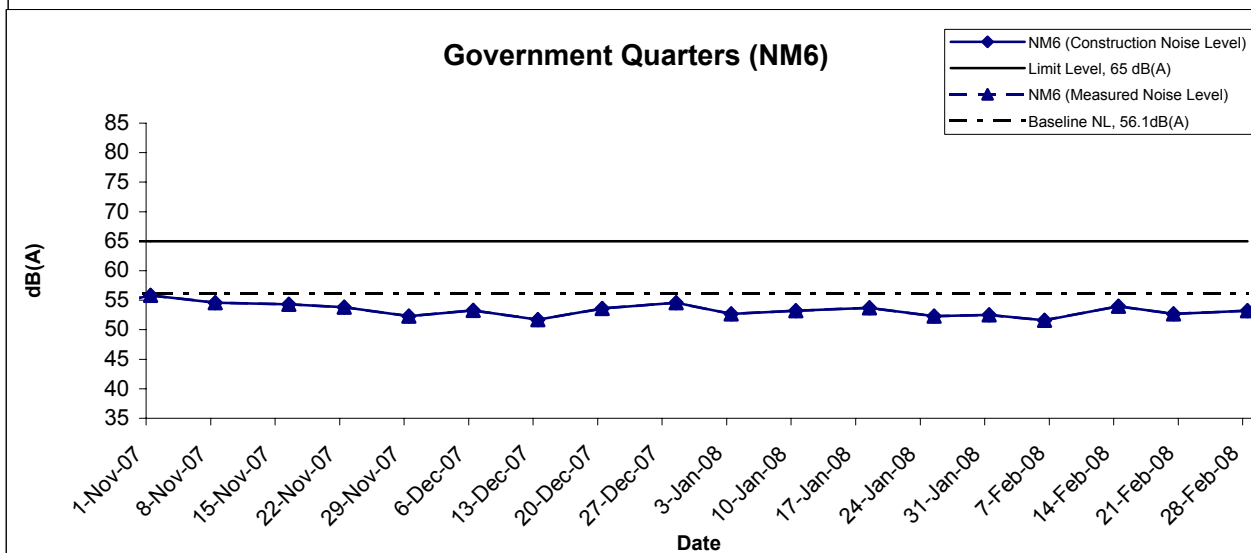
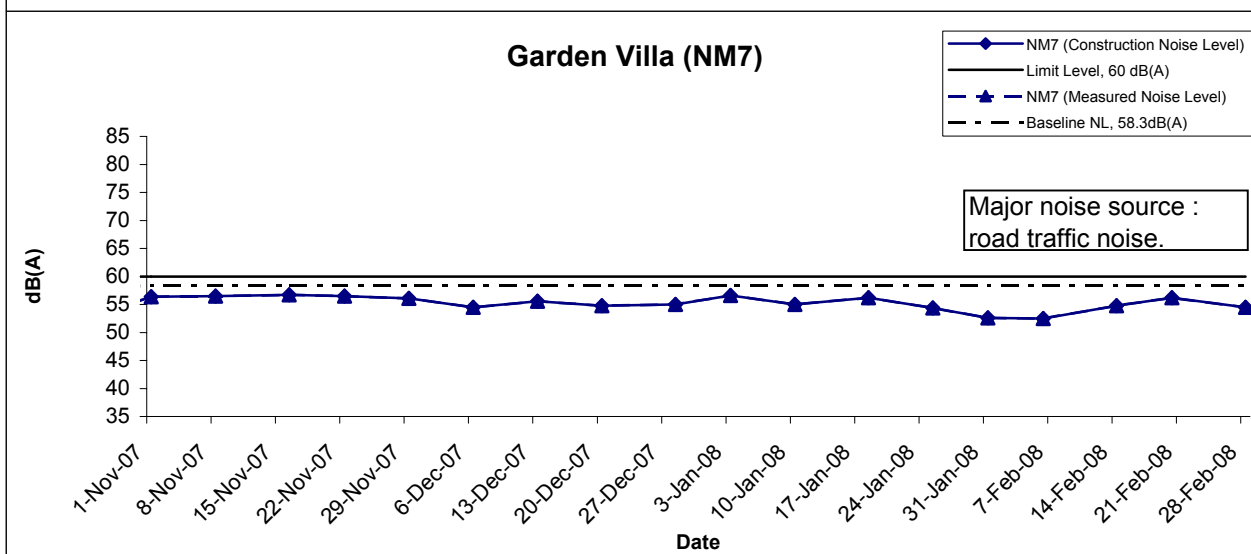
Restricted Hours (19:00 to 23:00) - Noise Levels

* Construction Noise Level = Measured Noise Level - Baseline Level
 (If the measured noise level is lower than the baseline level, the construction noise level will be taken as the measured one)

Title Route 8 (previously known as Route 9) between Cheung Sha Wan & Sha Tin Contract HY/2003/02 - Eagle's Nest Tunnel and Associated Works Graphical Presentation of Construction Noise Monitoring Results	Scale N.T.S	Project No. MA3024	
	Date Feb 08	Appendix G

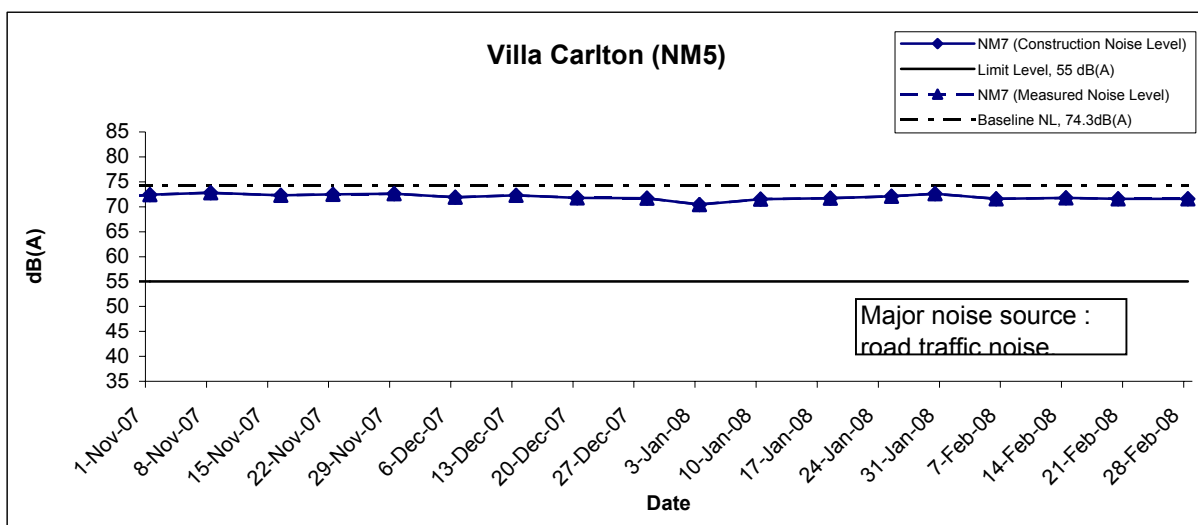
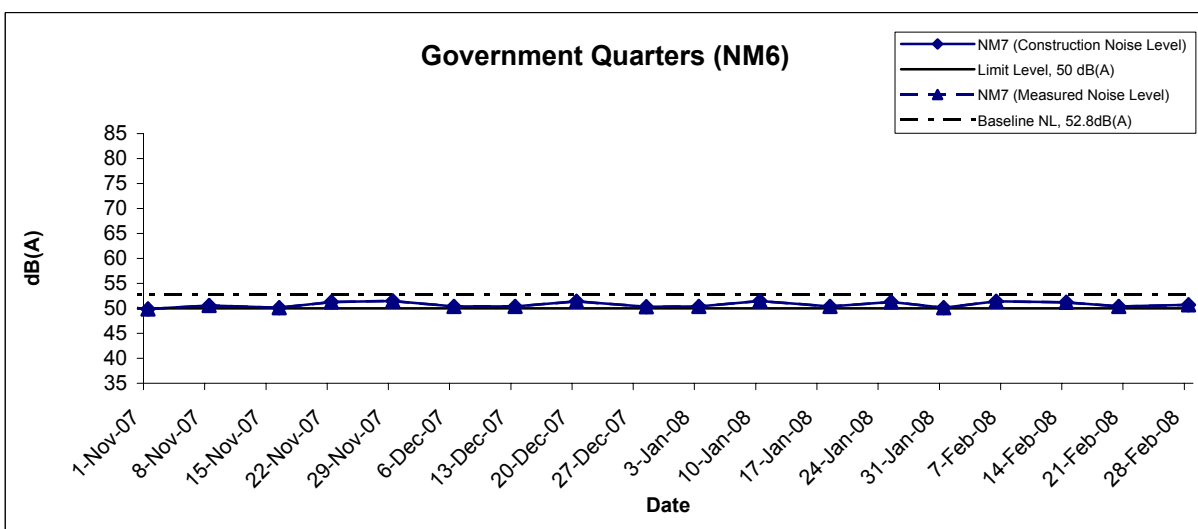
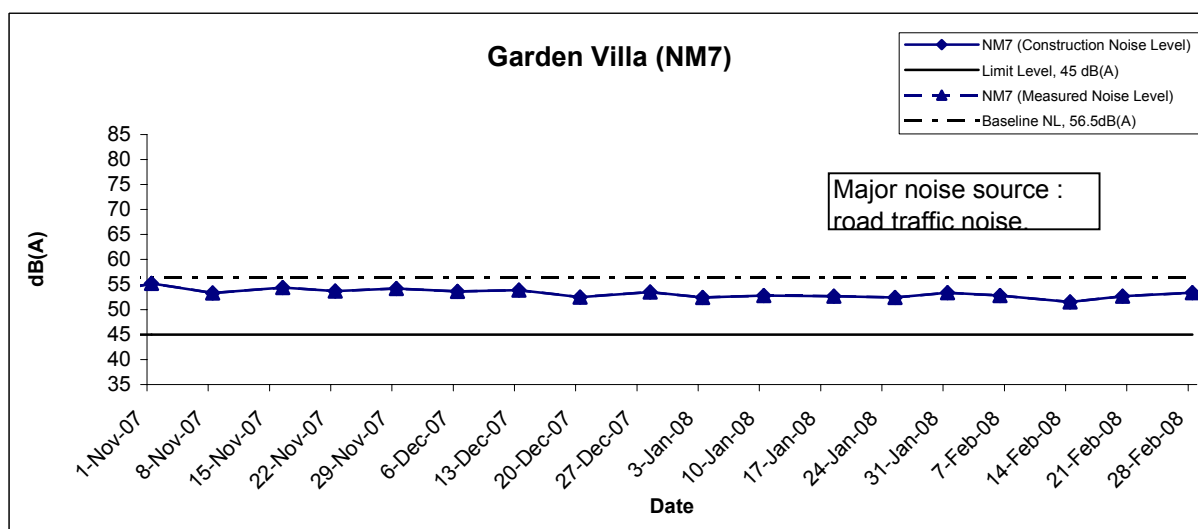
Restricted Hours (23:00 to 07:00) - Noise Levels

* Construction Noise Level = Measured Noise Level - Baseline Level
 (If the measured noise level is lower than the baseline level, the construction noise level will be taken as the measured one)

Title Route 8 (previously known as Route 9) between Cheung Sha Wan & Sha Tin Contract HY/2003/02 - Eagle's Nest Tunnel and Associated Works Graphical Presentation of Construction Noise Monitoring Results	Scale N.T.S	Project No. MA3024	CINOTECH
	Date Feb 08	Appendix G
