**Public Golf Course at Kau Sai Chau Island, Sai Kung**  
**Operation Phase**  
**Environmental Monitoring & Audit (EM&A) Report**  
**for July 2008**

**(Report No. 382812/0201/005)**

This is the fifth Operation Phase Monthly Environmental Monitoring and Audit (EM&A) Report prepared by Black & Veatch for the Project "Proposed Extension of Public Golf Course at Kau Sai Chau Island, Sai Kung". This report presents the results of the EM&A works conducted in the month of July 2008 (25<sup>th</sup> June to 24<sup>th</sup> July 2008).

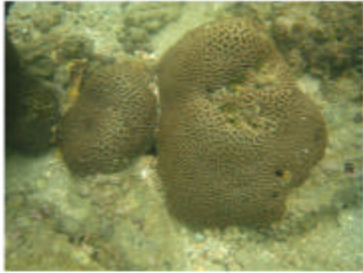
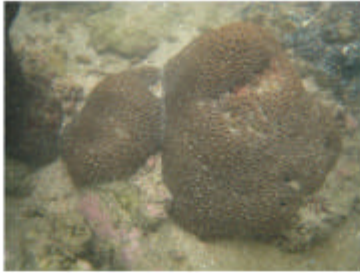
X-01

- 4.2.7 The Control Site is the buoy of coral marker established by AFCD in Sharp Island. Similar with Site C, both the coral coverage percentage and the sizes of coral colonies were high at this site and would not be impacted by the Project. The site and its vicinity still remained similar conditions as during the Construction Phase Monitoring. Coral X-05 was lost in previous construction phase monitoring in June 2006. Replacement coral for X-05 will be selected in next monitoring survey. The remaining 19 tagged corals were recovered. The corals remained similar conditions as during the construction phase monitoring (**Annex C - Photo Plates 4.2-5 to 4.2-6**). No mortality, sedimentation or bleaching was found on any of the tagged corals (see **Table 4.2-3**).

- 4.2.8 **Photo Plates 4.2-1 to 4.2-6** showed the photos of each tagged corals. The assigned numbers, species, mortality percentage, sedimentation coverage percentage and bleaching percentage of the baseline conditions of tagged corals and their present conditions were presented in **Tables 4.2-1 to 4.2-3** below.

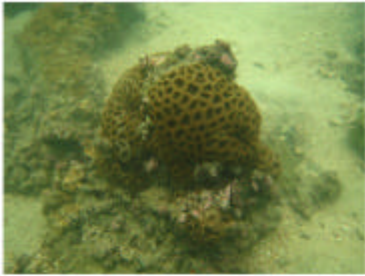
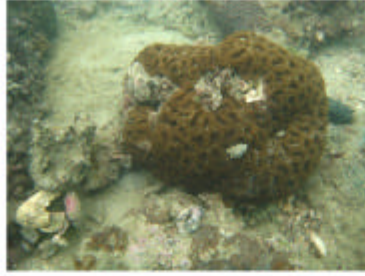
C-11

- 4.2.4 Site C was on the south-eastern coast of Kau Sai Chau Island and had a high coral coverage among the sites investigated during the EIA Study. The sizes of coral colonies at Site C were also larger than those at other sites. Site C was away from the boundary of the new golf course and would not be subject to direct impacts during construction. The site and its vicinity still remained similar conditions as during the Baseline Survey. Among the 20 tagged corals in Site C, C-04 and C-20 were found missing. C-04 had been previously destroyed by adverse weather during the construction phase (this had been reported in previous construction phase monitoring report.). C-20 could still be recovered in the last construction phase monitoring survey in December 2007, and thus might be affected by weather conditions and typhoons in the last few months. Replacement coral colonies will be selected in next monitoring survey. For other

recovered corals, no mortality or sedimentation was found (see **Table 4.2-1** and **Annex C - Photo Plates 4.2-1 to 4.2-2**).
