# Ocean Park Master Redevelopment Project

Monthly Environmental Monitoring & Audit  
Report – June 2008

**Environmental Permit No. EP-249/2006/A - Condition 3.4**

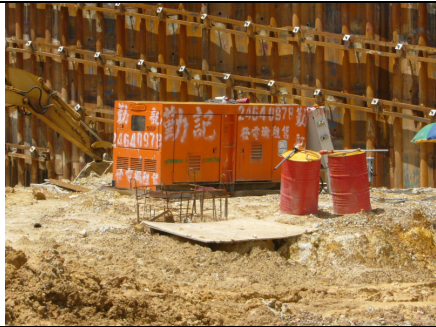
P1060492: Two oil drums were observed placed on bare ground. The Contractor shall provide drip trays to all oil drums on site to avoid oil spillage.

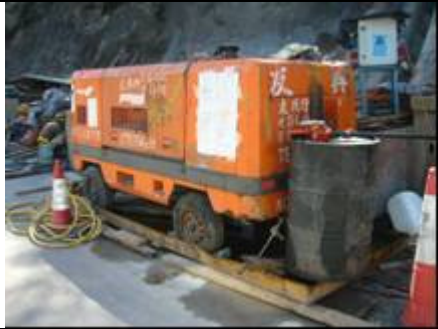
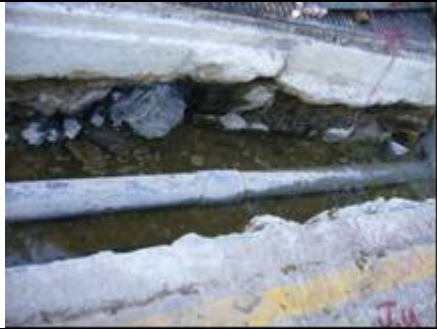
<p>P1060511: Water and oil were accumulated in a drip tray with a generator. The Contractor shall maintain all drip trays on site regularly.</p>	<p>P1060515: Stagnant water was accumulated in the trench. The Contractor shall remove it as soon as possible.</p>

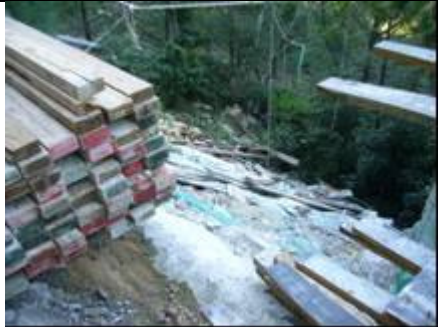
<p>P1060525: Construction waste were scattered along the sloping surface. The Contractor shall store them in designated area and dispose them regularly.</p>

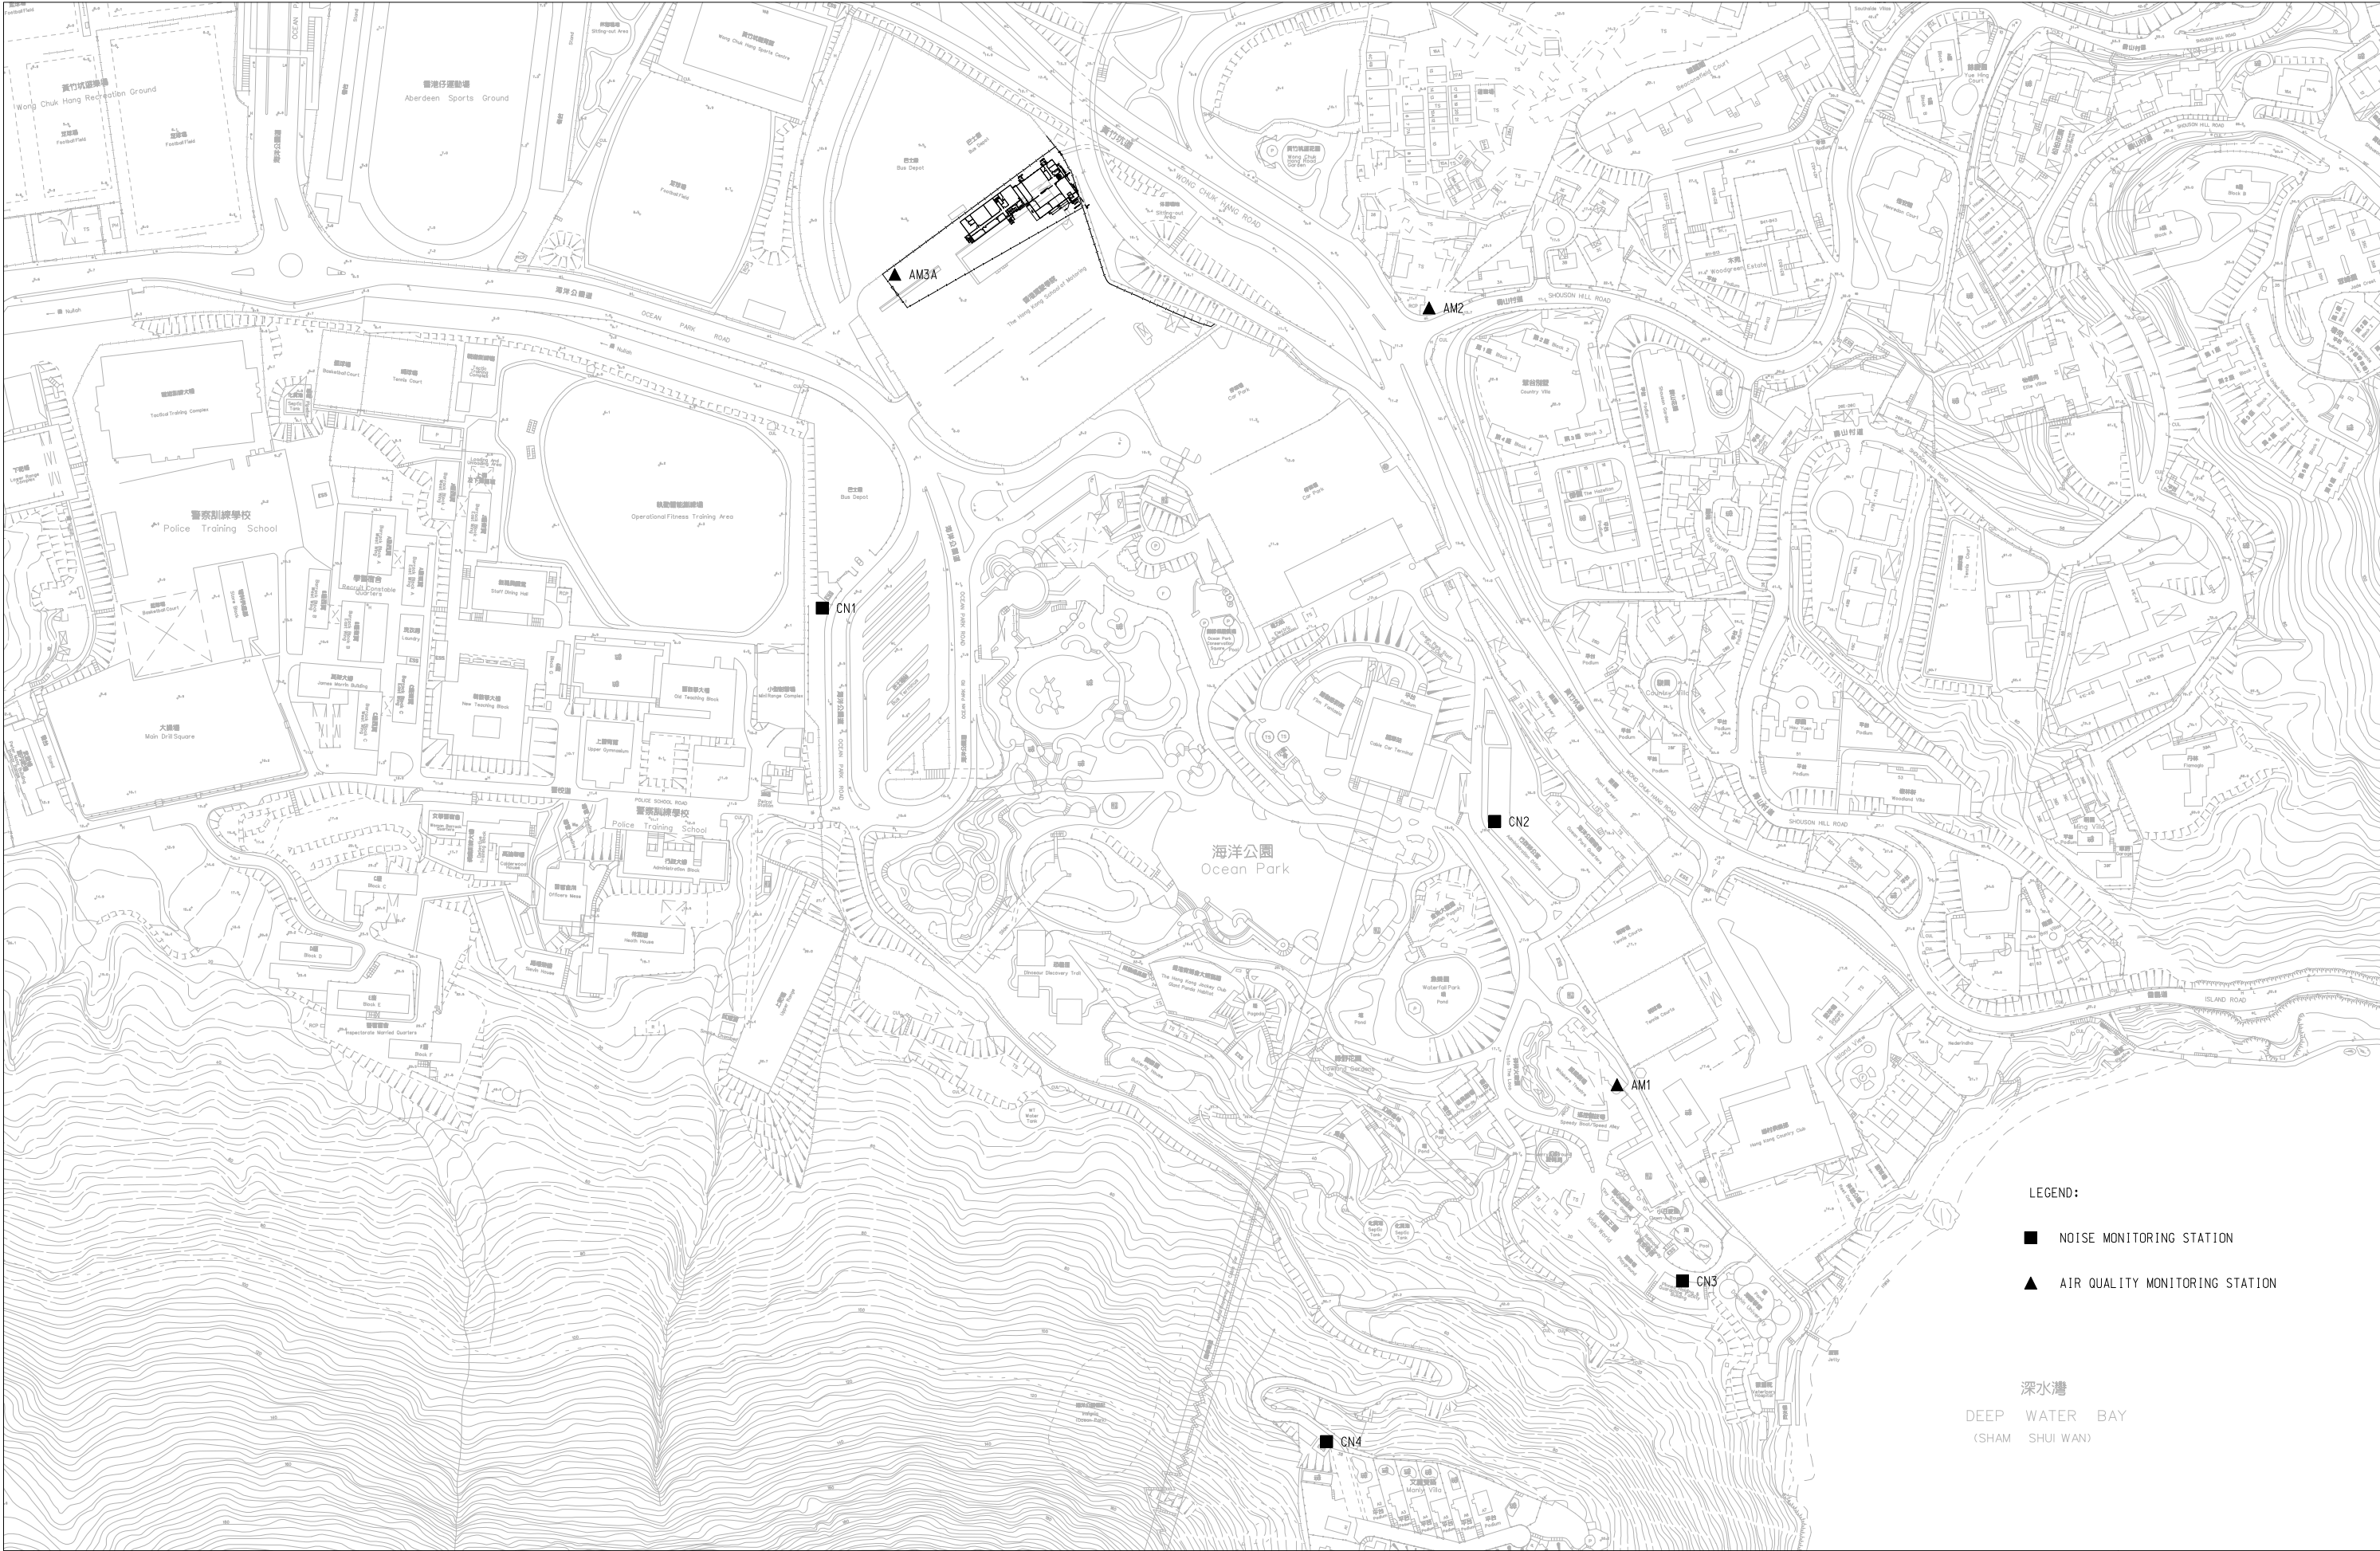
FIGURE 1.4  
AIR QUALITY AND  
NOISE MONITORING STATIONS  
LOCATION PLAN

- NOISE MONITORING STATION
- ▲ AIR QUALITY MONITORING STATION

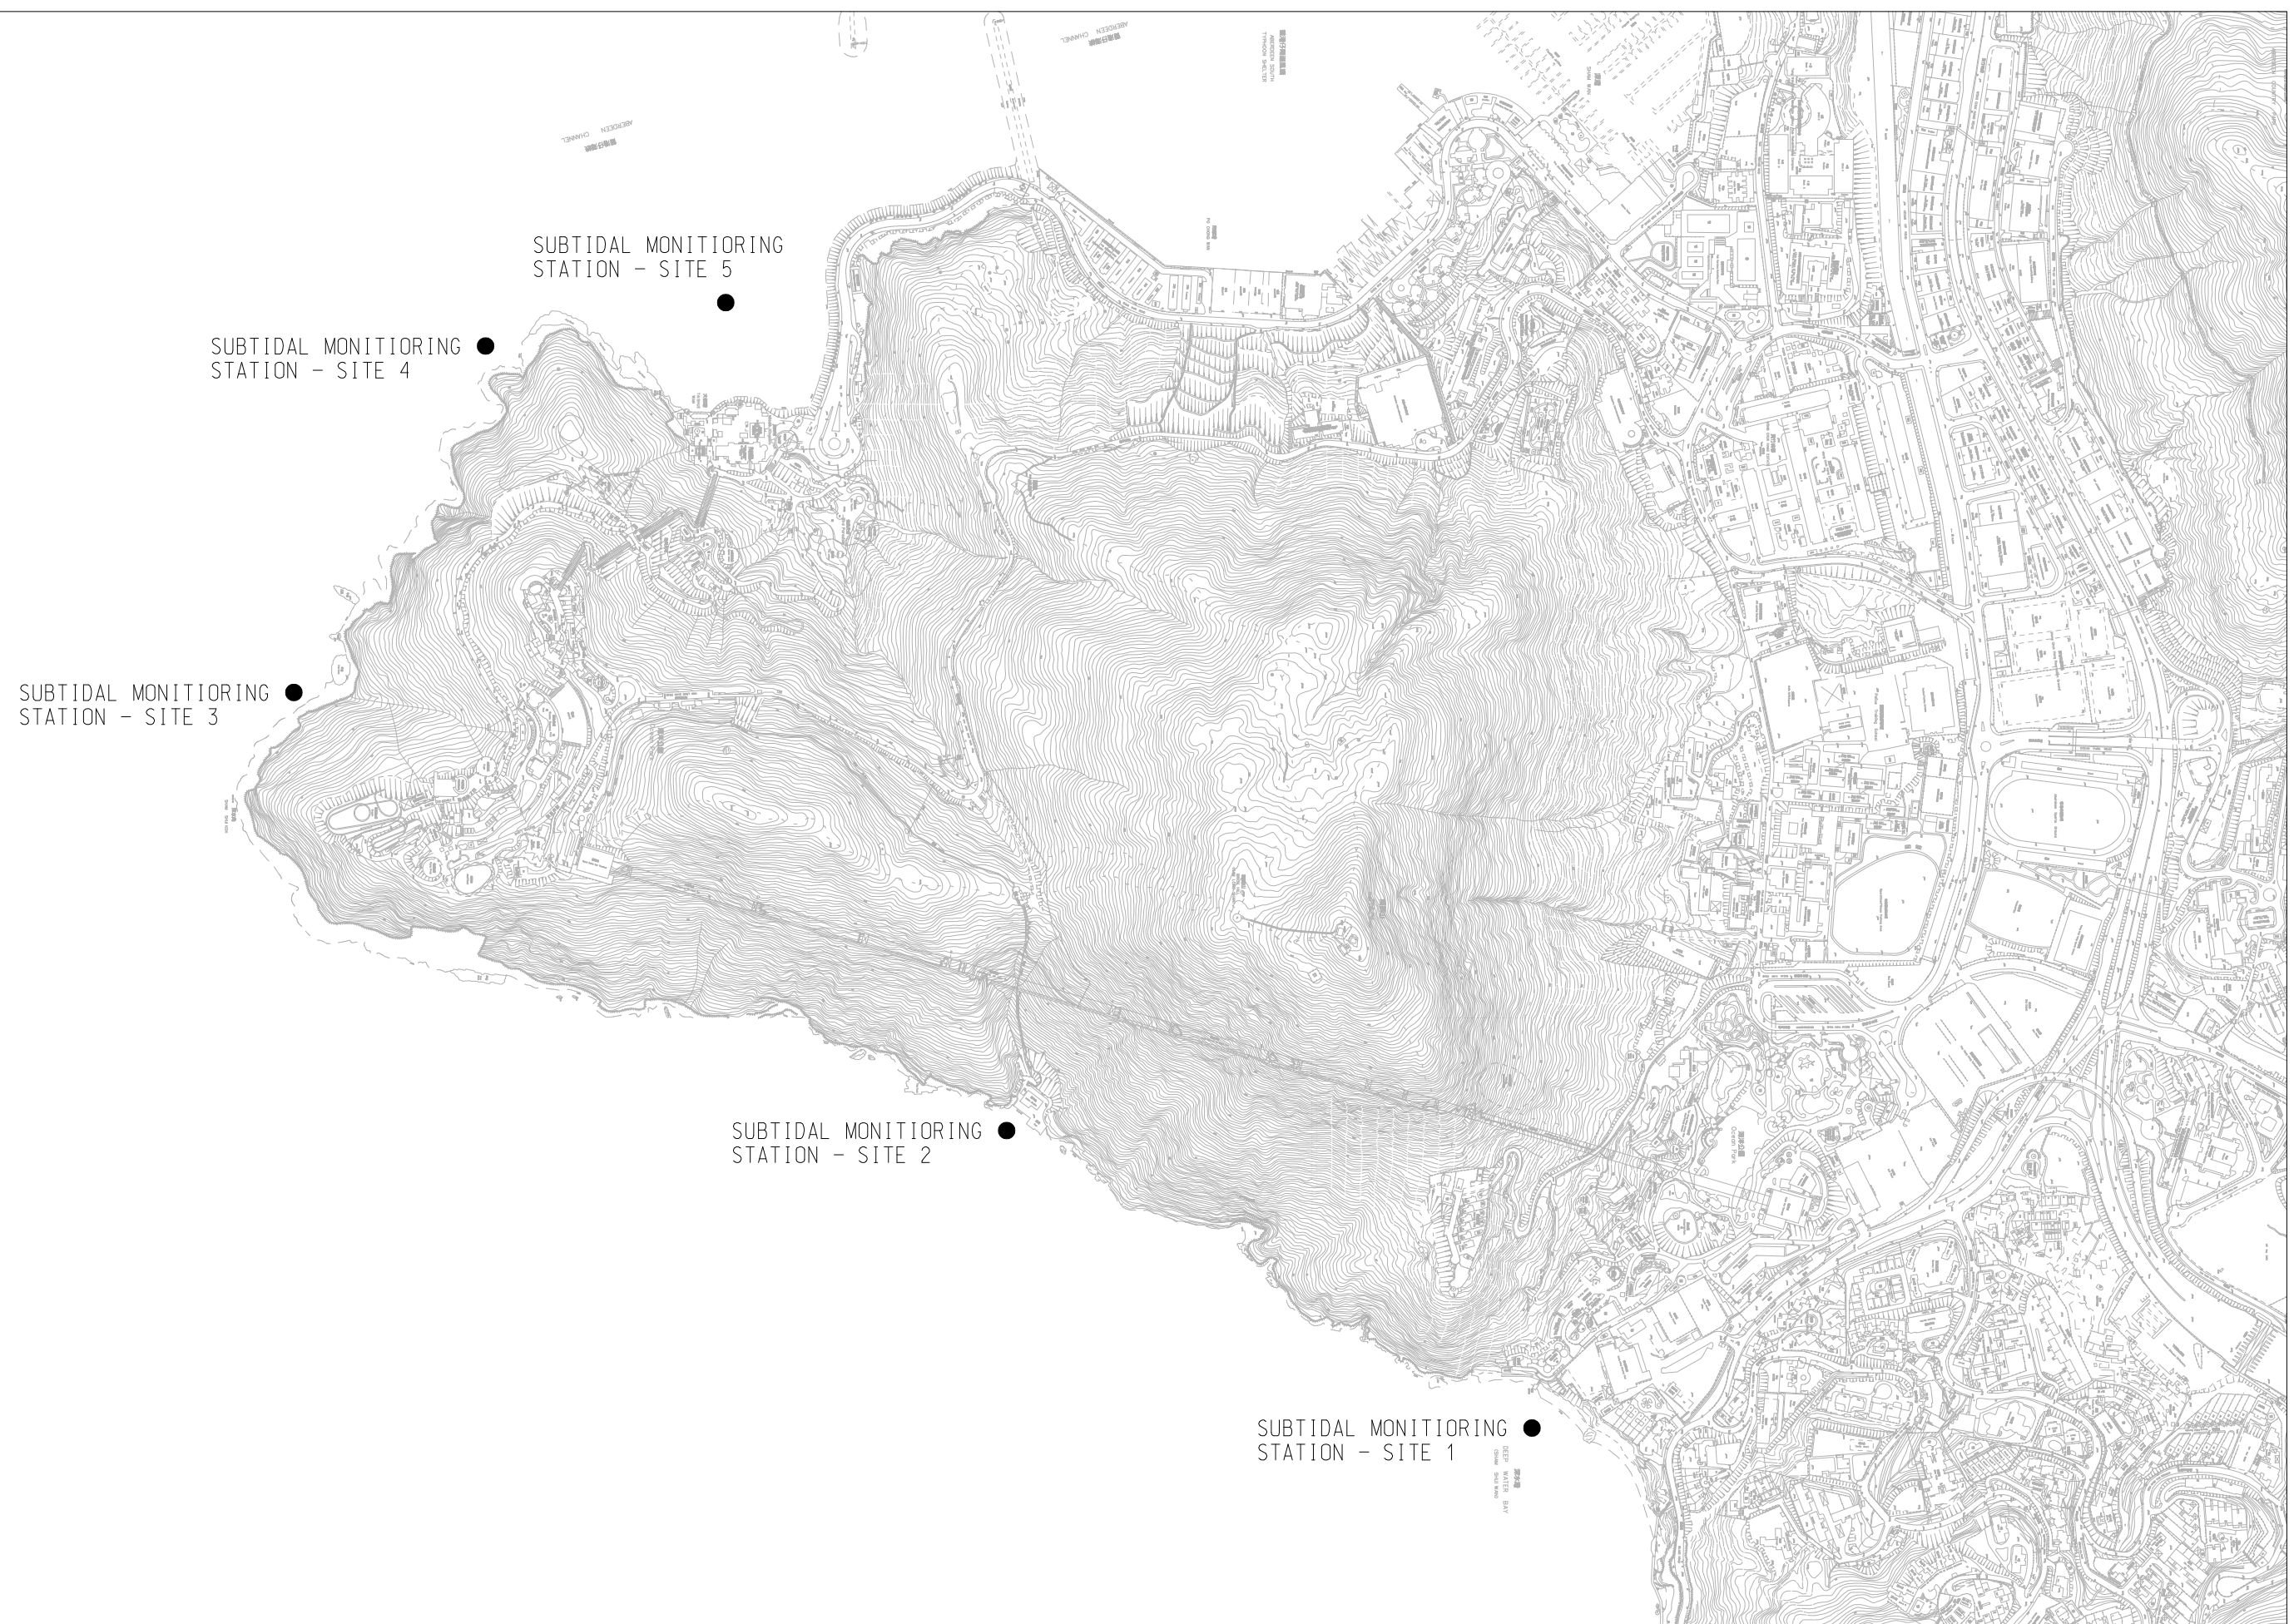
- 5.4 In accordance with the EM&A Manual, subtidal monitoring would be conducted at Tai Shue Wan and Chung Hom Kok. The monitoring locations are shown in Figure 5.1.
