Ocean Park Master Redevelopment Project

Monthly Environmental Monitoring & Audit
Report – July 2008

Environmental Permit No. EP-249/2006/A - Condition 3.4

Monthly EM&A Report – July 2008

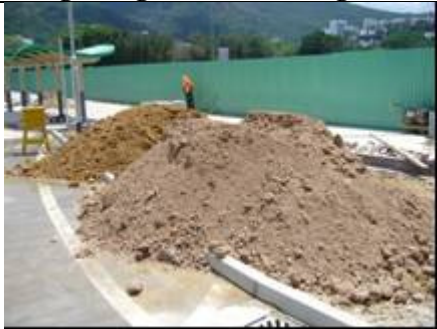
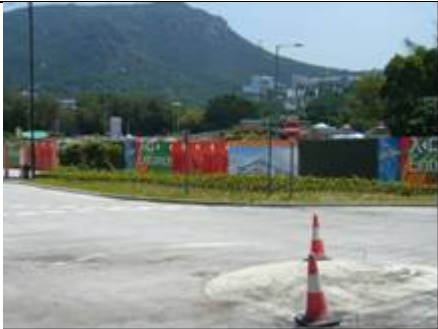
P1060493: Stockpiles of excavated materials were uncovered. The Contractor shall ensure all idle stockpiles on site are covered with tarpaulin sheets or other means and backfilled as soon as possible.	Closed - P1060662: Stockpiles of excavated materials were backfilled.
Crusher Area

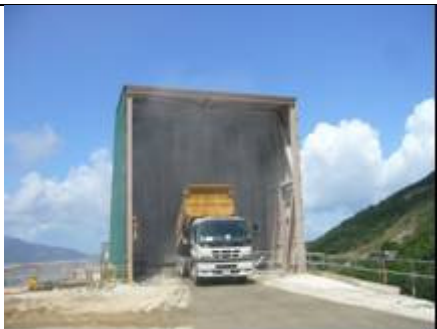
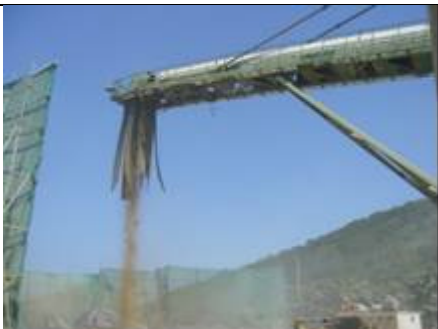
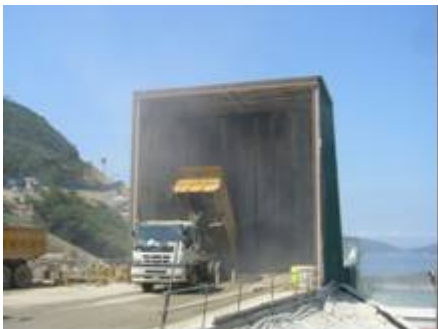
P1060485: The Crusher Area was still dry and dusty. The Contractor shall apply watering to suppress dust.	P1060631 & P1060639: The Conveyor Crusher Area was still dry and dusty. The Contractor shall apply watering to suppress dust.

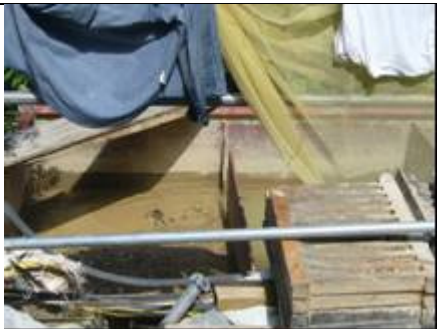
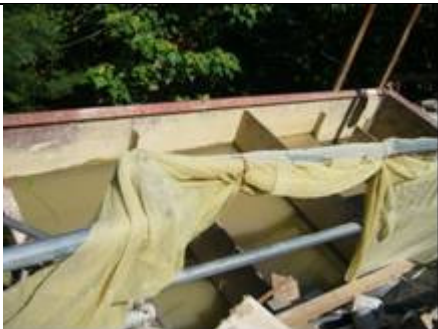
Summit Terminus

P1060466: The sedimentation tank was accumulated with sand and rock. The Contractor shall maintain it more frequently.	Closed – P 1060626: Sand and rock accumulated in the sedimentation tank had been removed.
Conveyor Crusher Area

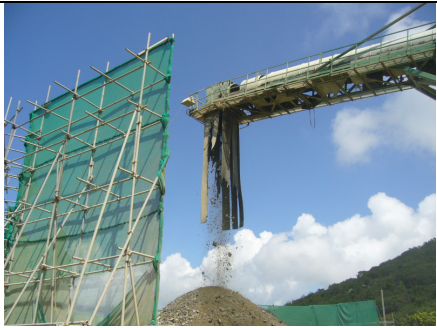
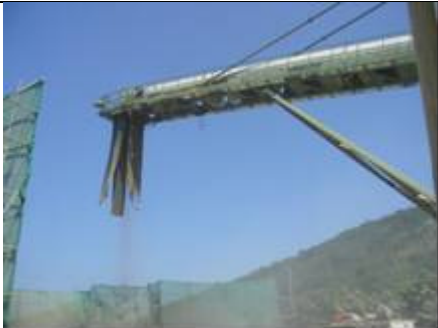
- (i) The Contractor was reminded to provide more water spray to suppress dust at the Conveyor Crusher Area.
- (ii) The flexible curtain hanged on the enclosed chute was damaged after maintenance few weeks ago. The Contractor was reminded to replace the torn curtains again.

P1060470: The flexible curtain hanged on the enclosed chute was damaged. The Contractor shall replace the curtain as soon as possible.	P1060632: The flexible curtain hanged on the enclosed chute was damaged after maintenance. The Contractor shall replace the curtain more frequently.
Waterfront Access Road

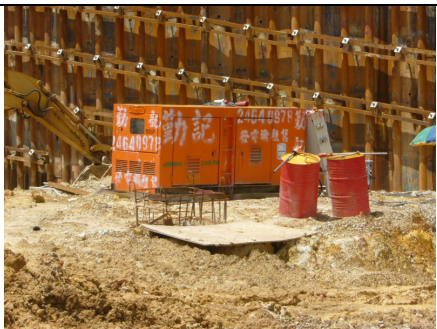
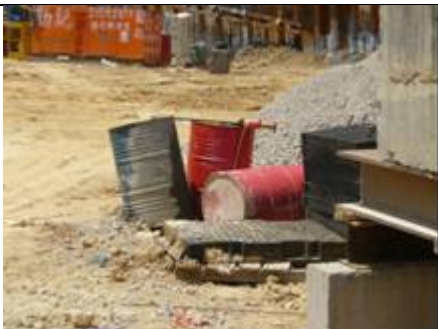
- (iii) A few oil drums were observed placing on bareground. The Contractor was reminded to provide drip tray for the oil drums.

P1060492: Two oil drums were observed placed on bare ground. The Contractor shall provide drip trays to all oil drums on site to avoid oil spillage.	P1060660: A few oil drums were still placed on bare ground. The Contractor shall provide drip trays to all oil drums on site to avoid oil spillage.

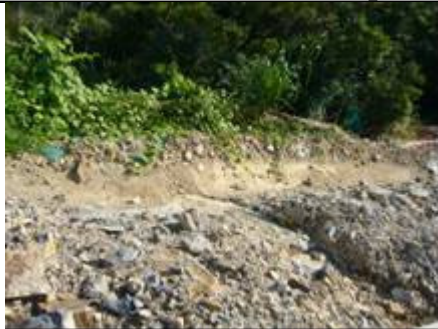
P1060519: The temporary drainage channel was still blocked by rocks and construction materials. The Contractor shall ensure that it is clear of blockage at all times.	Closed - P1060692: Blockage of the temporary drainage channel was cleared.

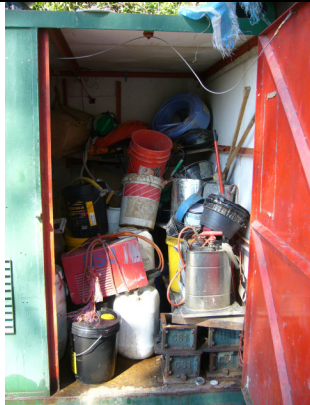
P1060684: Containers & materials other than construction waste were placed in the Chemical Waste Storage Area. The Contractor shall ensure materials other than chemical waste be removed from the Chemical Waste Storage Area.

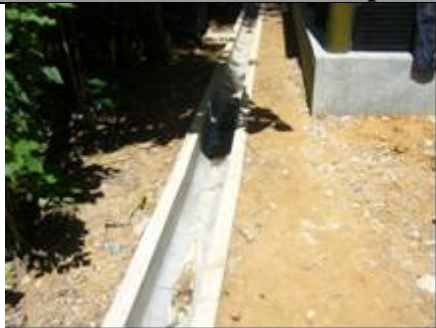
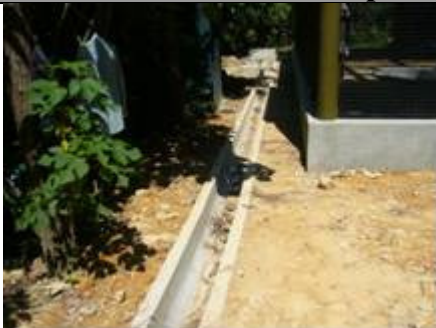
P1060504: Storm drain surrounding the Bird Exercise Aviary was still deposited with sand. The Contractor shall ensure that it is clear of blockage at all times.	P1060679: Storm drain surrounding the Bird Exercise Aviary was still deposited with sand and rock. The Contractor shall ensure that it is clear of blockage at all times.

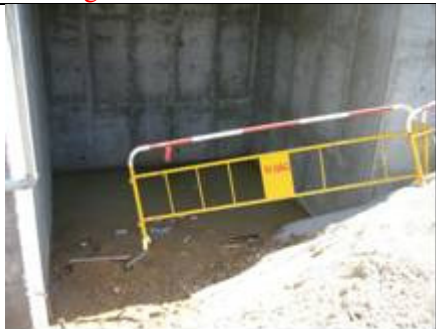
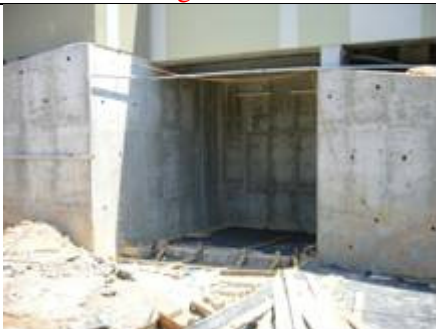
P1060503: Stagnant water was accumulated at the Bird House. The Contractor shall remove them by pump as soon as possible.	Closed - P1060664: Stagnant water accumulated at the Bird House had been removed.

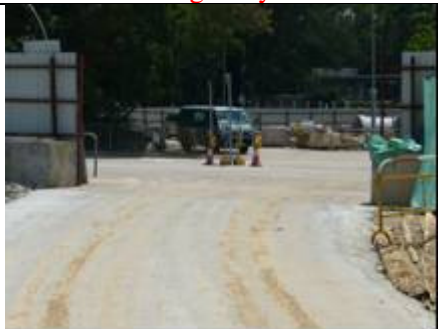
<p>P1060507: Construction waste was accumulated around the site. The Contractor shall store construction waste at designated areas and remove them regularly.</p>	<p>P1060677: Construction waste was still accumulated around the site. The Contractor shall store construction waste at designated areas and remove them regularly.</p>

<p>P1060495: Stockpiles of excavated material at Wing Hing Storage Area (previous CI12B) were not covered with tarpaulin sheets or other means. The Contractor shall ensure all idle stockpiles on site are covered with tarpaulin sheets or other means and backfilled as soon as possible.</p>	<p>P1060683: Stockpiles of excavated material at Wing Hing Storage Area (previous CI12B) were still not covered with tarpaulin sheets or other means. The Contractor shall ensure all idle stockpiles onsite are covered with tarpaulin sheets or other means and backfilled as soon as possible.</p>

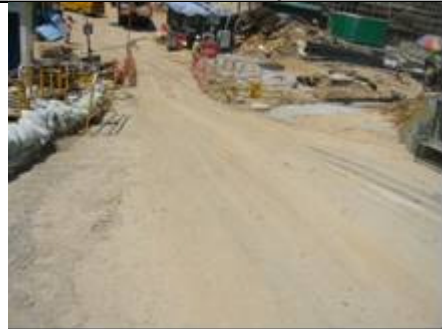
P1060669: Haul road was dry and dusty. The Contractor shall provide water spray more frequently to suppress dust.

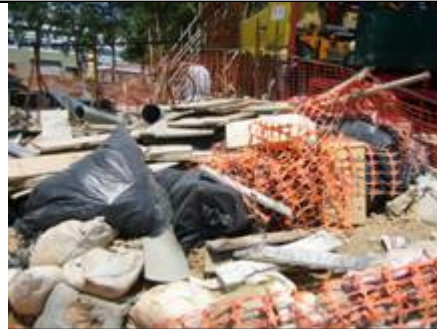
P1060671: General refuse and construction waste were mixed in a stockpile. The Contractor shall ensure general refuse are stored in enclosed bins or compaction units separate from construction waste.

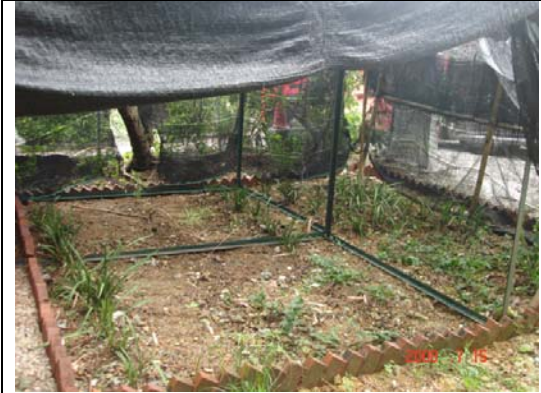
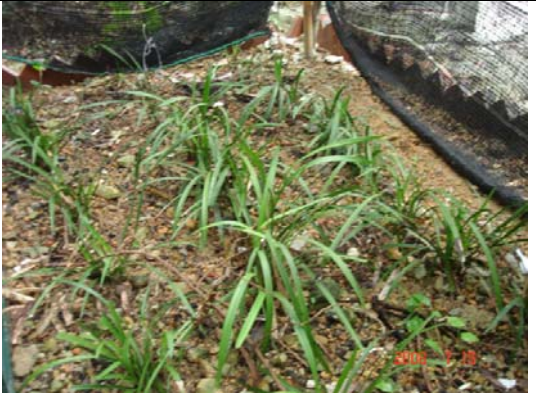
Photo 1 - Plant nursery.	Photo 2 - Transplanted Sword-leaved Orchid at the plant nursery site.
