# Ocean Park Master Redevelopment Project

## Monthly Environmental Monitoring & Audit Report – January 2010

This is the combined monthly EM&A Report for Ocean Park Master Redevelopment Project, which includes CI07 “Entry Plaza, Aqua City and Grand Aquarium”, CW02 “The Astounding Asia”, CS02 “Rainforest” and CS03 “Trill Mountain and Polar Adventure”. This report presents the results of EM&A works conducted in the reporting month of January 2010 (from 26 December 2009 to 25 January 2010).

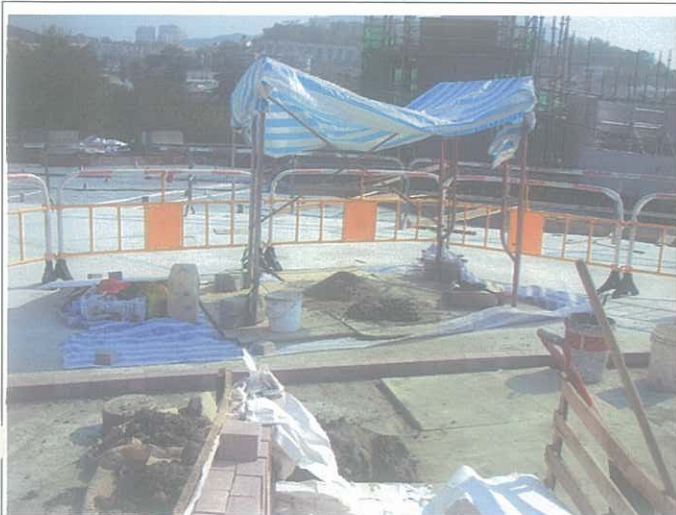
1. A temporary facility located on the podium for mixing cement was found lacking of side coverage.

1. The contractor was reminded to provide coverage on three sides along with top coverage.

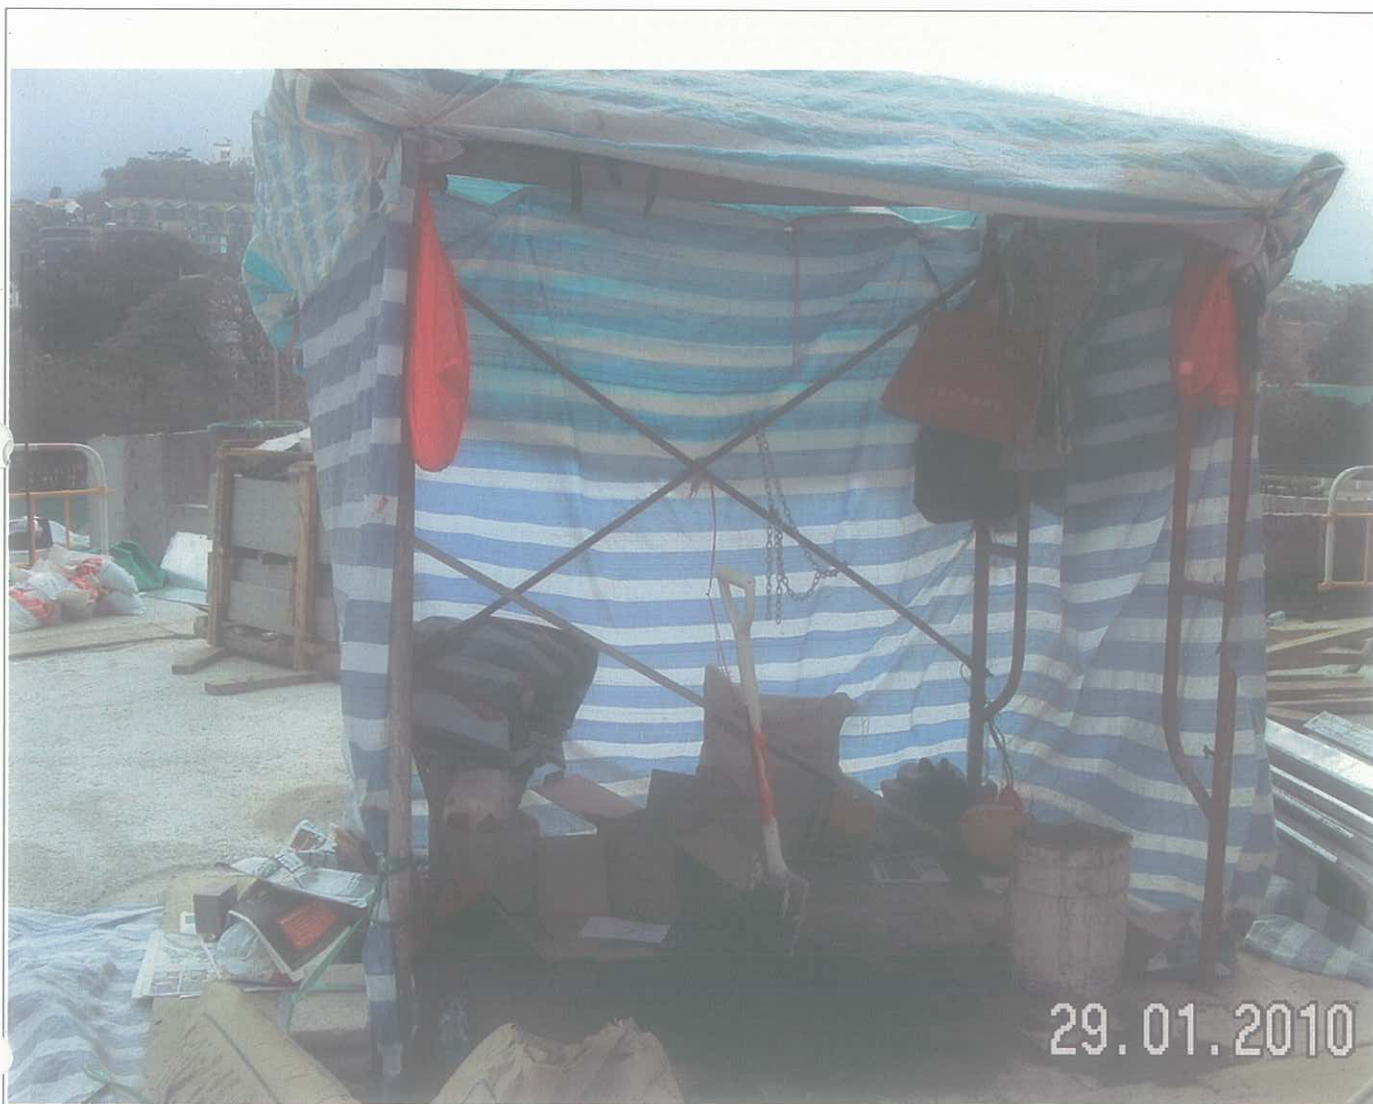
**Inspection / Follow up Report No 062.**

1. Cement mixing was conducted in temporary facilities located on the podium which were covered 3 sides with top coverage.

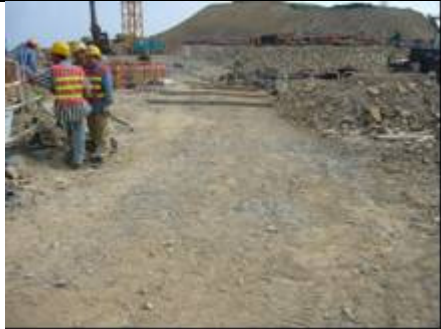
<p>P1080429: Haul road near the site entrance was dry and dusty. The Contractor should provide water spray to all haul road on-site more frequently.</p>
