Ocean Park Master Redevelopment Project

Monthly EM&A Report – April 2010

Environmental Permit No. EP-249/2006/A - Condition 3.4

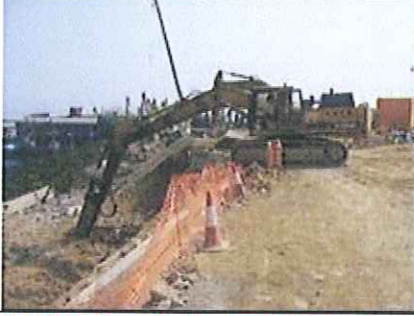
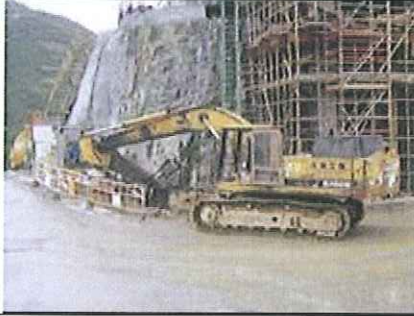
P1080805: Rock breaking was in operation without provision of dust suppression measures. The Contractor should provide water spray during rock breaking activity to suppress dust.		Closed - P1080984: Rock breaking was not in operation during the site inspection.

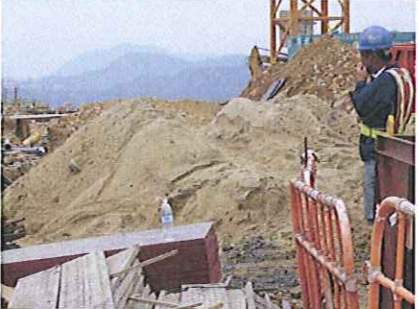
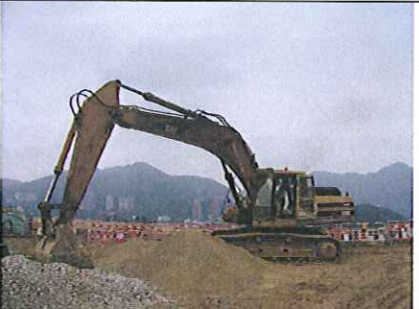
<p>P1080992: Stockpiles of dusty material was not covered with tarpaulin sheets or other means. The Contractor should cover all idle stockpiles of dusty materials on-site to suppress dust.</p>	<p>P1080999: Dark smoke was emitted by a backhoe. The Contractor should provide better maintenance to the backhoe to avoid emission of dark smoke.</p>
