Ocean Park Master Redevelopment Project

Monthly EM&A Report – July 2010

Environmental Permit No. EP-249/2006/A - Condition 3.4

Monthly Environmental Monitoring & Audit Report – July 2010

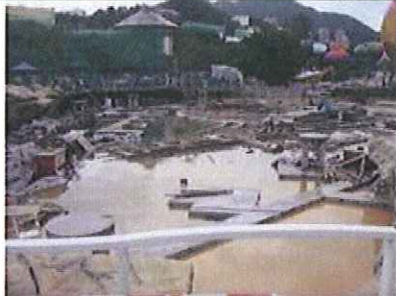
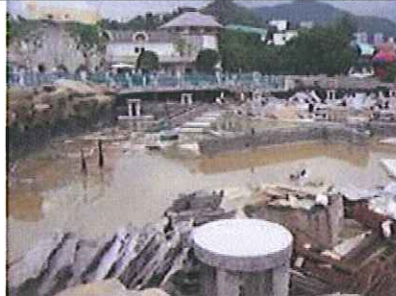
Contract CI07 Entry Plaza, Aqua City and Grand Aquarium			
Follow up observations in June 2010			
Observation in last site inspection		Observation in this site inspection

P1090672: Stagnant water was accumulated around the site due to rainfall. The Contractor is reminded to remove them as soon as possible.		P1090918: Stagnant water was accumulated around the site due to heavy rain the day before. The Contractor is reminded to remove them as soon as possible.	
Observations in July 2010

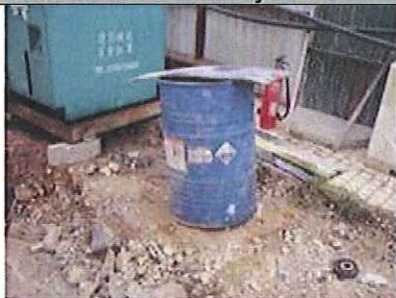
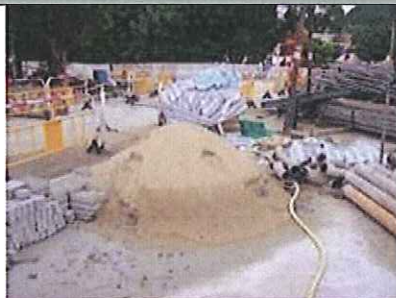
P1090923: An empty oil drum was placed on bare ground. The Contractor is reminded to place it in the chemical waste storage area and remove it from the site as soon as possible.		P1090913: A stockpile of dusty construction material was not covered with tarpaulin sheets or other means. The Contractor is reminded to cover all dusty stockpiles on site with tarpaulin sheets or other means.

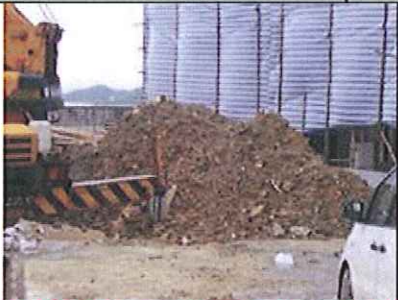
Contract CS03 Trill Mountain and Polar Adventure	
Follow up observations in June 2010	
Observation in last site inspection	Observation in this site inspection

N/A
<p>P1090698: A stockpile of dusty C&D material was not covered with tarpaulin sheets or other means. The Contractor should cover all idle stockpiles of dusty materials on-site to suppress dust.</p>	<p>Closed - Stockpile of dusty C&D material was not observed on-site.</p>

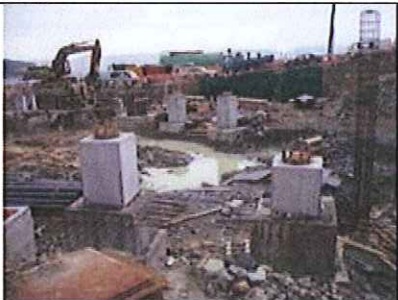
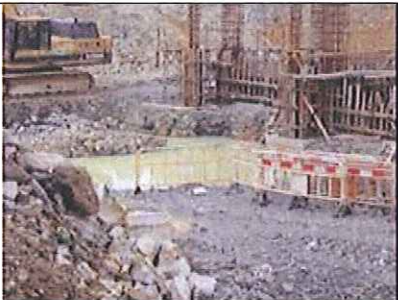
<p>P1090693: Stagnant water was observed accumulated around the site due to rainfall. Removal by pumps was in progress. The Contractor was reminded to remove them as soon as possible.</p>	<p>P1090943: Stagnant water was accumulated around the site due to heavy rain the day before. The Contractor is reminded to remove them as soon as possible.</p>

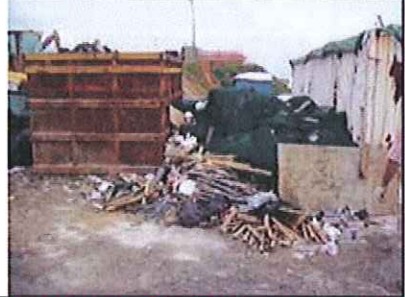
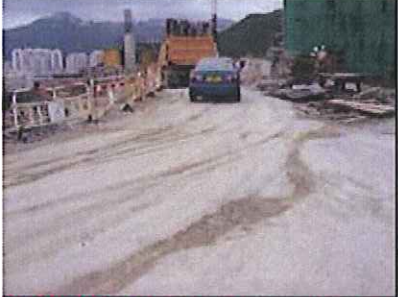
Observations in July 2010

<p>P1090947: General refuse were accumulated on-site. The Contractor is reminded to store them in enclosed bins or compaction units separate from C&D materials.</p>	<p>P1090952: Section of paved access road near the site entrance was dry and dusty. The Contractor is reminded to provide water spray regularly to suppress dust.</p>

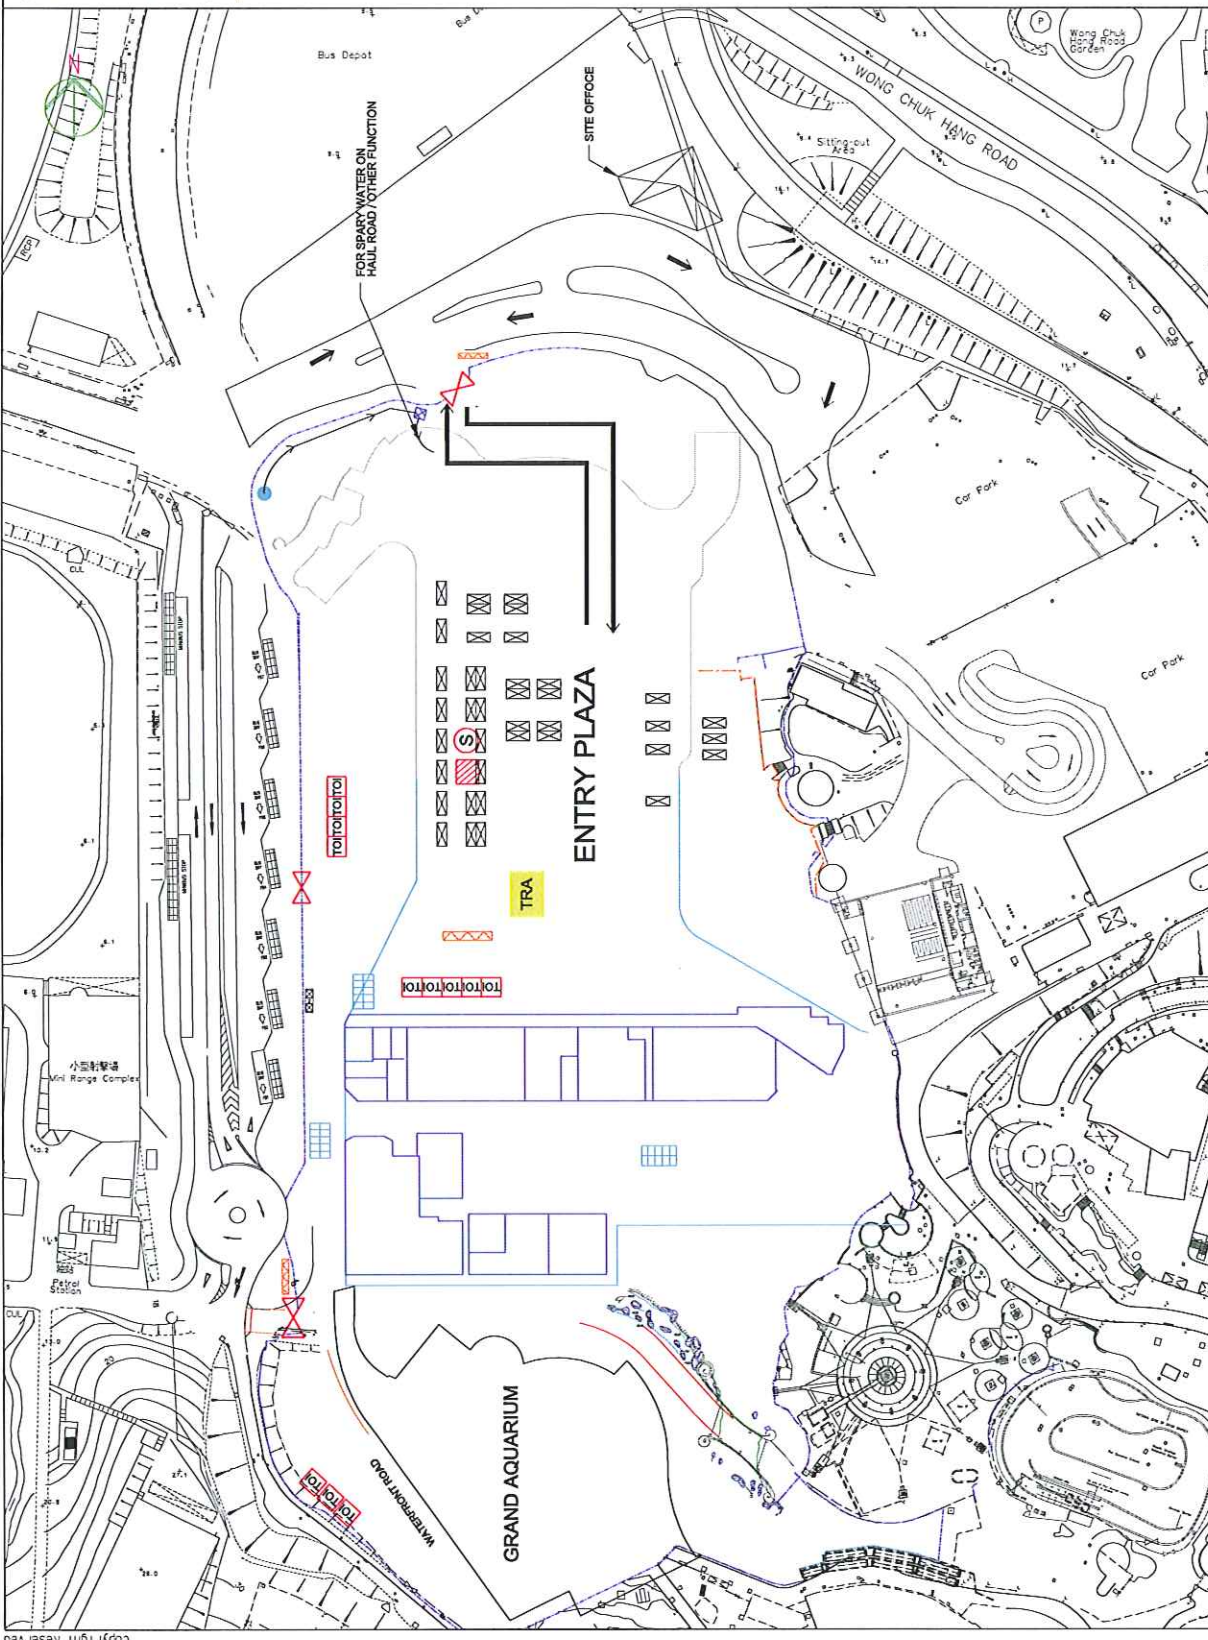
Figure 1.1 – Site Layout Plan

The "Repositioning and Long Term Operation Plan of Ocean Park" is being implemented by the Ocean Park Corporation at the existing site of Ocean Park and Nam Long Shan, Aberdeen. The purpose of this project is to upgrade and expand the existing Ocean Park to meet anticipated visitor demands and to position Ocean Park as a premium tourist attraction and a regional leader in themed recreational and educational park experience. The site layout plan is illustrated in Figure 1.1.

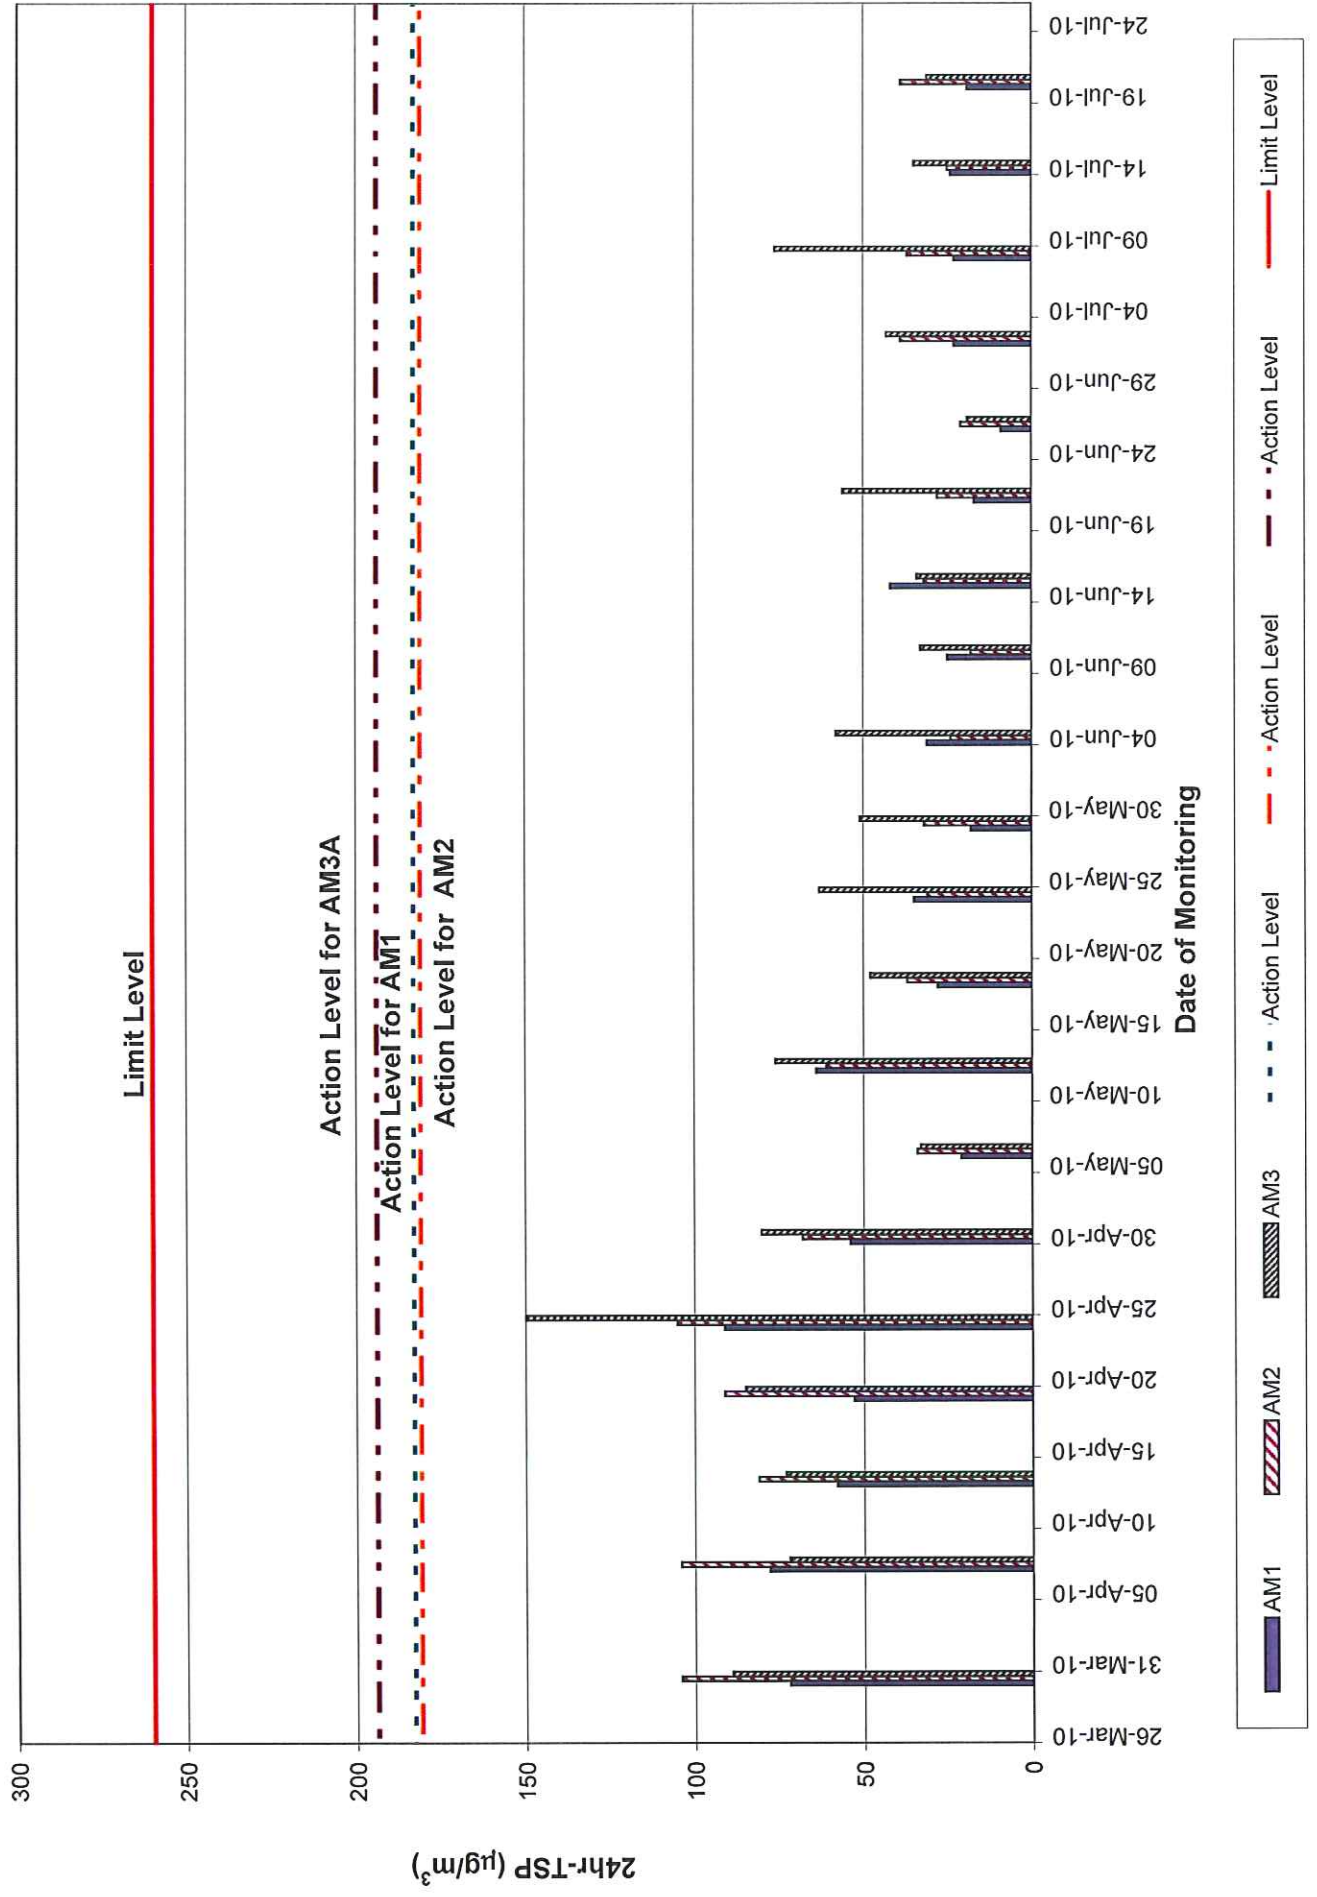
Figure C.4 24-hr TSP monitoring results of Monitoring Station AM1, AM2 & AM3A

- Remarks:**
1. Bold value indicated an Action Level exceedance
 2. Bold & Italic value indicated an Limit Level exceedance
 3. x - denotes no measurement due to power supply failure
 4. * - not 24 hrs due to power supply failure

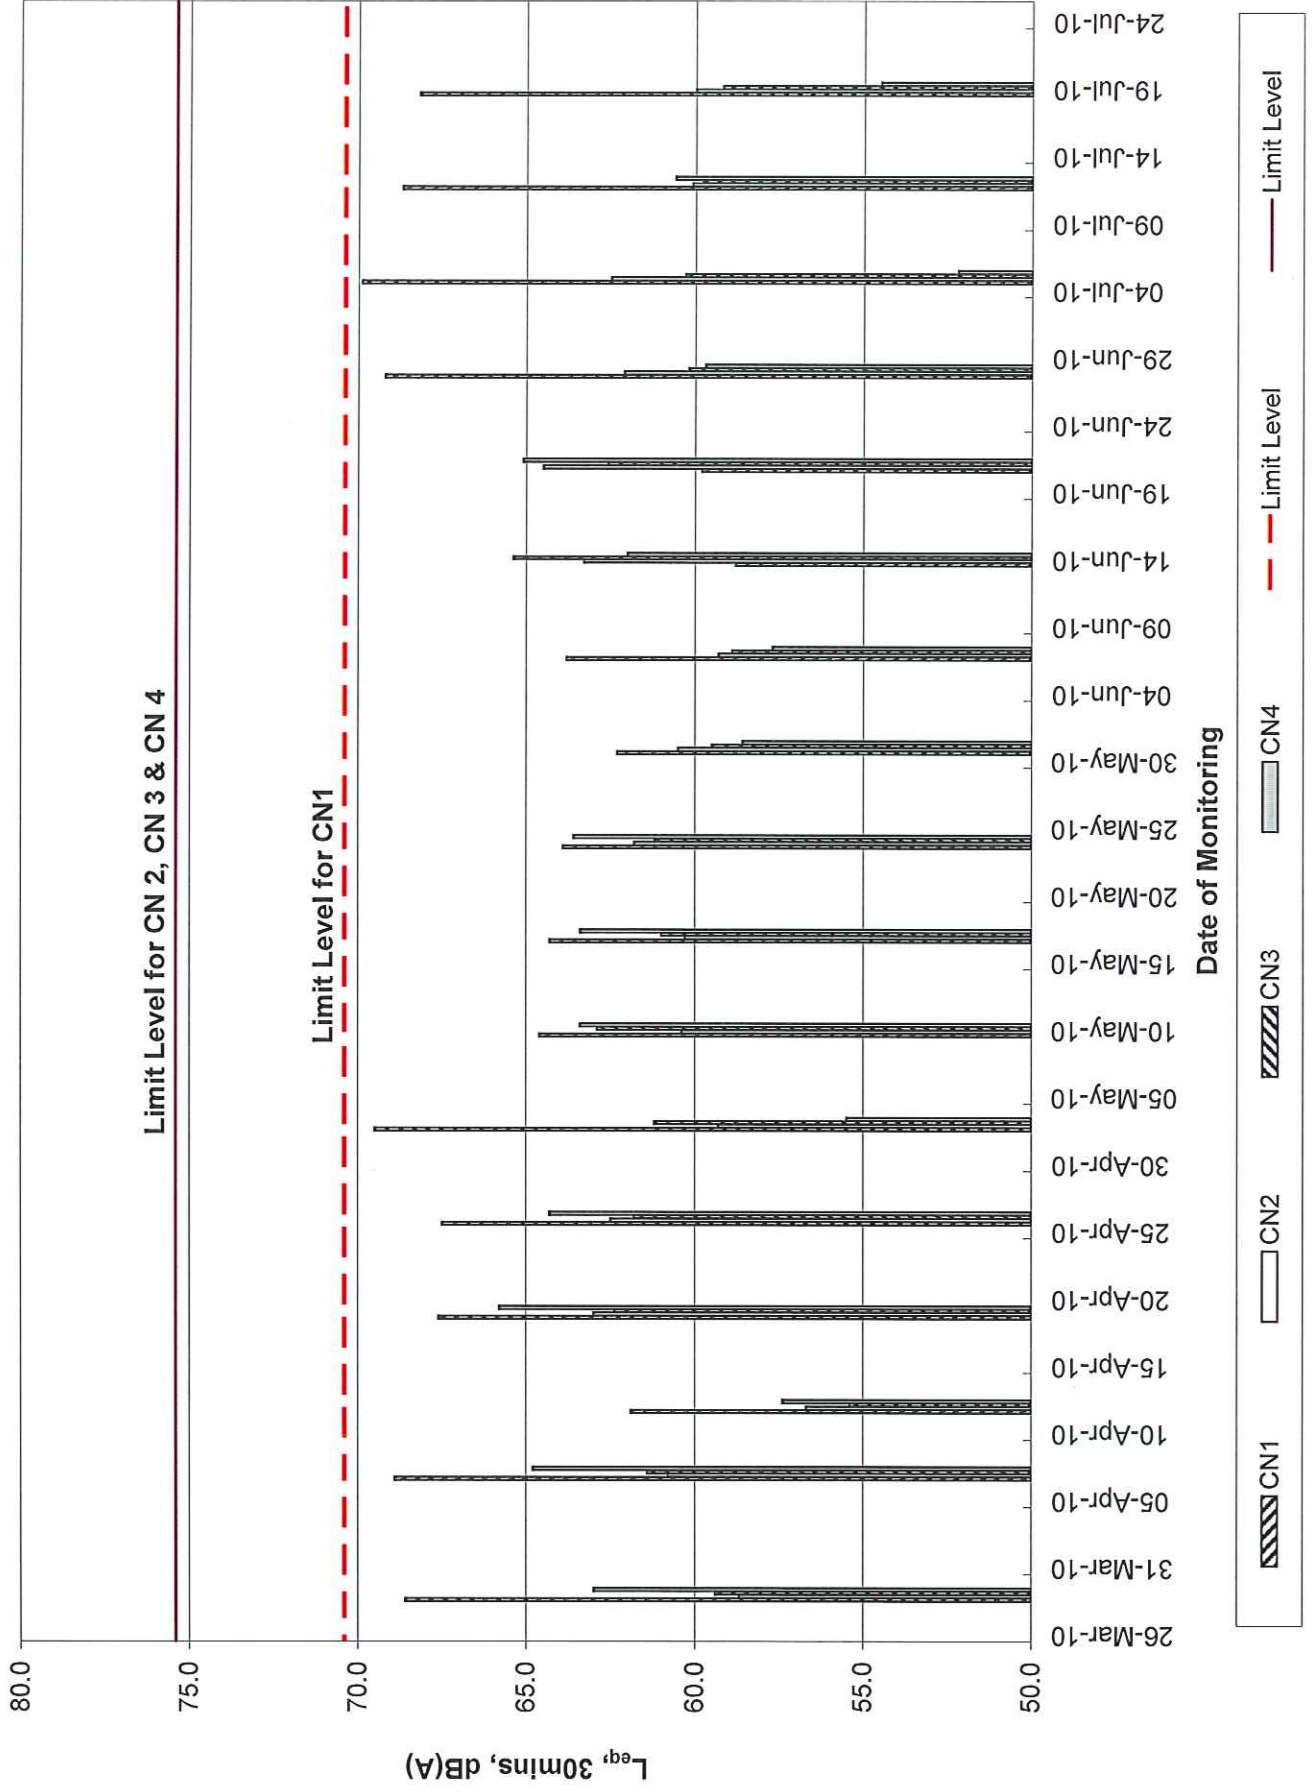
Fig D.1 - Daytime Noise Monitoring Results of Monitoring Stations CN1, CN2, CN3 & CN4

Remarks: Bold & Italic value indicated an Limit Level exceedance

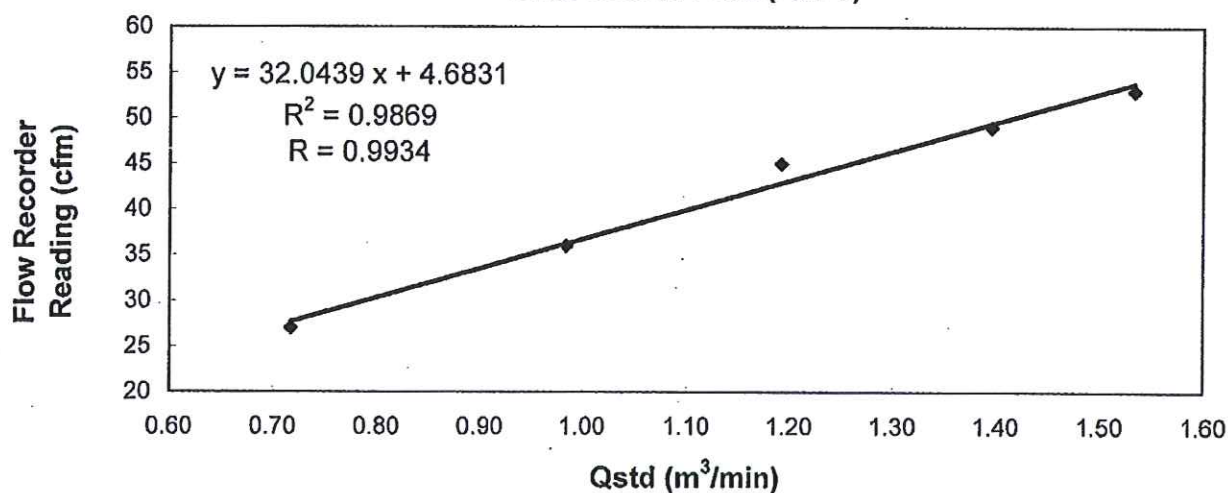
Sampler 1174 Calibration Curve
Site: Ocean Park (AM-1)

Results	Flow recorder reading (cfm)	53	49	45	36	27
	Qstd (Actual flow rate, m ³ /min)	1.53	1.40	1.19	0.98	0.72
	Pressure : 761.31 mm Hg	Temp. : 297 K

Acceptance Criteria : Correlation coefficient (r) of the calibration curve greater than 0.990 after a 5-point calibration.

The high volume sampler complies* / ~~does not comply~~* with the specified requirements and is deemed acceptable* / unacceptable* for use.

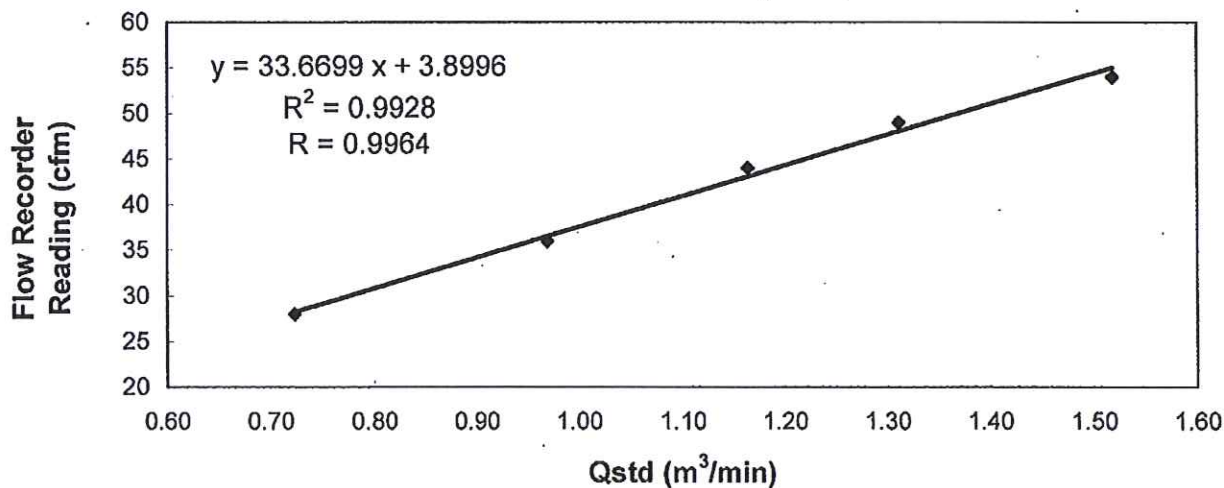
Sampler 1174 Calibration Curve
Site: Ocean Park (AM-1)

Results	Flow recorder reading (cfm)	54	49	44	36	28
	Qstd (Actual flow rate, m ³ /min)	1.52	1.31	1.16	0.97	0.72
	Pressure : 756.06 mm Hg	Temp. : 304 K

Acceptance Criteria : Correlation coefficient (r) of the calibration curve greater than 0.990 after a 5-point calibration.

The high volume sampler complies* / ~~does not comply~~* with the specified requirements and is deemed acceptable* / unacceptable* for use.

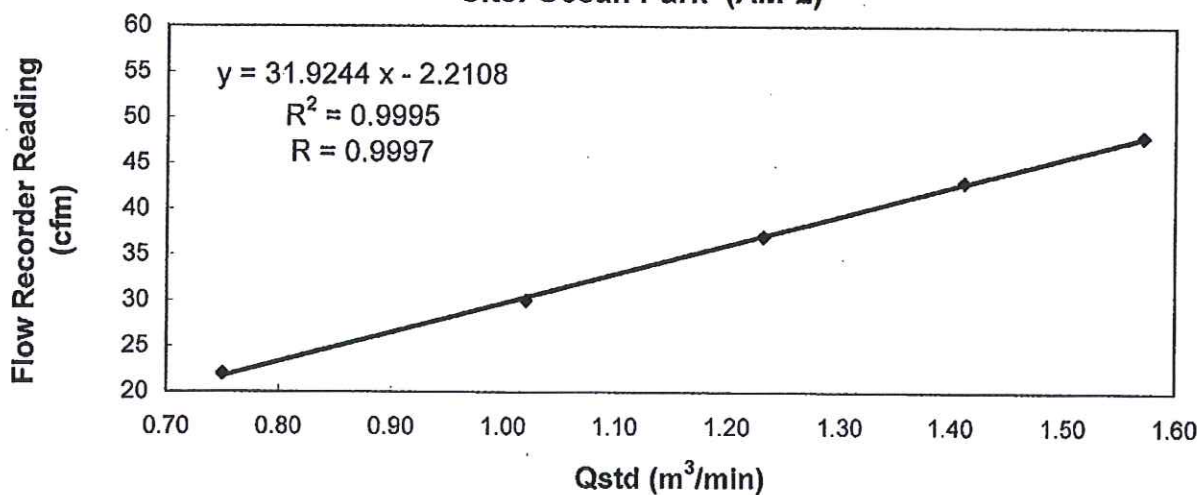
Sampler 1177 Calibration Curve
Site: Ocean Park (AM-2)

Results	Flow recorder reading (cfm)	48	43	37	30	22
	Qstd (Actual flow rate, m ³ /min)	1.57	1.41	1.23	1.02	0.75
	Pressure : 761.31 mm Hg	Temp. : 298 K

Acceptance Criteria : Correlation coefficient (r) of the calibration curve greater than 0.990 after a 5-point calibration.

The high volume sampler complies* / ~~does not comply*~~ with the specified requirements and is deemed acceptable* / unacceptable* for use.

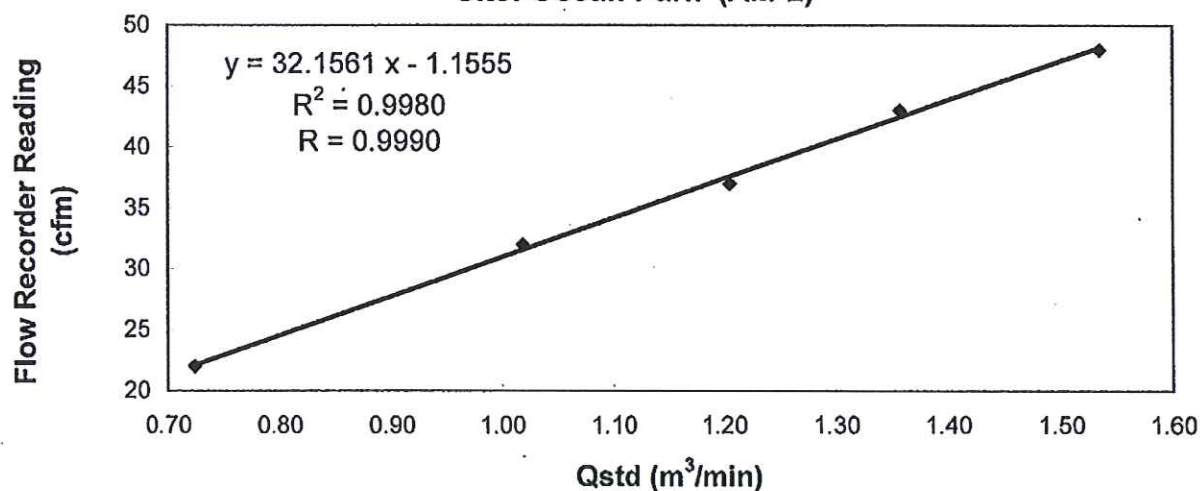
Sampler 1177 Calibration Curve
Site: Ocean Park (AM-2)

Flow recorder reading (cfm)	48	43	37	32	22
Qstd (Actual flow rate, m ³ /min)	1.53	1.36	1.21	1.02	0.72
Pressure :	756.06 mm Hg		Temp. :	304 K

Acceptance Criteria : Correlation coefficient (r) of the calibration curve greater than 0.990 after a 5-point calibration.

The high volume sampler complies* / ~~does not comply~~* with the specified requirements and is deemed acceptable* / unacceptable* for use.

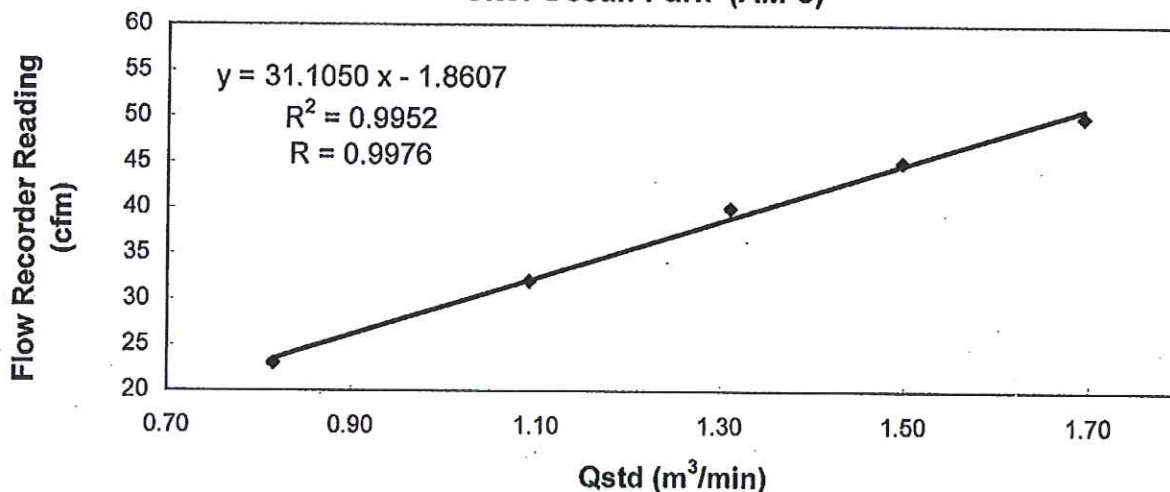
Sampler 9998 Calibration Curve
Site: Ocean Park (AM-3)

Results	Flow recorder reading (cfm)	50	45	40	32	23
	Qstd (Actual flow rate, m ³ /min)	1.69	1.50	1.31	1.09	0.81
	Pressure : 761.31 mm Hg	Temp. : 298 K

Acceptance Criteria : Correlation coefficient (r) of the calibration curve greater than 0.990 after a 5-point calibration.

The high volume sampler complies* / ~~does not comply~~* with the specified requirements and is deemed acceptable* / unacceptable* for use.

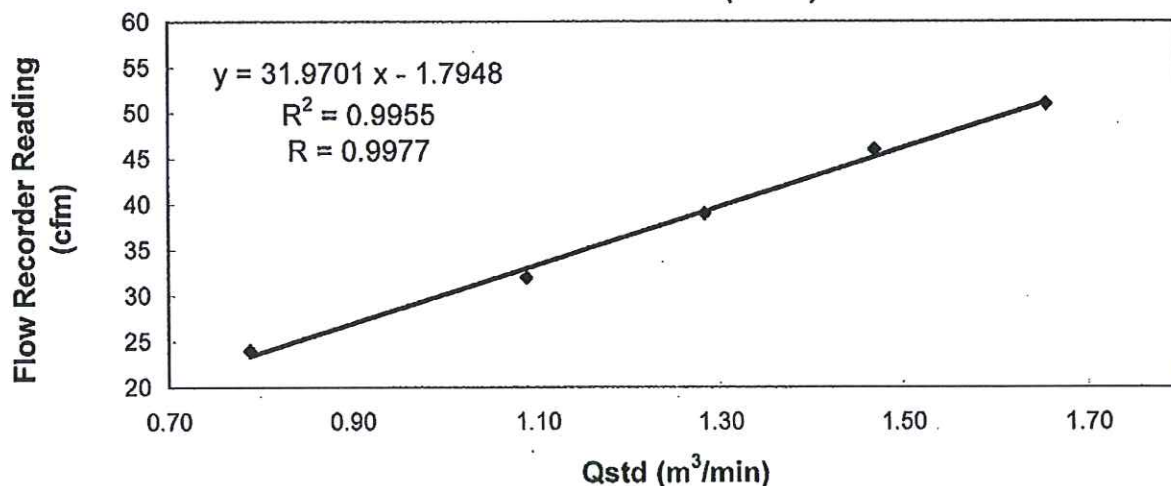
Sampler 9998 Calibration Curve
Site: Ocean Park (AM-3)

Results	Flow recorder reading (cfm)	51	46	39	32	24
	Qstd (Actual flow rate, m ³ /min)	1.66	1.47	1.28	1.09	0.79
	Pressure :	756.06 mm Hg			Temp. :	304 K

Acceptance Criteria : Correlation coefficient (r) of the calibration curve greater than 0.990 after a 5-point calibration.

The high volume sampler complies* / ~~does not comply~~* with the specified requirements and is deemed acceptable* / unacceptable* for use.

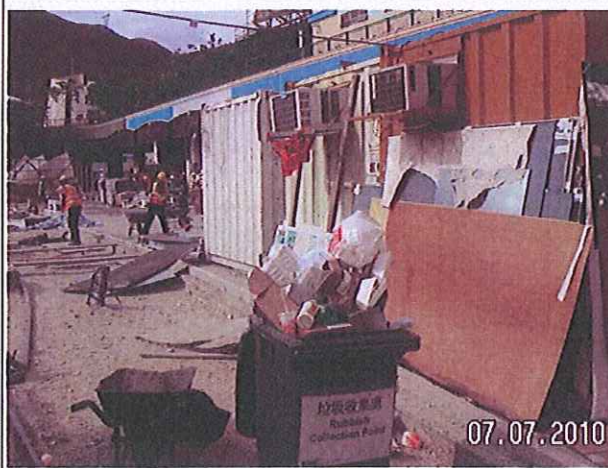
1. Garbage was over accumulated near Gate B.

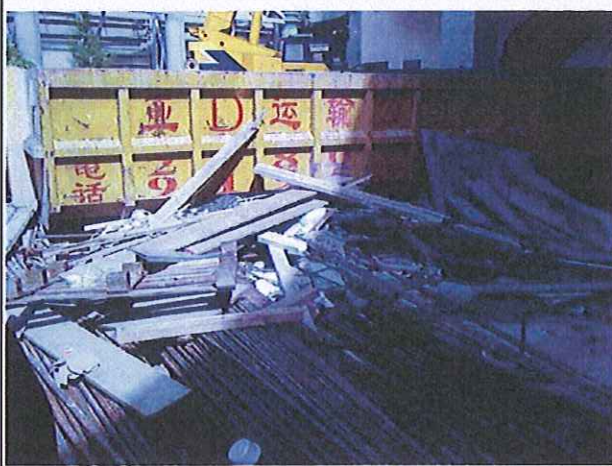
1. Rubbish was over accumulated near Area X.

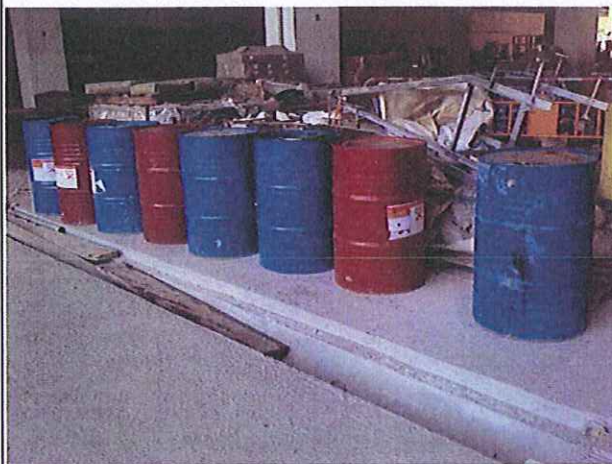
2. Chemical drums were placed on ground level without drip tray underneath.

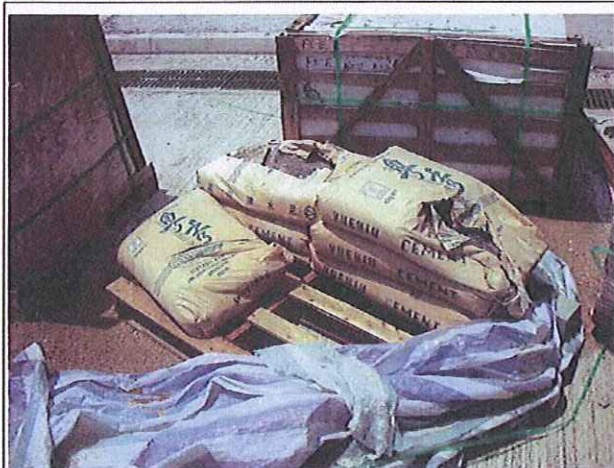
1. Near Gate C, opened cement bags was not covered with tarpaulin.

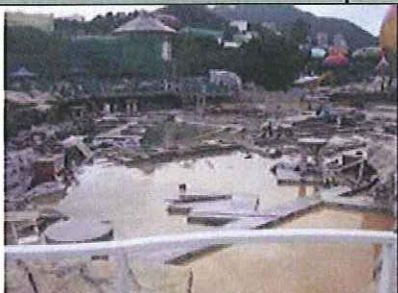
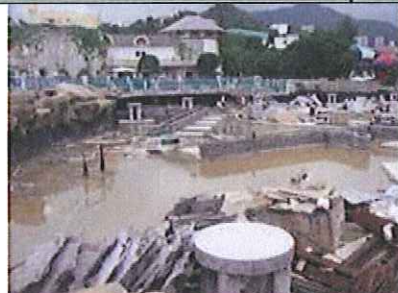
Contract CI07 Entry Plaza, Aqua City and Grand Aquarium	
Follow up observations in June 2010	
Observation in last site inspection	Observation in this site inspection

P1090672: Stagnant water was accumulated around the site due to rainfall. The Contractor is reminded to remove them as soon as possible.	P1090918: Stagnant water was accumulated around the site due to heavy rain the day before. The Contractor is reminded to remove them as soon as possible.
Observations in July 2010

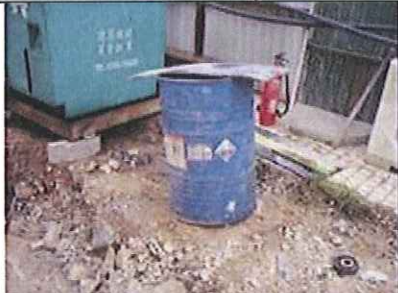
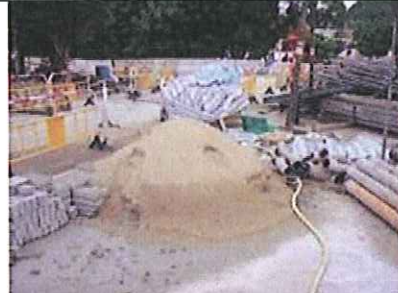
P1090923: An empty oil drum was placed on bare ground. The Contractor is reminded to place it in the chemical waste storage area and remove it from the site as soon as possible.	P1090913: A stockpile of dusty construction material was not covered with tarpaulin sheets or other means. The Contractor is reminded to cover all dusty stockpiles on site with tarpaulin sheets or other means.

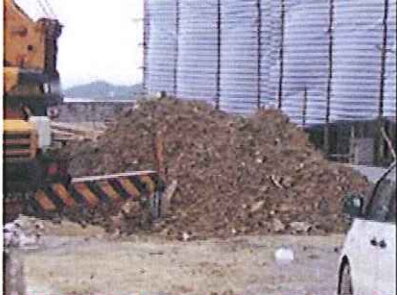
Contract CS03 Trill Mountain and Polar Adventure	
Follow up observations in June 2010	
Observation in last site inspection	Observation in this site inspection

N/A
<p>P1090698: A stockpile of dusty C&D material was not covered with tarpaulin sheets or other means. The Contractor should cover all idle stockpiles of dusty materials on-site to suppress dust.</p>	<p>Closed - Stockpile of dusty C&D material was not observed on-site.</p>

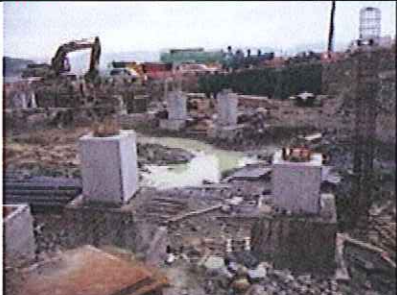
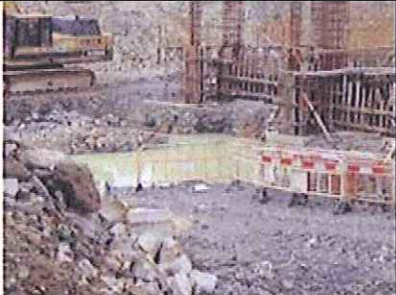
<p>P1090693: Stagnant water was observed accumulated around the site due to rainfall. Removal by pumps was in progress. The Contractor was reminded to remove them as soon as possible.</p>	<p>P1090943: Stagnant water was accumulated around the site due to heavy rain the day before. The Contractor is reminded to remove them as soon as possible.</p>

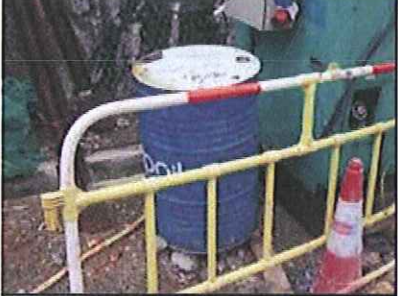
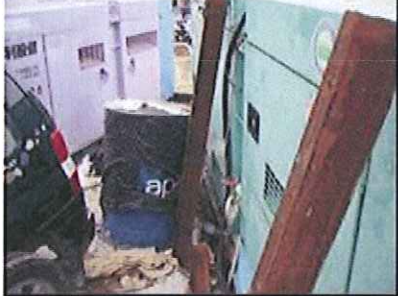
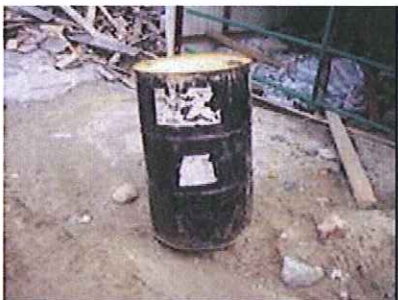
<p>P1090702: An oil drum was placed on bareground. The Contractor was reminded to provide drip trays for all oil drums on site to avoid oil spillage.</p>	<p>P1090935 & P1090941: A few empty oil drums were placed on bareground. The Contractor is reminded to place them in the chemical waste storage area and remove them from the site as soon as possible.</p>

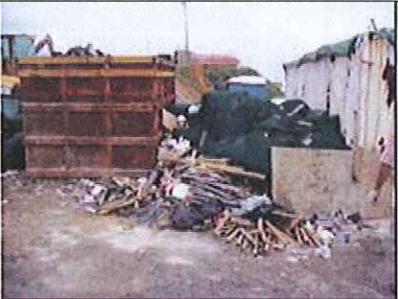
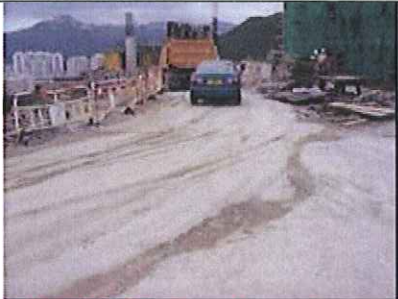
Observations in July 2010

<p>P1090947: General refuse were accumulated on-site. The Contractor is reminded to store them in enclosed bins or compaction units separate from C&D materials.</p>	<p>P1090952: Section of paved access road near the site entrance was dry and dusty. The Contractor is reminded to provide water spray regularly to suppress dust.</p>

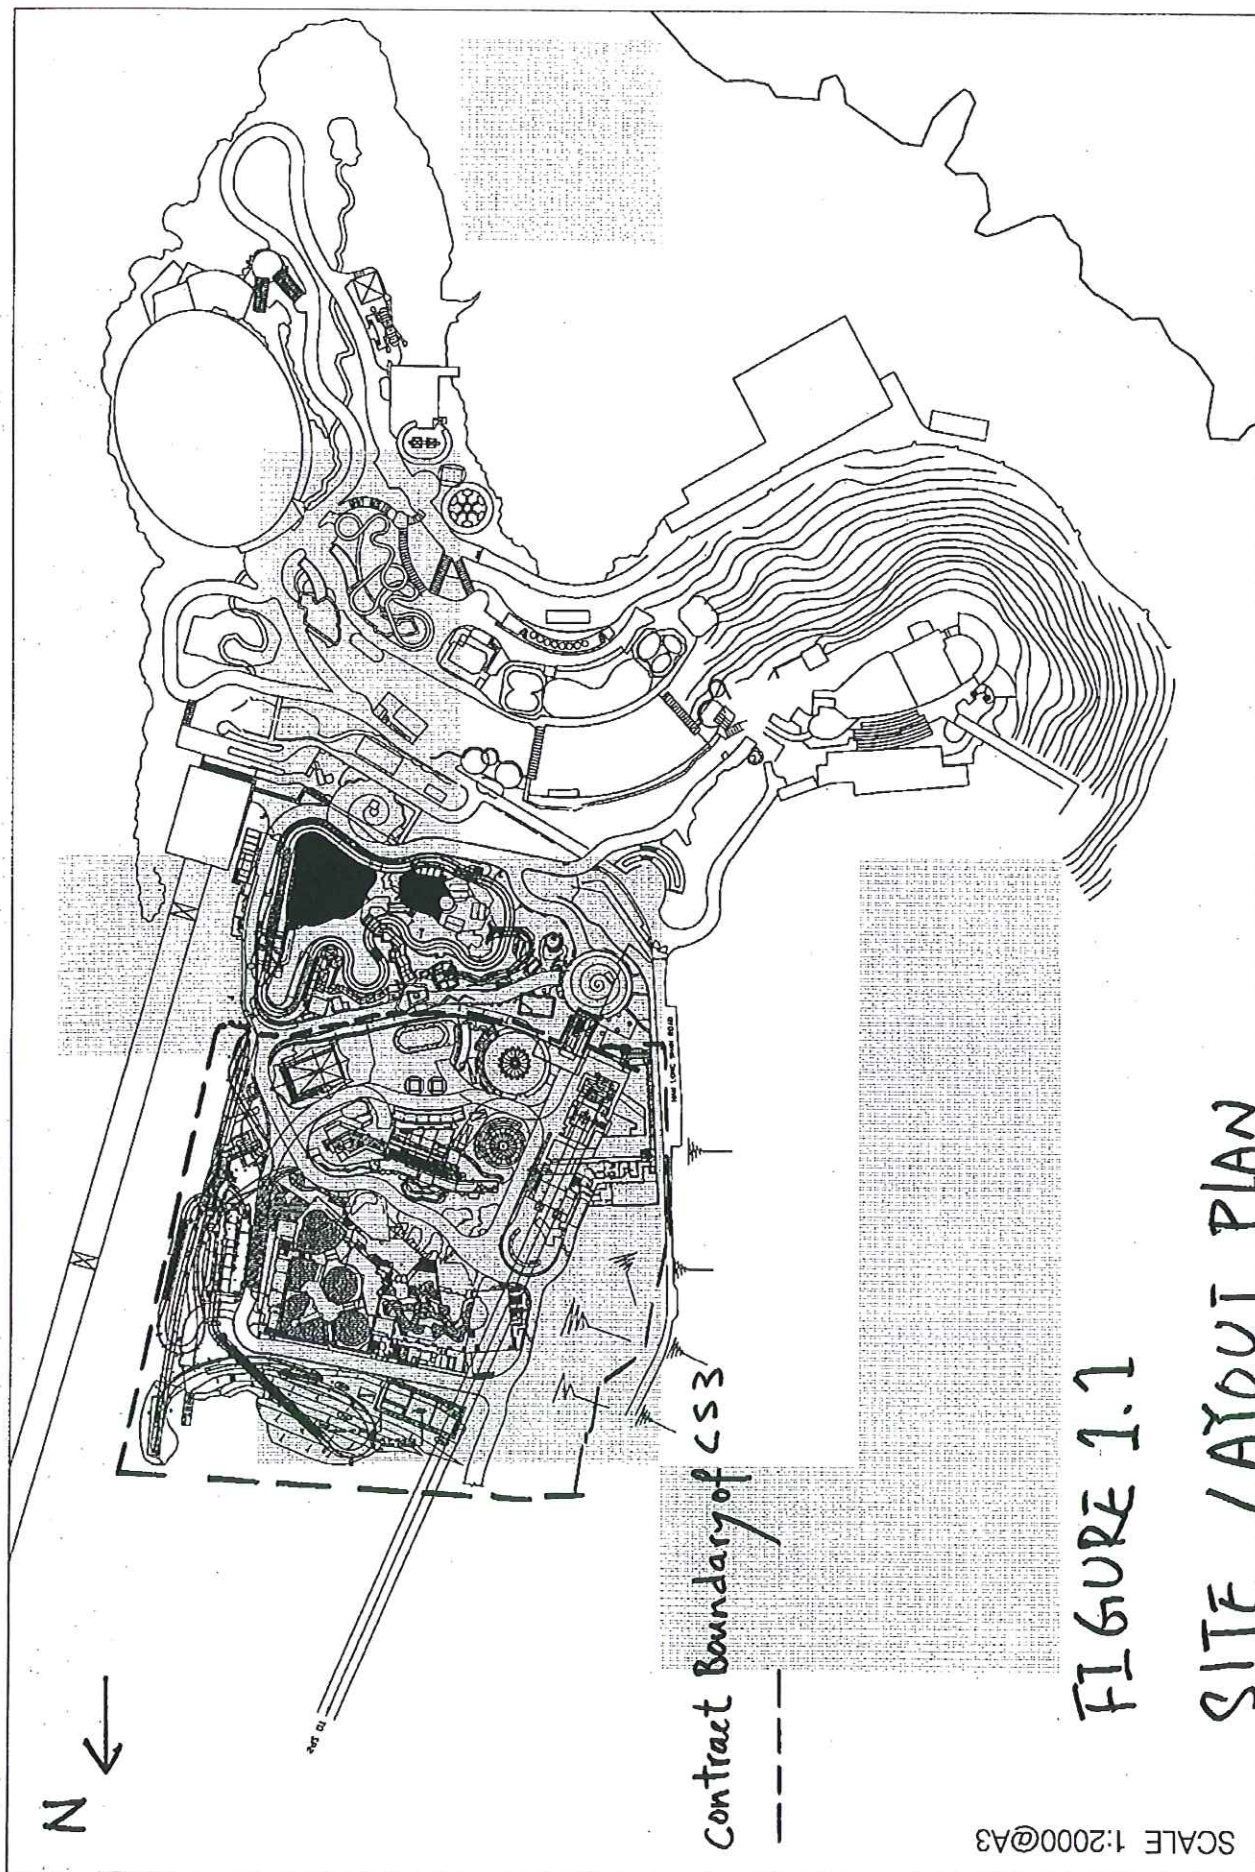
FIGURE 1.1

- 1.1 Kaden-ATAL JV (the Contractor) was commissioned by the Employer to undertake the construction of the Contract No. CS03 “Ocean Park Redevelopment Project – Thrill Mountain & Polar Adventure” (the Project) and the project was commenced on 2nd November 2009. The site layout plan is illustrated in Figure 1.1.

SITE LAYOUT PLAN

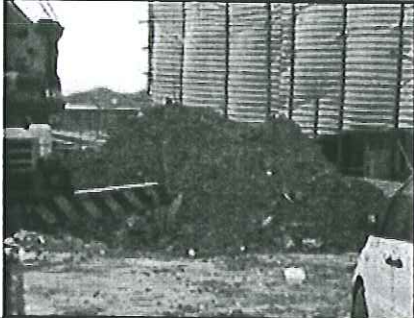
Contract CS03 Trill Mountain and Polar Adventure			
Follow up observations in June 2010			
Observation in last site inspection		Observation in this site inspection

N/A	
P1090698: A stockpile of dusty C&D material was not covered with tarpaulin sheets or other means. The Contractor should cover all idle stockpiles of dusty materials on-site to suppress dust.		Closed - Stockpile of dusty C&D material was not observed on-site.

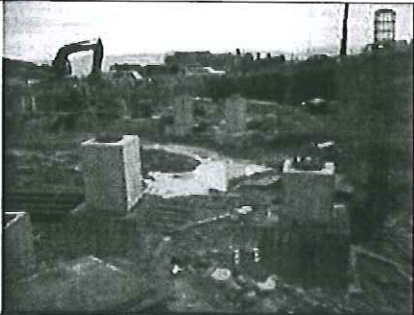
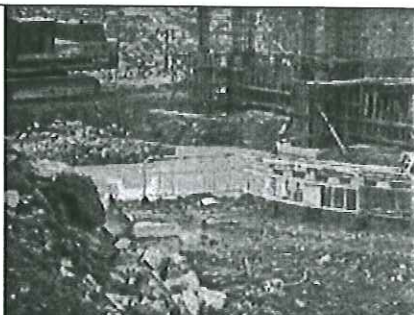
P1090693: Stagnant water was observed accumulated around the site due to rainfall. Removal by pumps was in progress. The Contractor was reminded to remove them as soon as possible.		P1090943: Stagnant water was accumulated around the site due to heavy rain the day before. The Contractor is reminded to remove them as soon as possible.

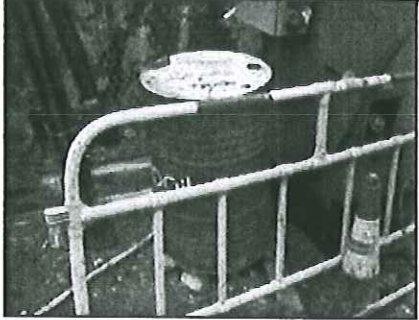
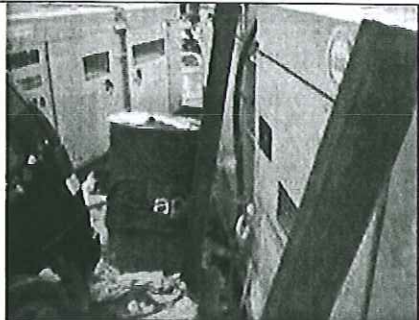
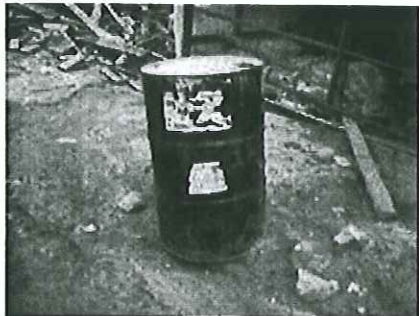
<p>P1090702: An oil drum was placed on bareground. The Contractor was reminded to provide drip trays for all oil drums on site to avoid oil spillage.</p>	<p>P1090935 & P1090941: A few empty oil drums were placed on bareground. The Contractor is reminded to place them in the chemical waste storage area and remove them from the site as soon as possible.</p>

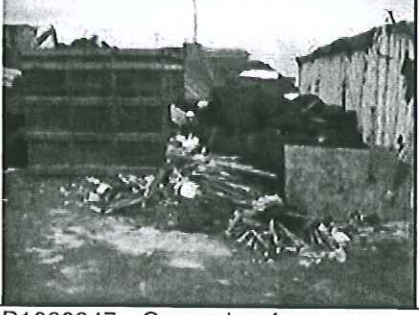
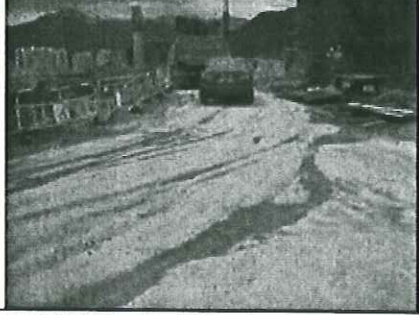
Observations in July 2010

<p>P1090947: General refuse were accumulated on-site. The Contractor is reminded to store them in enclosed bins or compaction units separate from C&D materials.</p>	<p>P1090952: Section of paved access road near the site entrance was dry and dusty. The Contractor is reminded to provide water spray regularly to suppress dust.</p>
