Ocean Park Master Redevelopment Project

Contract No. CI07 – Entry Plaza, Aqua City and Grand Aquarium

Monthly EM & A Report December 2010 and January 2011

**Monthly EM&A Report – Dec 2010**

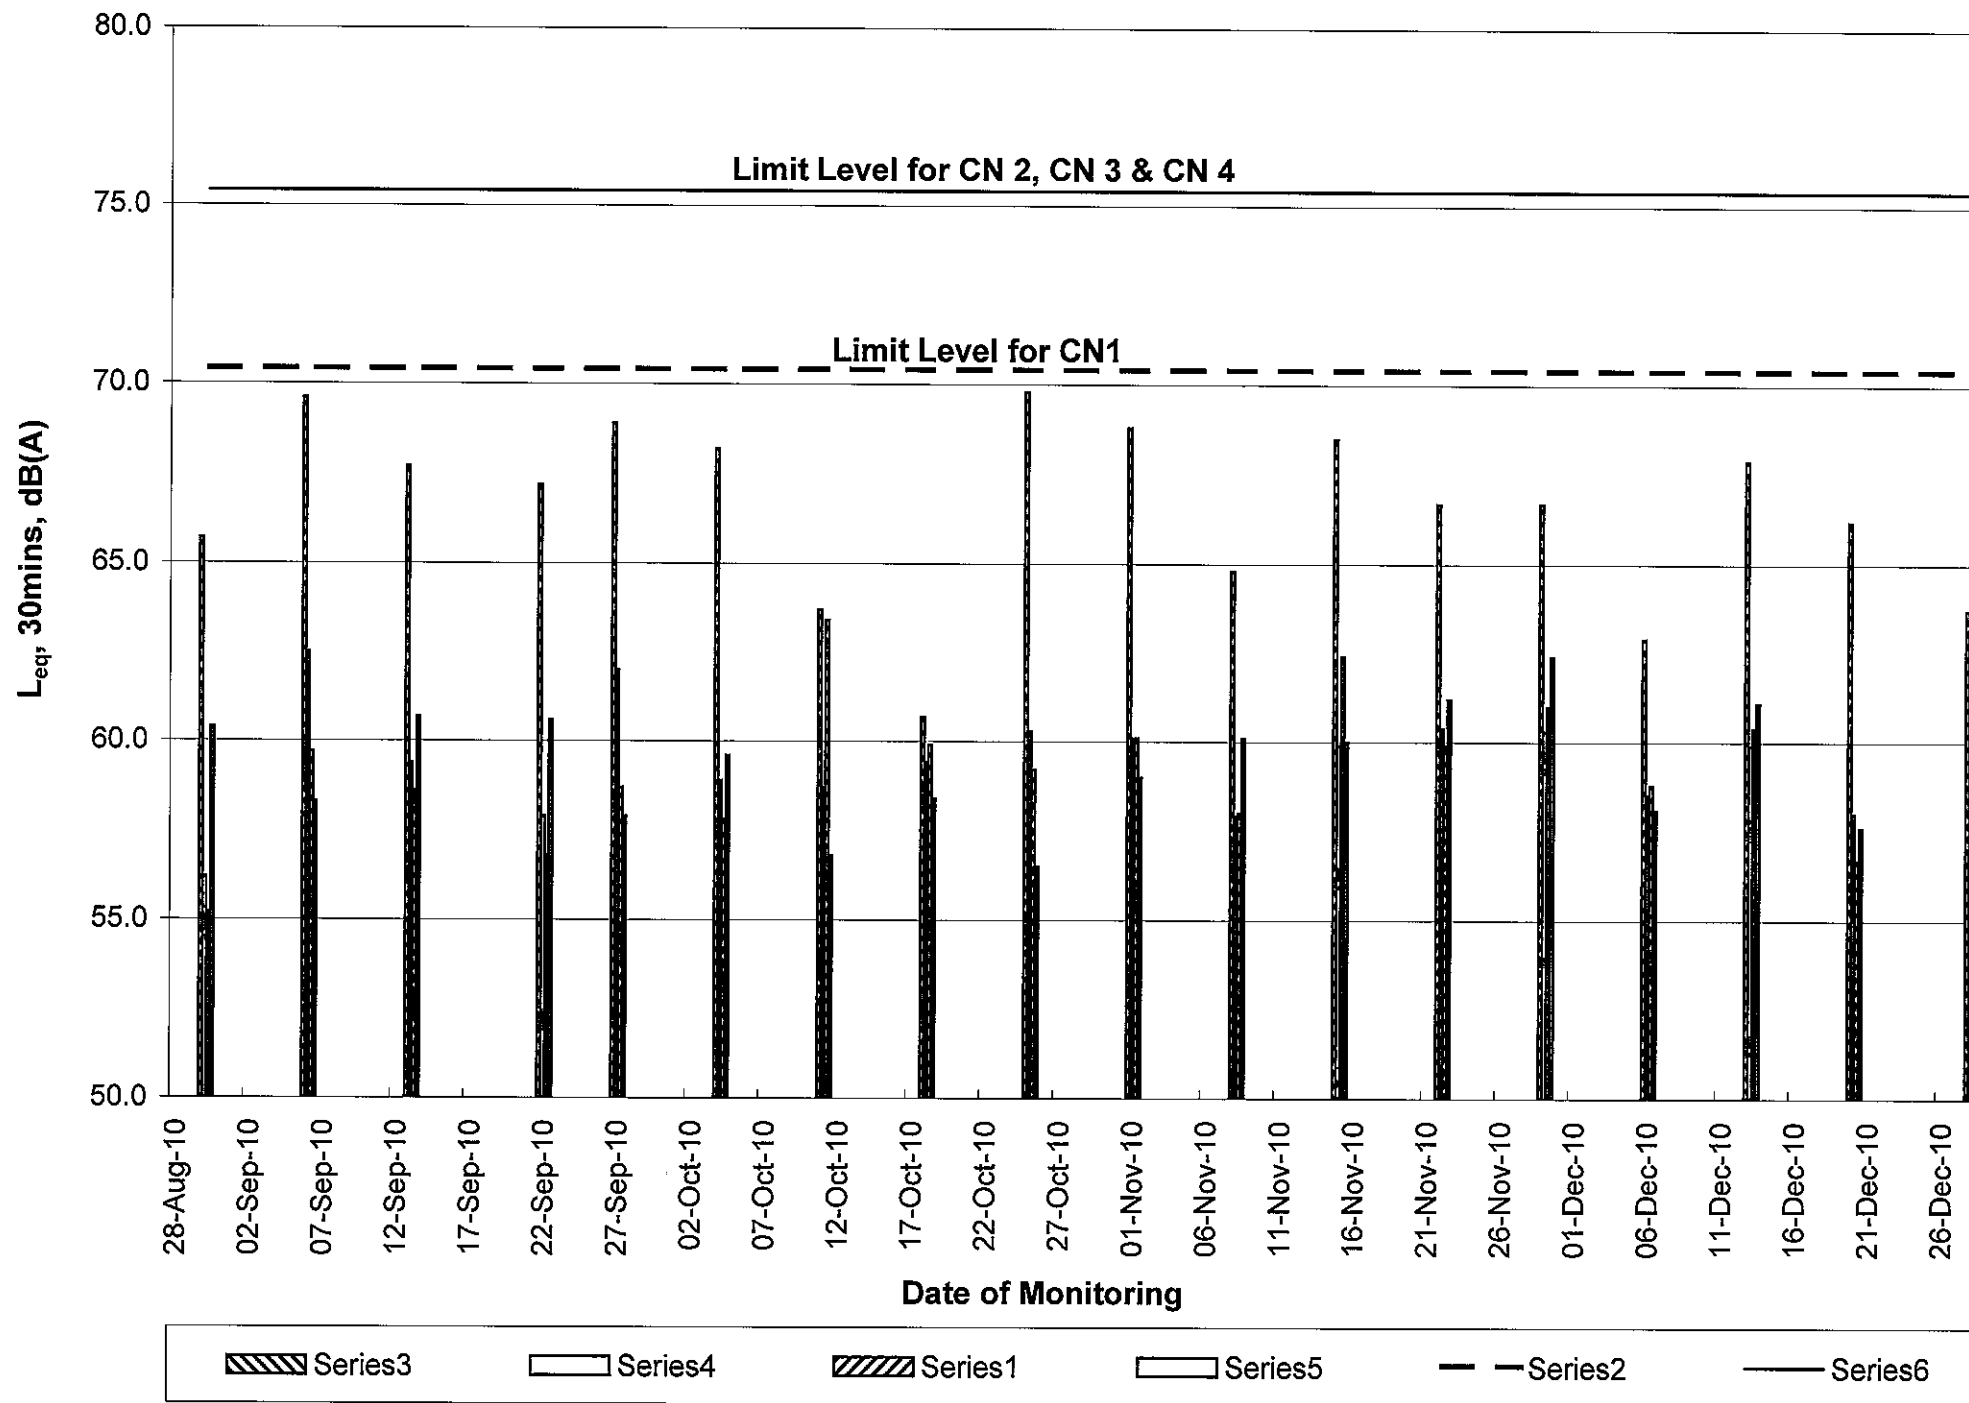
Fig D.1 - Daytime Noise Monitoring Results of Monitoring Stations CN1, CN2, CN3 & CN4
