Ocean Park Master Redevelopment Project

Monthly EM&A Report – January 2012

Monthly Environmental Monitoring & Audit Report – January 2012

**Ocean Park Redevelopment Project
- Thrill Mountain & Polar Adventure**

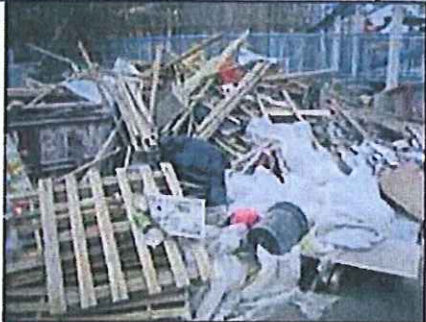
<p>P1140567: General refuse were scattered around the site. The Contractor was reminded to provide more waste skips for storage of general refuse.</p>

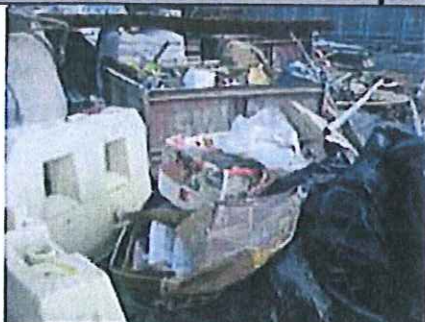
<p>Closed - P11407762: General refuse were stored at designated areas.</p>

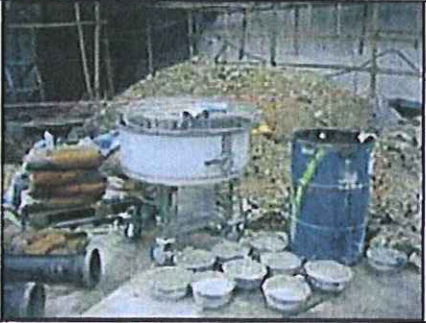
<p>P1140570: The Contractor was recommended to ensure all mortar mixing works were carried out within an enclosure with the top and three sides enclosed.</p>

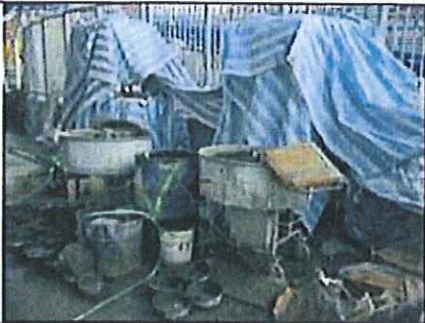
<p>P1140769: The Contractor was recommended to ensure all mortar mixing works were carried out within an enclosure with the top and three sides enclosed.</p>

- ① The Contractor was recommended to ensure all mortar mixing works were carried out within an enclosure with the top and three sides enclosed.
- ② A stockpile of excavated material which is idled was not covered.
- ③ Over 20 cement bags were not fully covered.

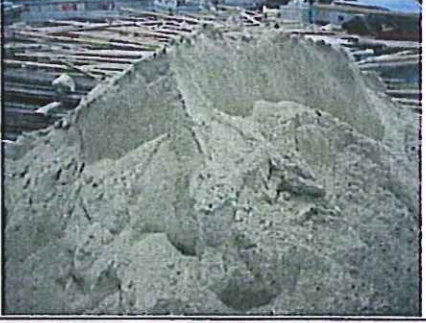
<p>P1140569: An idled stockpile of sand was not covered. The Contractor was reminded to cover any idled dusty stockpile on-site to suppress dust.</p>

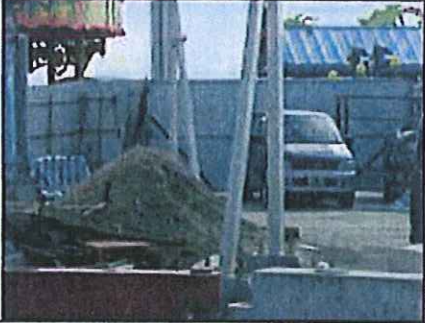
<p>P1140765: An idled stockpile of excavated material was not covered. The Contractor was reminded to cover any idled dusty stockpile on-site to suppress dust.</p>

Parameters	Date	Observations / Recommendations	Remediation/ Follow up
Dust Control	17/1/12	A stockpile of excavated material which was idled was not covered.	Stockpiles of excavated material was removed.
	17/1/12	Over 20 bags of cement were not fully covered.	Cement stock was covered by tarpaulin sheet.
	17/1/12	The contractor was recommended to ensure all motor mixing works were carried out within an enclosure with the top and 3 sides enclosed.	All motor mixing works will be carried out within an enclosure with the top and 3 sides enclosed.
Water Pollution	27/1/12	Nil.	
Air Pollution	27/1/12	Nil

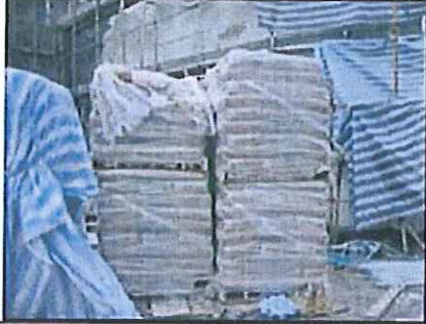
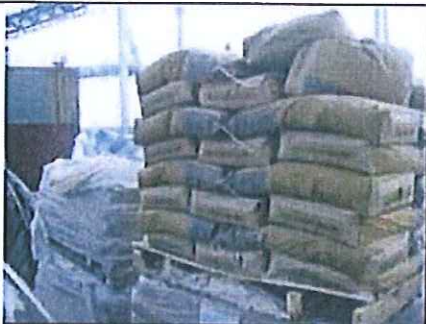
<p>P1140565: Over 20 cement bags were not covered. The Contractor was reminded to cover any piles of over 20 cement bags on-site with tarpaulin sheets or other means to suppress dust.</p>	<p>P1140760: Over 20 cement bags were not fully covered. The Contractor was reminded to fully cover any piles of over 20 cement bags on-site with tarpaulin sheets or other means to suppress dust.</p>
