**CONTRACT NO. DC/2009/01 BUILDING AND
CIVIL MAINTENANCE AND MINOR WORKS OF
DSD PLANTS AND FACILITIES (2009-2012)**

**GROUNDWATER MONITORING AT
NGONG PING STW AND EFFLUENT EXPORT
PIPE**

MONTHLY EM&A REPORT

(NOVEMBER 2009)

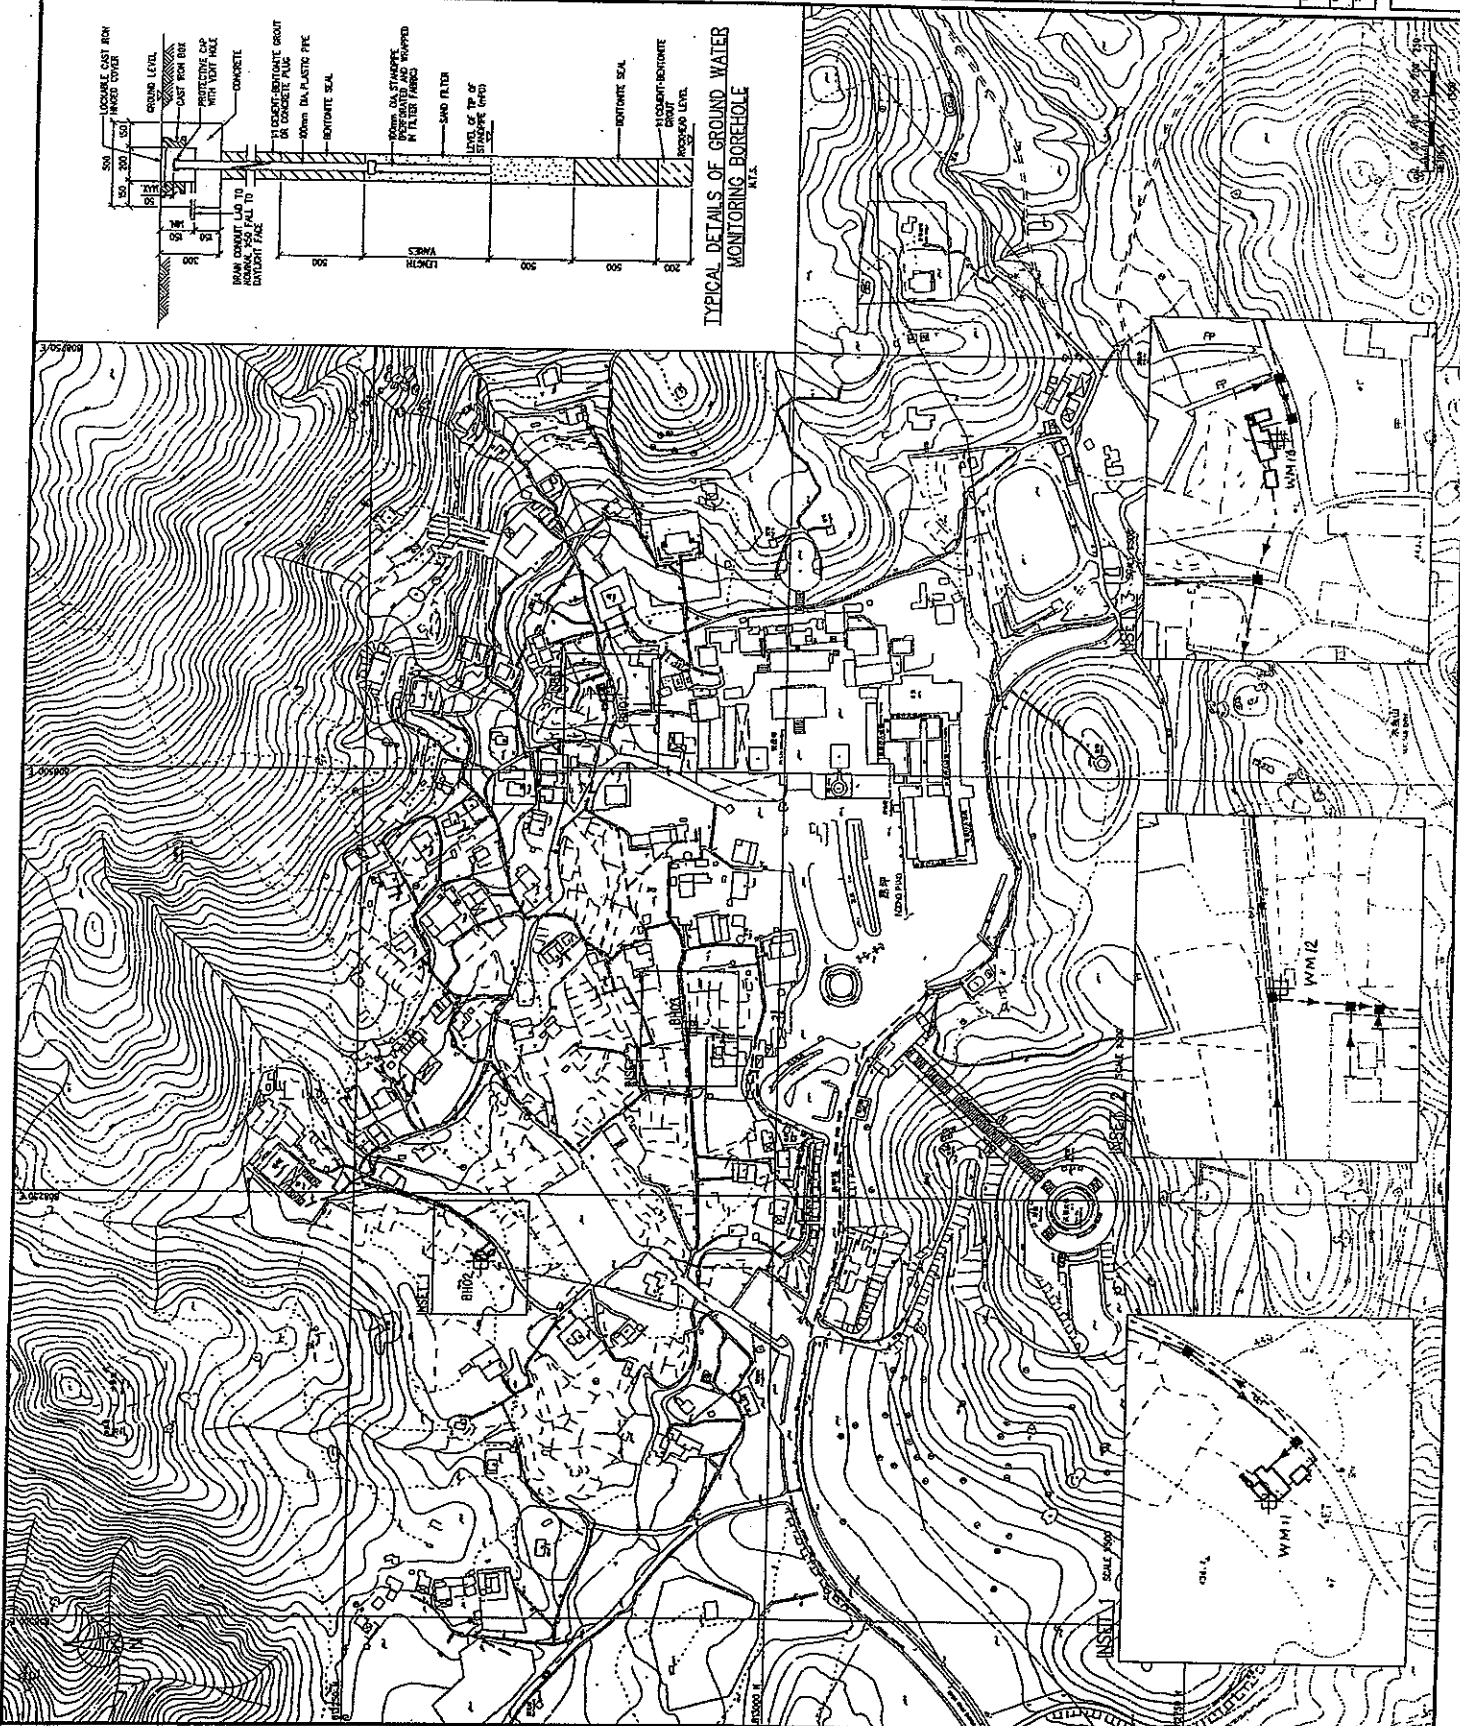
LOCATION & TYPICAL DETAILS OF
 GROUND WATER MONITORING BOREHOLE

The general layout plan of the project is shown in Appendix D. The groundwater monitoring locations are also shown in the Drawing No. 23400/R/VS/406.

TYPICAL DETAILS OF GROUND WATER MONITORING BOREHOLE
 N.T.S.
