# Contract No. SS M333

# Reprovisioning of Diamond Hill Crematorium

Monthly EM&A Report for May 2005

June 2005

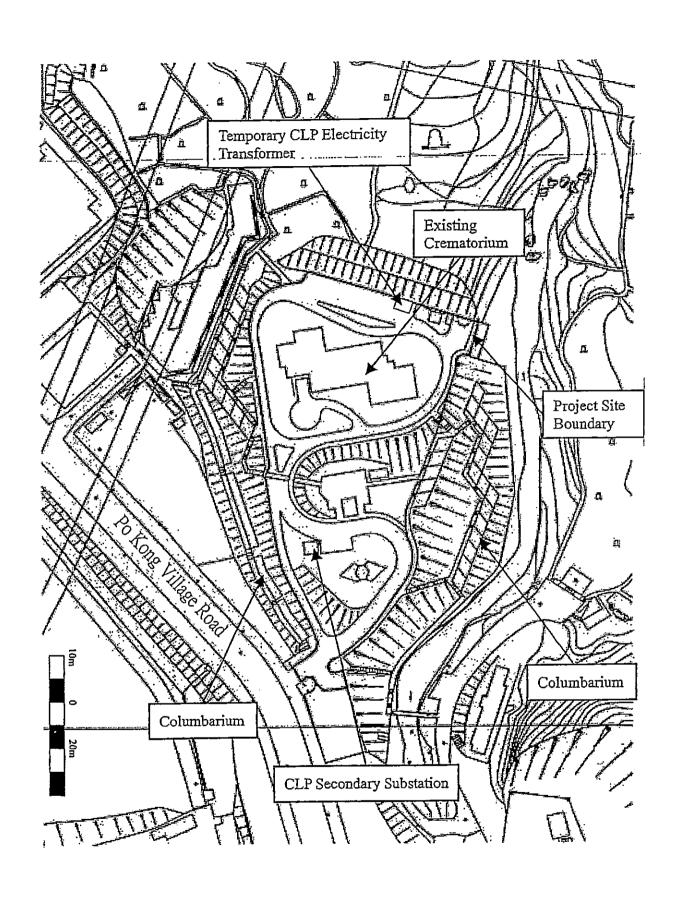
LAYOUT OF WORK SITE

- 1.4 The construction programme of the Project is provided in Appendix B. In the month, the following activities took place for the construction of the Project:
  - Sheet pile or pipe pile drilling;
  - Construction of tower crane foundation and tower crane erection;
  - Construction of footing and ground beam.
  - · Excavation and site formation work to reduced level; and
  - · Steel fixing, erection of formation and concreting for fair face mock-up panel;
- 1.5 Layout plan of the Project work site is provided in Figure 1.2.
