**MONTHLY ENVIRONMENTAL MONITORING & AUDIT REPORT**

Route 8  
Between Tsing Yi and Cheung Sha Wan  
Phase 3  
Stonecutters Bridge

*Monthly Environmental  
Monitoring & Audit Report  
(29<sup>th</sup> October 2008 – 28<sup>th</sup> November 2008)*

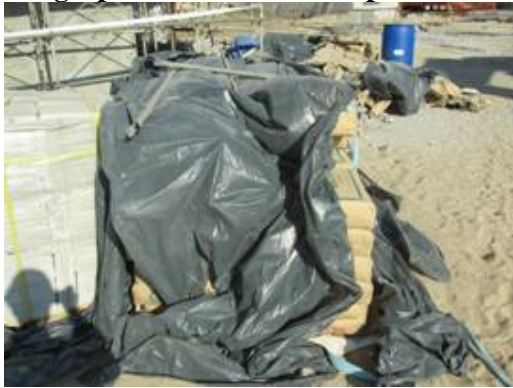
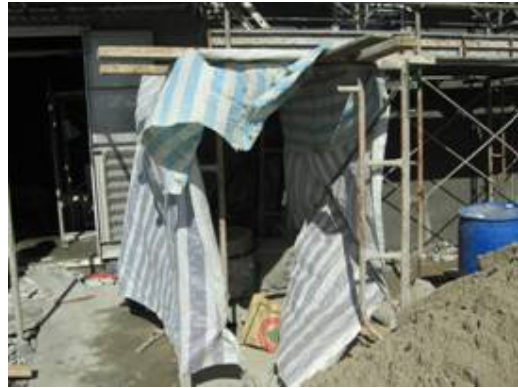
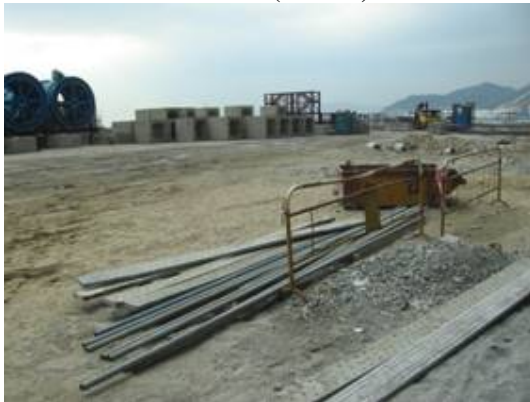
Item	Findings	MHYHJV's Corrective and Preventive measures	Effectiveness of measures
1	More than 20 bags of cement and used cement bags without proper dust control measures were observed at area P3-SA3. In addition, MHYHJV was reminded to provide totally enclosed system and adequate air pollution control measures for the de-bagging and mixing processes by using of bagged cement at areas P3-SA3.	All bagged cement had been removed from the concerned area and stored properly. Plastic bags and waste skip have been deployed on site for the temporary storage of used cement bags. All de-bagging, batching and mixing process shall be carried out in enclosed area during the use of bagged cement.	Completed and closed. (Please refer <i>Appendix Q</i> Photo 01 to 03).
2	Oil stain on the ground and a generator without drip tray were observed at area P3-SA5 (next to Richwell's workshop).	All contaminated materials were cleared as chemical waste and the generator had been removed from site.	Completed and closed. (Please refer <i>Appendix Q</i> Photo 04).

*Corrective and Preventive Actions* – All bagged cement had been removed from the concerned area and stored properly. Plastic bags and waste skip have been deployed on site for the temporary storage of used cement bags. All de-bagging, batching and mixing process shall be carried out in enclosed area during the use of bagged cement. Completed and closed. (Please refer **Appendix Q** Photo 01 to 03).

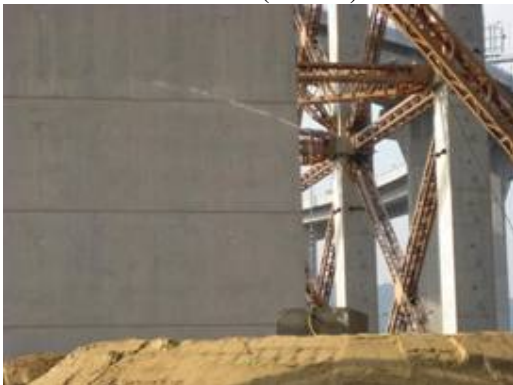
**Photo 05 (P3-SA3)**

- iii. Open stockpiles of dusty materials were observed at areas P3-SA3 and P3-SA5.

*Corrective and Preventive Actions* – All open stockpiles of dusty material have been entirely covered by impervious sheeting or to be sprayed by sufficient water / other suitable means to maintain the entire surface moist. Completed and closed. (Please refer **Appendix Q** Photo 05 & 06).

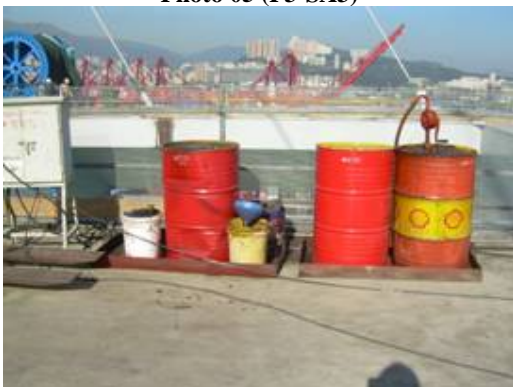
**Photo 07 (P3-SA5 (Deck))**

- iv. MHYHJV was reminded that all fuel / chemical should be placed in bunded area or drip tray at the deck (area P3-SA5). In addition, adequate enclosed system should be provided and maintained for the blasting / painting / cleaning processes at the steel deck in order to avoid loose material / chemical entering into sea.

3	Open stockpiles of dusty materials were observed at areas P3-SA3 and P3-SA5.	All open stockpiles of dusty material have been entirely covered by impervious sheeting or to be sprayed by sufficient water / other suitable means to maintain the entire surface moist.	Completed and closed. (Please refer <i>Appendix Q</i> Photo 05 & 06)
4	MHYHJV was reminded that all fuel / chemical should be placed in bunded area or drip tray at the deck (area P3-SA5). In addition, adequate enclosed system should be provided and maintained for the blasting / painting / cleaning processes at the steel deck in order to avoid loose material / chemical entering into sea.	All chemical and fuel were stored in drip tray and proper enclosure and ventilation systems have been deployed and maintained for the blasting / painting / cleaning processes.	Completed and closed. (Please refer <i>Appendix Q</i> Photo 07 & 08).
