MONTHLY ENVIRONMENTAL MONITORING & AUDIT REPORT

Route 8
Between Tsing Yi and Cheung Sha Wan
Phase 3
Stonecutters Bridge

*Monthly Environmental
Monitoring & Audit Report
(29th December 2008 – 28th January 2009)*

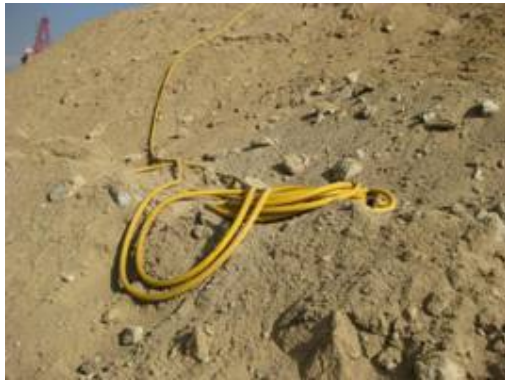
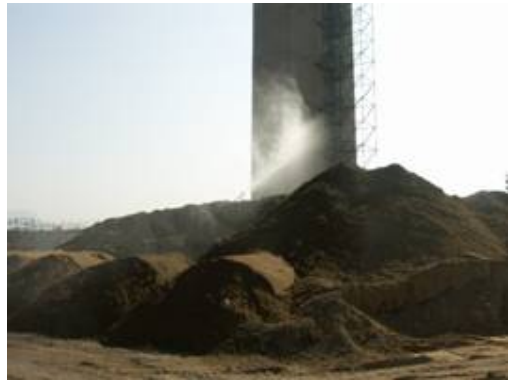
Photo 01 (P3-SA3)

- i. MHYHJV was reminded to cover all open stockpiles of dusty material entirely by tarpaulin sheet or to be sprayed by sufficient water to maintain the entire surface moist at area P3-SA3.

Corrective and Preventive Actions – Water sprinklers and hoses have been deployed on site to maintain the entire surface moist. Completed and closed. (Please refer **Appendix Q** Photo 01 & 02).

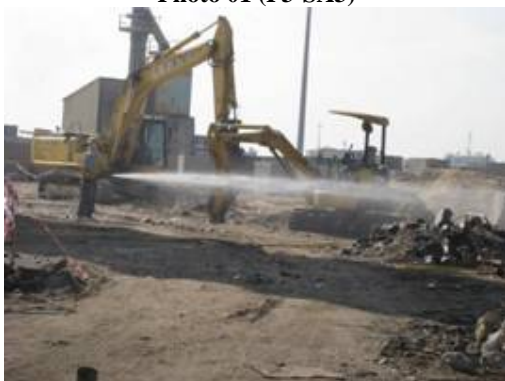
Photo 03 (P3-SA5)

Item	Findings	MHYHJV's Corrective and Preventive measures	Effectiveness of measures
1	MHYHJV was reminded to cover all open stockpiles of dusty material entirely by tarpaulin sheet or to be sprayed by sufficient water to maintain the entire surface moist at area P3-SA3.	Water sprinklers and hoses have been deployed on site to maintain the entire surface moist.	Completed and closed. (Please refer <i>Appendix Q</i> Photo 01 & 02).
2	MHYHJV was reminded to further enhance the dust control measures for the soil excavation / earth moving operation at area P3-SA5.	All excavation area or earth moving operation should be sprayed with sufficient water before, during and immediately after the operation.	Completed and closed. (Please refer <i>Appendix Q</i> Photo 03).

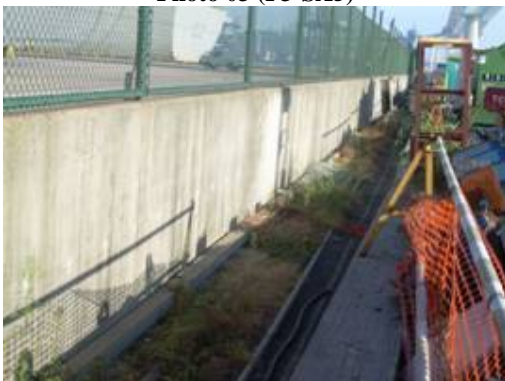
Photo 05 (P3-SA3)

- iv. General refuse and C&D waste were found scattering around the channel at area P3-SA3.

4	General refuse and C&D waste were found scattering around the channel at area P3-SA3.	All general refuse and C&D waste had been cleared and proper containers have been deployed on site for waste storage.	Completed and closed. (Please refer <i>Appendix Q</i> Photo 05).
5	More than 20 bags of cement and used cement bags without proper dust control measures were observed at area P3-SA6.	All bagged cement had been removed from the concerned area and stored properly. Plastic bags and waste skip have been deployed on site for the temporary storage of used cement bags.	Completed and closed. (Please refer <i>Appendix Q</i> Photo 06).
