MONTHLY ENVIRONMENTAL MONITORING & AUDIT REPORT

Highways Department

Route 8
Between Tsing Yi and Cheung Sha Wan
Phase 2b East Tsing Yi Viaduct

*Monthly Environmental
Monitoring & Audit Report
(29th May 2009 - 28th June 2009)*

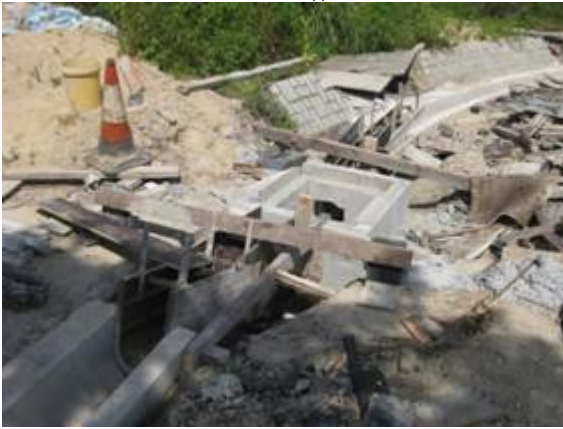
Photo 01 (area P2-SA6B (roundabout, next to Gate 4))

Item	Findings	DCBJV's Corrective and Preventive measures	Effectiveness of measures
1.	Sub-standard effluent was observed entering into the storm drain at area P2-SA6B (Gate 4). DCBJV was reminded to divert all sub-standard effluent to treatment facilities prior to discharge.	Labours have been arranged to clean up the drainage system on site regularly and sandbag barrier had been deployed to avoid sub-standard effluent entering into storm drain directly.	The situation will be closely monitored by both RSS and ET. (Please refer to <i>Appendix Q</i> Photo 01).

- i. Sub-standard effluent was observed entering into the storm drain at area P2-SA6B (Gate 4). DCBJV was reminded to divert all sub-standard effluent to treatment facilities prior to discharge.
