MONTHLY ENVIRONMENTAL MONITORING & AUDIT REPORT

Route 8
Between Tsing Yi and Cheung Sha Wan
Phase 2b East Tsing Yi Viaduct

*Monthly Environmental
Monitoring & Audit Report
(29th June 2009 - 28th July 2009)*

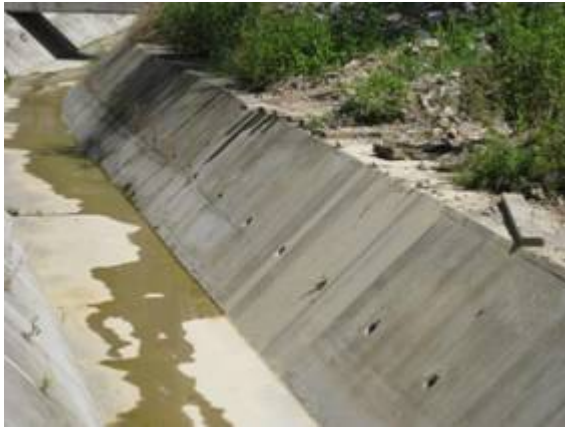
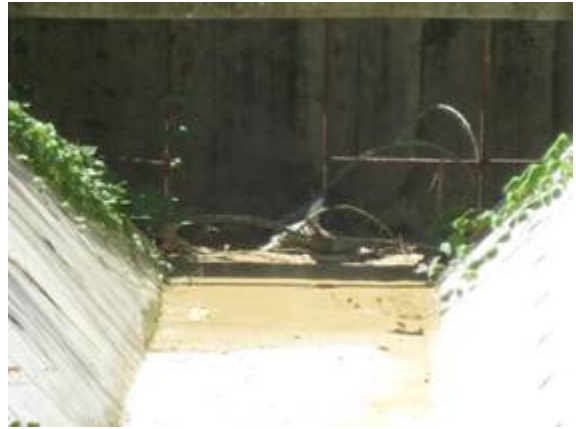
Photo 01 (area P2-SA6B (next to Gate 4))

- i. DCBJV was reminded to provide sandbag barriers in the trapezoidal channel to avoid loose material entering into storm drain directly at area P2-SA6B (next to Gate 4).

Corrective and Preventive Actions – The loose material nearby the drainage system had been cleared in order to minimize loose material and sub-standard effluent entering into the storm drain. In addition, sediments had been removed from the trapezoidal channel after the site inspection. Completed and closed. (Please refer to **Appendix Q** Photo 01 & 02).

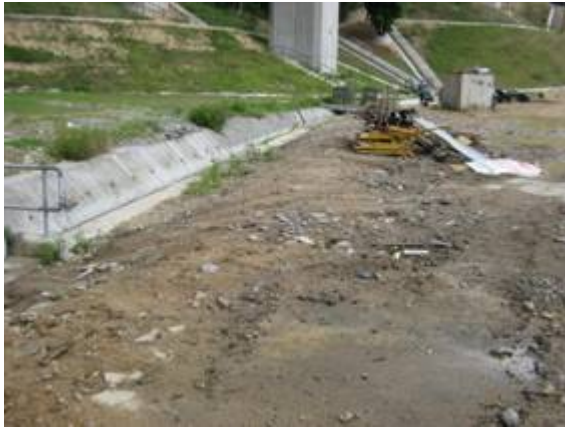
Photo 03 (area P2-SA6B (next to Gate 4))

2.	Rubbish was scattered around the area P2-SA6B (next to Gate 4).	All the rubbish had been removed from site after site inspection.	Completed and closed. (Please refer to Appendix Q Photo 03).
3	Stagnant water was accumulated in the steel works and drip trays at area P2-SA8.	Labours have been arranged to clean up the stagnant water on site regularly.	Completed and closed. (Please refer to Appendix Q Photo 04)
