MONTHLY ENVIRONMENTAL MONITORING & AUDIT REPORT

Route 8
Between Tsing Yi and Cheung Sha Wan
Phase 3
Stonecutters Bridge

*Monthly Environmental
Monitoring & Audit Report
(29th August 2009 – 28th September 2009)*

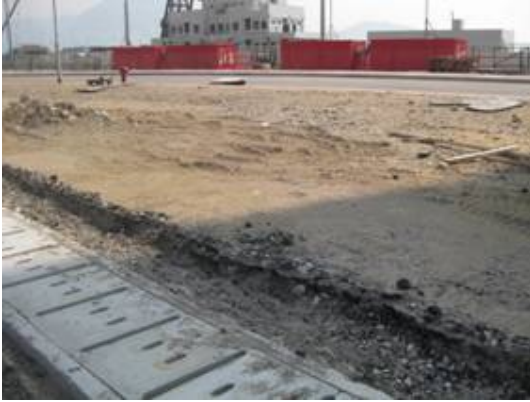
Photo 01 (P3-SA6)

| Item | Findings | MHYHJV's Corrective and Preventive measures | Effectiveness of measures |
|---|--|--|--|
| 1 | C&D waste was found scattering around at area P3-SA6. MHYHJV was also reminded to remove C&D waste and general refuse from site more frequently | All general refuse was collected and temporarily stored in waste skip on site. The frequency of removal of C&D waste from site has been increased. | Completed and closed. (Please refer <i>Appendix Q</i> Photo 01). |

- i. C&D waste was found scattering around at area P3-SA6. MHYHJV was also reminded to remove C&D waste and general refuse from site more frequently.

| Item | Findings | MHYHJV's Corrective and Preventive measures | Effectiveness of measures |
|---|---|--|--|
| 1 | C&D waste was found scattering around at area P3-SA6. | All general refuse was collected and temporarily stored in waste skip on site. The frequency of removal of C&D waste from site has been increased. | Completed and closed. (Please refer <i>Appendix Q</i> Photo 01). |

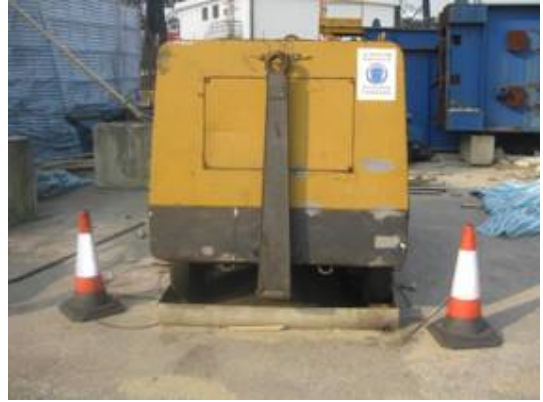
Photo 02 (P3-SA6)

| Item | Findings | MHYHJV's Corrective and Preventive measures | Effectiveness of measures |
|---|--|--|--|
| 2 | Stagnant water was accumulated on the uneven ground and drip tray at area P3-SA6. | All stagnant water had been removed as far as practical and larvicidal oil has been applied wherever necessary in order to reduce the risk of mosquito breeding. | Completed and closed. (Please refer <i>Appendix Q</i> Photo 02). |

Corrective and Preventive Actions – All stagnant water had been removed as far as practical and larvicidal oil has been applied wherever necessary in order to reduce the risk of mosquito breeding. Completed and closed. (Please refer **Appendix Q** Photo 02).

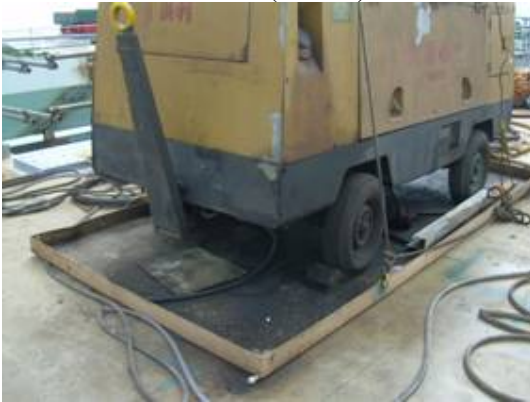
Photo 03 (P3-SA5A)

| Item | Findings | MHYHJV's Corrective and Preventive measures | Effectiveness of measures |
|---|--|--|--|
| 3 | MHYHJV was reminded to provide proper valve for the drip tray at deck level and remove rain water from the drip trays after each rainstorm (area P3-SA5A). | Proper valve had been provided and rain water had been removed from the drip tray. | Completed and closed. (Please refer <i>Appendix Q</i> Photo 03). |

Corrective and Preventive Actions – Proper valve had been provided and rain water had been removed from the drip tray. Completed and closed. (Please refer **Appendix Q** Photo 03).
