**MONTHLY ENVIRONMENTAL MONITORING & AUDIT REPORT**

Route 8  
Between Tsing Yi and Cheung Sha Wan  
Phase 3  
Stonecutters Bridge

*Monthly Environmental  
Monitoring & Audit Report  
(29<sup>th</sup> November 2009 – 19<sup>th</sup> December 2009)*

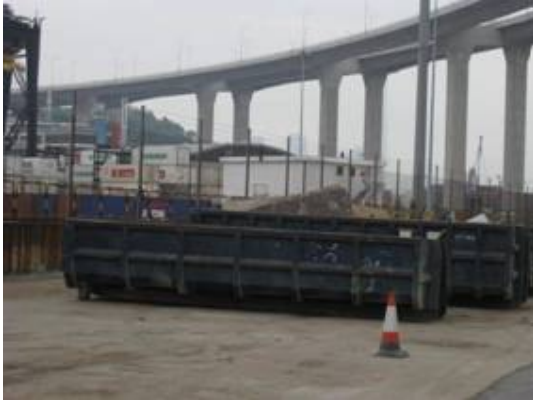
**Photo 01 (P3-SA5)**

- i. The waste skips at area P3-SA5 were full and C&D waste was found scattering around.  
*Corrective and Preventive Actions* – All general refuse was collected and temporarily stored in waste skip on site. The frequency of removal of C&D waste from site has been increased. Completed and closed. (Please refer *Appendix Q* Photo 01).

Item	Findings	MHYHJV's Corrective and Preventive measures	Effectiveness of measures
1	The waste skips at area P3-SA5 were full.	All general refuse was collected and temporarily stored in waste skip on site. The frequency of removal of C&D waste from site has been increased.	Completed and closed. (Please refer <i>Appendix Q</i> Photo 01).
