China Harbour – China State Joint Venture

CONTRACT NO. CV/2009/02

HANDLING OF SURPLUS PUBLIC FILL

MONTHLY EM&A REPORT NO.25

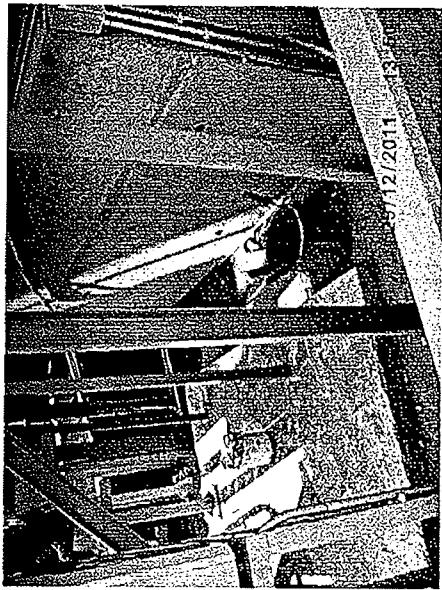
Photo 111229_003 (New weighbridge)

- Few buckets of paint were discarded at new weighbridge during the weekly site inspection on 29 December 2011. The Contractor was reminded to collect and store the paint properly when not in use. Since the finding was observed at the last weekly site inspection, it will be verified in the coming month; and
