HANDLING OF SURPLUS PUBLIC FILL

TUEN MUN AREA 38 FILL BANK

MONTHLY EM&A REPORT NO.26

(JANUARY 2012)

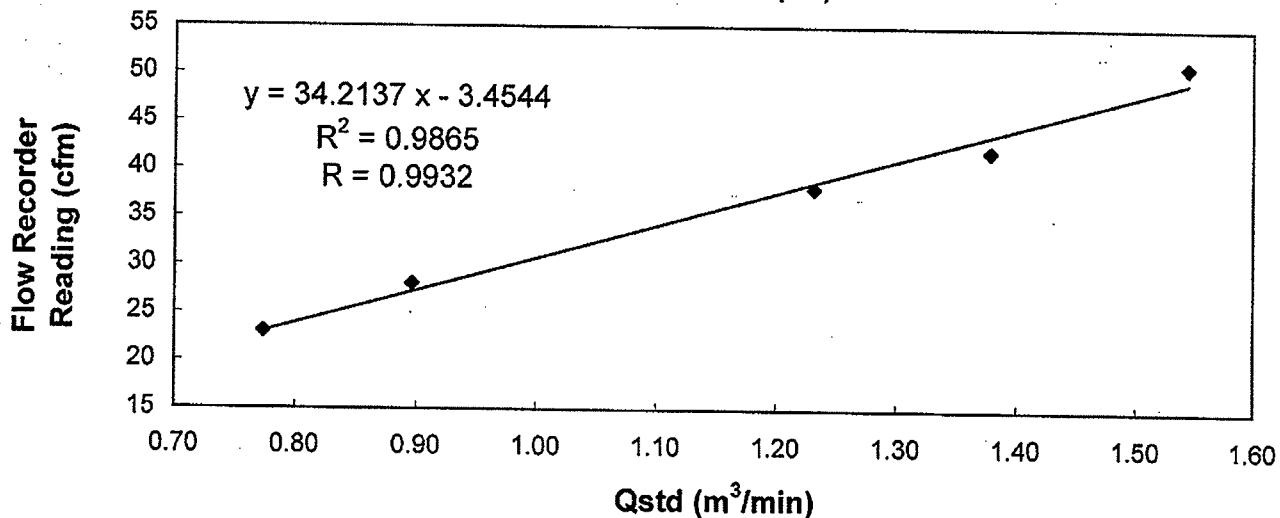
Sampler 9795 Calibration Curve
Site: Tuen Mun (A1)

Acceptance Criteria : Correlation coefficient (r) of the calibration curve greater than 0.990 after a 5-point calibration

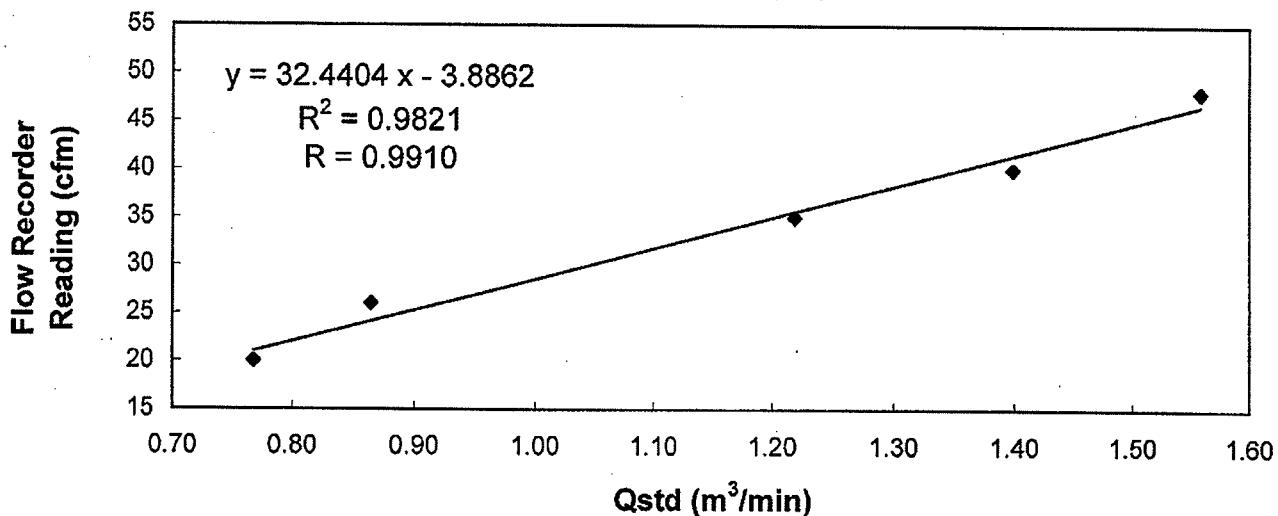
Sampler 9795 Calibration Curve
Site: Tuen Mun (A1)

Acceptance Criteria : Correlation coefficient (r) of the calibration curve greater than 0.990 after a 5-point calibration

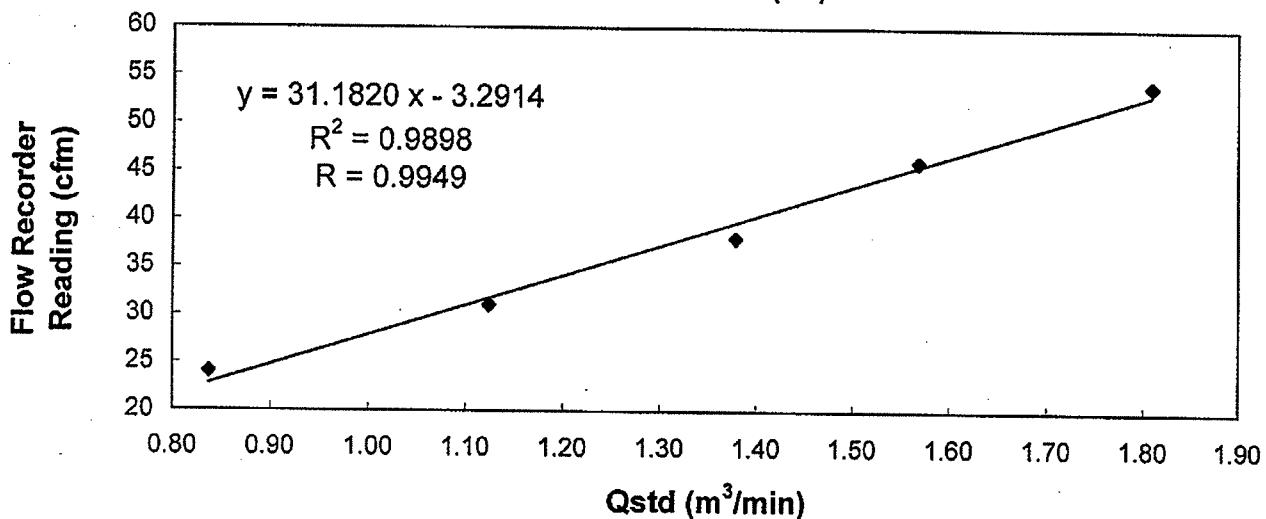
**Sampler 9864 Calibration Curve
Site: Tuen Mun (A2)**

Acceptance Criteria : Correlation coefficient (r) of the calibration curve greater than 0.990 after a 5-point calibration

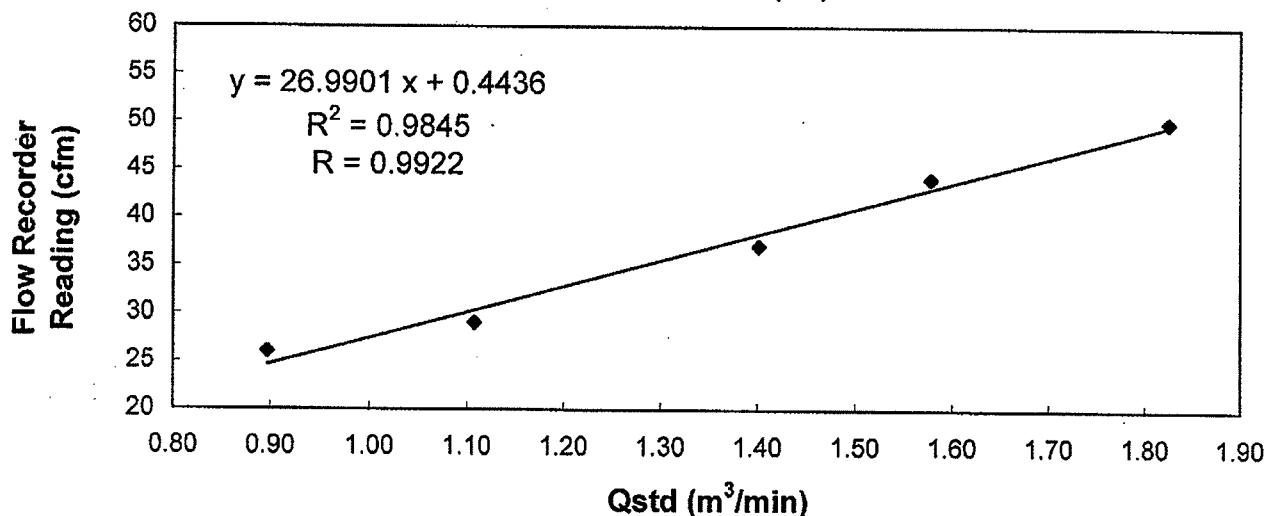
**Sampler 9864 Calibration Curve
Site: Tuen Mun (A2)**

Acceptance Criteria : Correlation coefficient (r) of the calibration curve greater than 0.990 after a 5-point calibration

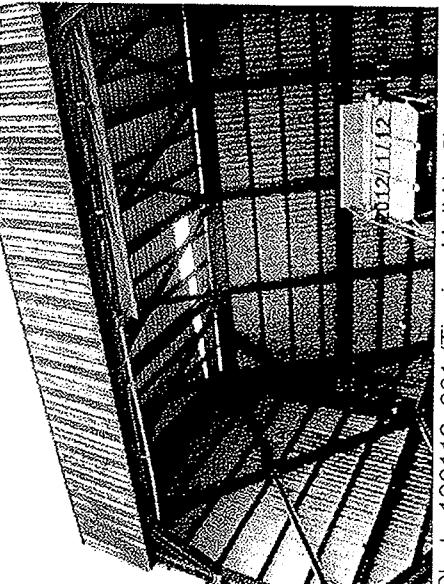
- Follow up action to outstanding finding in the previous month, roof of Tipping Hall No.2 was still found damaged during the several weekly sit inspections in this reporting month. The Contractor was reminded to repair the damage part of the tipping hall as soon as possible. Since the finding was still observed at the last weekly site inspection, it will be verified in the coming month;

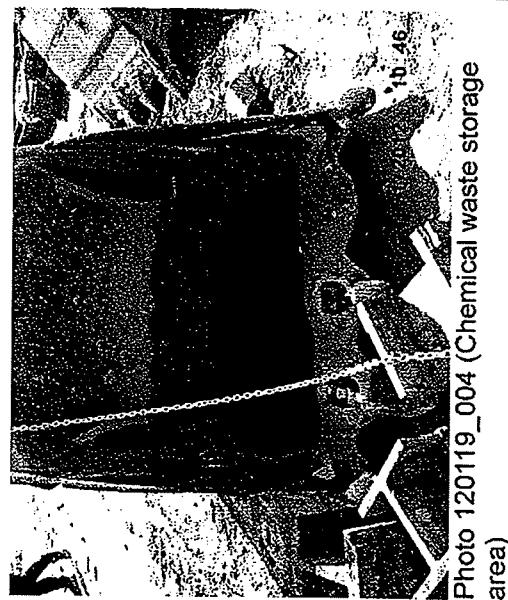
Photo 120119_004 (Chemical waste storage
area)

- Standing water was noted inside the bucket of an excavator near chemical waste storage area during the weekly site inspection on 19 January 2012. The Contractor was reminded to clear the standing water or apply pesticide to avoid mosquito breeding. During the next weekly site inspection on 27 January 2012, no standing water was noted inside the bucket of the excavator; and
