TEST REPORT

CONTRACT NO. CV/2009/02
HANDLING OF SURPLUS PUBLIC FILL
TUEN MUN AREA 38 FILL BANK
MONTHLY EM&A REPORT NO.40
(MARCH 2013)

Issue Date: 11 April 2013

Report No.: ENA30868

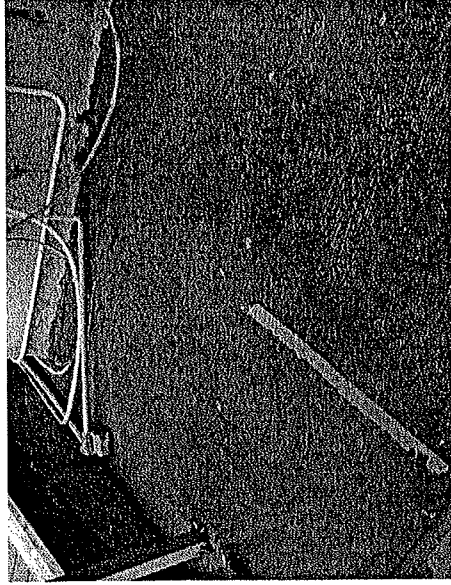
Photo 130328_002 (Weighbridge C)

Stagnant water was noted under the weighbridge C (near the site entrance). (New item)	To clear up the accumulated water or apply pesticide to avoid mosquito breeding.	---	Follow-up
	The enclosure of the chemical waste storage area was found broken. (New item)	To repair the damaged part of the chemical waste storage area immediately.	---	Follow-up
