TEST REPORT

CONTRACT NO. CV/2009/02
HANDLING OF SURPLUS PUBLIC FILL
TUEN MUN AREA 38 FILL BANK
MONTHLY EM&A REPORT NO.41
(APRIL 2013)

Report No.: ENA31015

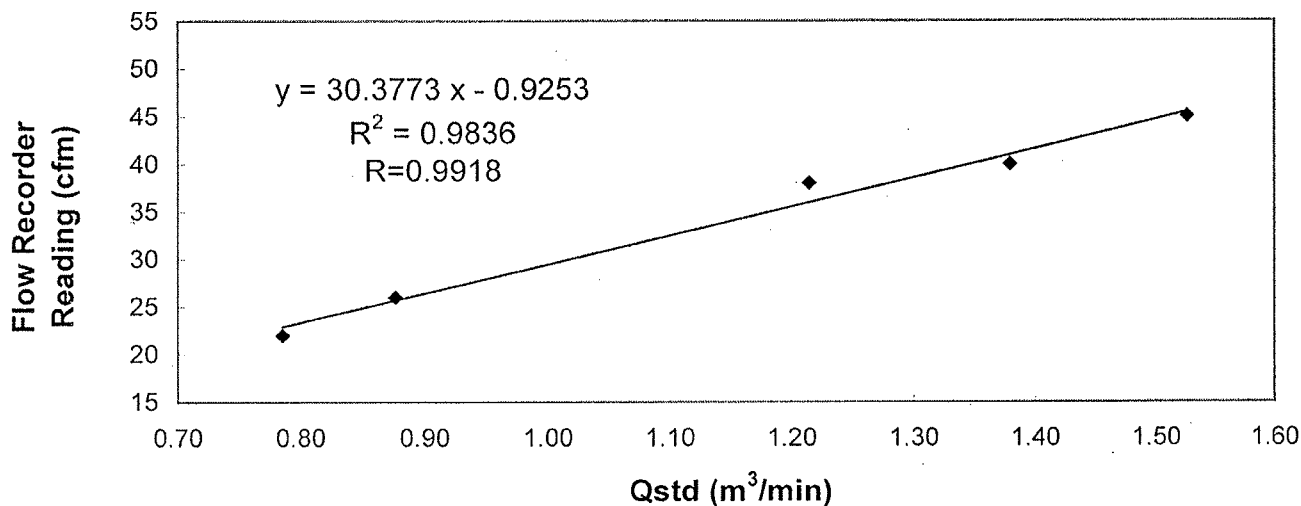
Sampler 9795 Calibration Curve
Site: Tuen Mun (A1)

Flow recorder reading (cfm)	45	40	38	26	22
Qstd (Actual flow rate, m ³ /min)	1.53	1.38	1.21	0.88	0.79
Pressure :	757.56 mm Hg			Temp. :	295 K

Acceptance Criteria : Correlation coefficient (r) of the calibration curve greater than 0.990 after a 5-point calibration

The high volume sampler complies* / does not comply* with the specified requirements and is deemed acceptable*/ unacceptable* for use.

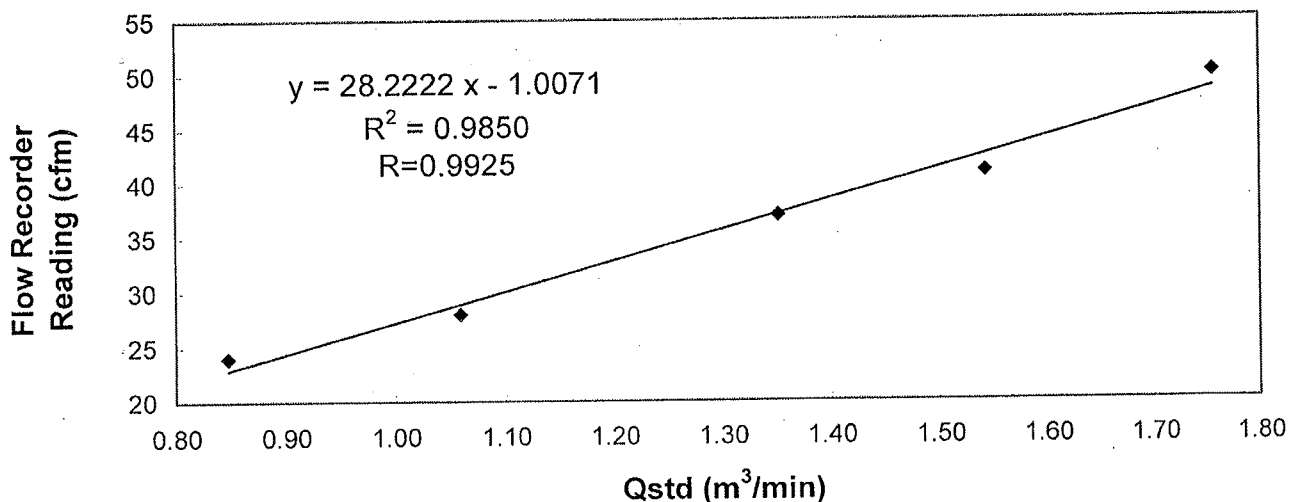
**Sampler 9864 Calibration Curve
Site: Tuen Mun (A2)**

Results	Flow recorder reading (cfm)	50	41	37	28	24
	Qstd (Actual flow rate, m ³ /min)	1.76	1.54	1.35	1.06	0.85
	Pressure :	757.56 mm Hg			Temp. :	295 K

Acceptance Criteria : Correlation coefficient (r) of the calibration curve greater than 0.990 after a 5-point calibration

The high volume sampler complies* / ~~does not comply*~~ with the specified requirements and is deemed acceptable* / unacceptable* for use.

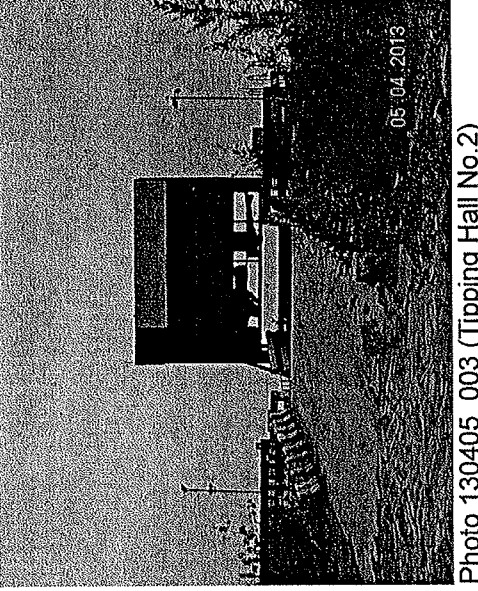
<p>Photo 130405_003 (Tipping Hall No.2)</p>

The enclosure of tipping hall No.2 was found broken. (Previous item)	To repair the damaged part of the tipping hall properly.	---	Follow-up
	Mud and silt were noted accumulated inside the drainage channel near the weighbridge at the Pier No.2. (New item)	To clear the accumulated mud and silt in order to avoid any blockage.	---	Follow-up
	Waste oil and C&D waste were found discarded near the Contractor's site office. (New item)	To collect and store / dispose of the waste properly.	---	Follow-up
25 April 2013	The enclosure of tipping hall No.2 was found broken. (Previous item)	To repair the damaged part of the tipping hall properly.	---	Follow-up
	Mud and silt were noted accumulated inside the drainage channel near the weighbridge at the Pier No.2. (Previous item)	To clear the accumulated mud and silt in order to avoid any blockage.	---	Follow-up
	Waste oil and C&D waste were found discarded near the Contractor's site office. (Previous item)	To collect and store / dispose of the waste properly.	Waste oil and C&D waste discarded near the Contractor's site office were cleared.	Closed

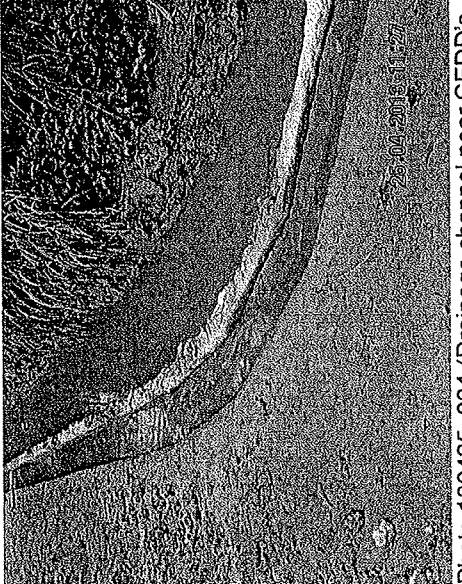
<p>Photo 130425_004 (Drainage channel near CEDD's site office)</p>

Mud and silt were noted accumulated inside the drainage channel near the CEDD's site office. (New item)	To clear the accumulated mud and silt in order to avoid any blockage.	---	Follow-up
