TEST REPORT

CONTRACT NO. CV/2009/02
HANDLING OF SURPLUS PUBLIC FILL
TUEN MUN AREA 38 FILL BANK
MONTHLY EM&A REPORT NO.42
(MAY 2013)

Report No.: ENA31190

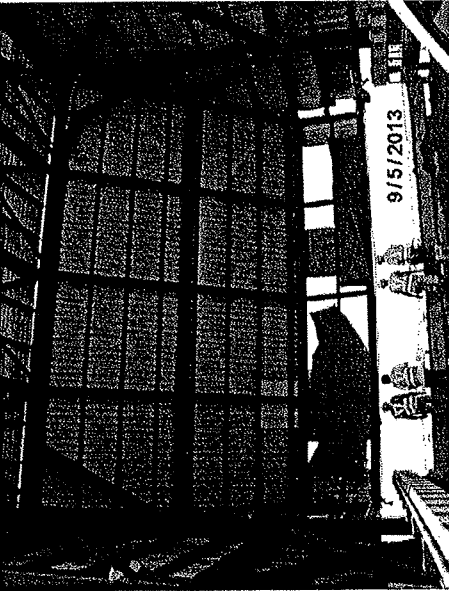
<p>Photo 130509_001 (Tipping Hall No.2)</p>

Date	Key Findings	Action(s) Taken recommended by ET	Action(s) Taken by the Contractor during the site audit	Rectification Status by ET
09 May 2013	The enclosure of tipping hall No.2 was found broken. (Previous item)	To repair the damaged part of the tipping hall properly.	---	Follow-up
	Mud and silt were noted accumulated inside the drainage channel near the weighbridge at the Pier No.2. (Previous item)	To clear the accumulated mud and silt in order to avoid any blockage.	Mud and silt accumulated inside the drainage channel near the weighbridge at the Pier No.2 were cleared.	Closed
	Mud and silt were noted accumulated inside the drainage channel near the CEDD's site office. (Previous item)	To clear the accumulated mud and silt in order to avoid any blockage.	---	Follow-up
15 May 2013	The enclosure of tipping hall No.2 was found broken. (Previous item)	To repair the damaged part of the tipping hall properly.	---	Follow-up

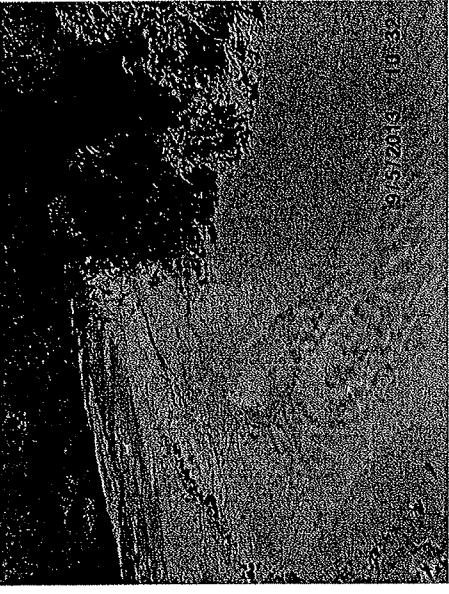
<p>Photo 130509_003 (Drainage channel near CEDD's site office)</p>

Mud and silt were noted accumulated inside the drainage channel near the CEDD's site office. (Previous item)	To clear the accumulated mud and silt in order to avoid any blockage.	---	Follow-up
	Standing water was found inside the drip tray for a generator near work shop. (New item)	To clear the standing water or apply pesticide to avoid mosquito breeding.	---	Follow-up
	No skirt curtain was provided for the drip tray for a generator near work shop. (New item)	To provide appropriate skirt curtain.	---	Follow-up
23 May 2013	The enclosure of tipping hall No.2 was found broken. (Previous item)	To repair the damaged part of the tipping hall properly.	---	Follow-up
	Mud and silt were noted accumulated inside the drainage channel near the CEDD's site office. (Previous item)	To clear the accumulated mud and silt in order to avoid any blockage.	---	Follow-up
	Standing water was found inside the drip tray for a generator near work shop. (Previous item)	To clear the standing water or apply pesticide to avoid mosquito breeding.	---	Follow-up
