Reprovisioning and Upgrading of Salt
Water Service Reservoirs in Western
District for Water Supplies Department:
*Seventeenth Monthly Environmental
Monitoring and Audit Report*

January 2009

MONTHLY ENVIRONMENTAL
MONITORING & AUDIT REPORT

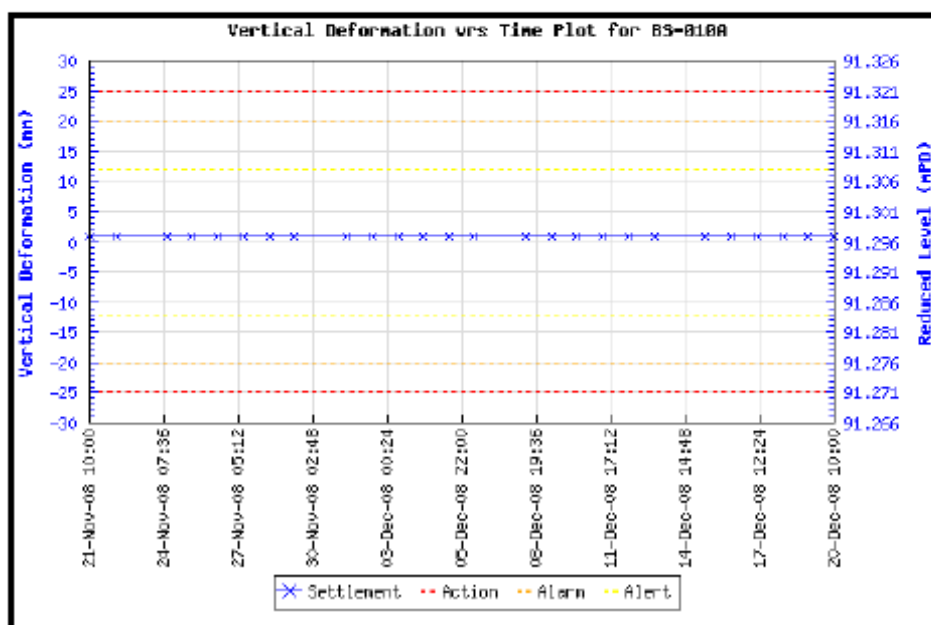
SETTLEMENT MONITORING RECORD SHEET

Instrument ID : BS-010A
Easting : 831808.247
Location : Valve House
Remark :

Type : Building Settlement Marker Type DMP5
Northing : 816016.001 Initial Level : 91.296 mPD
