Reprovisioning and Upgrading of Salt
Water Service Reservoirs in Western
District for Water Supplies Department:
*Twenty-first Monthly Environmental
Monitoring and Audit Report*

May 2009

Reference 0067560

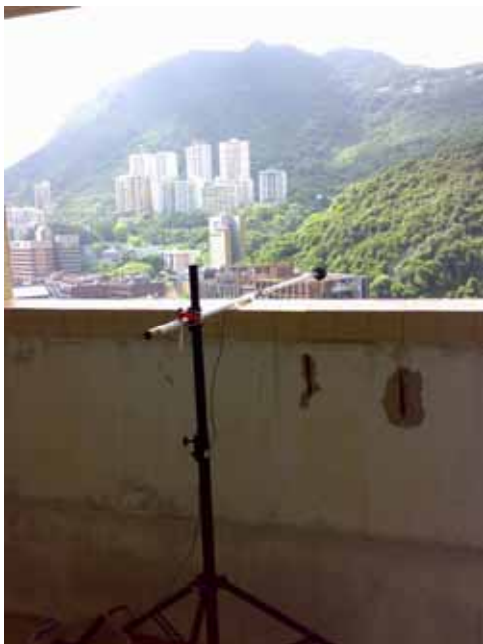
Noise Monitoring Station (NM1)

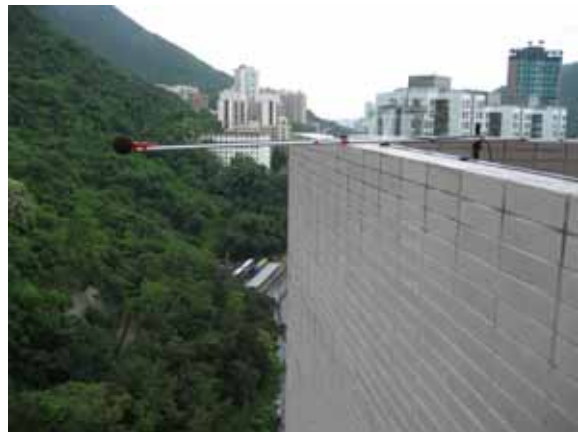
Baseline Noise Monitoring Station (NM2)

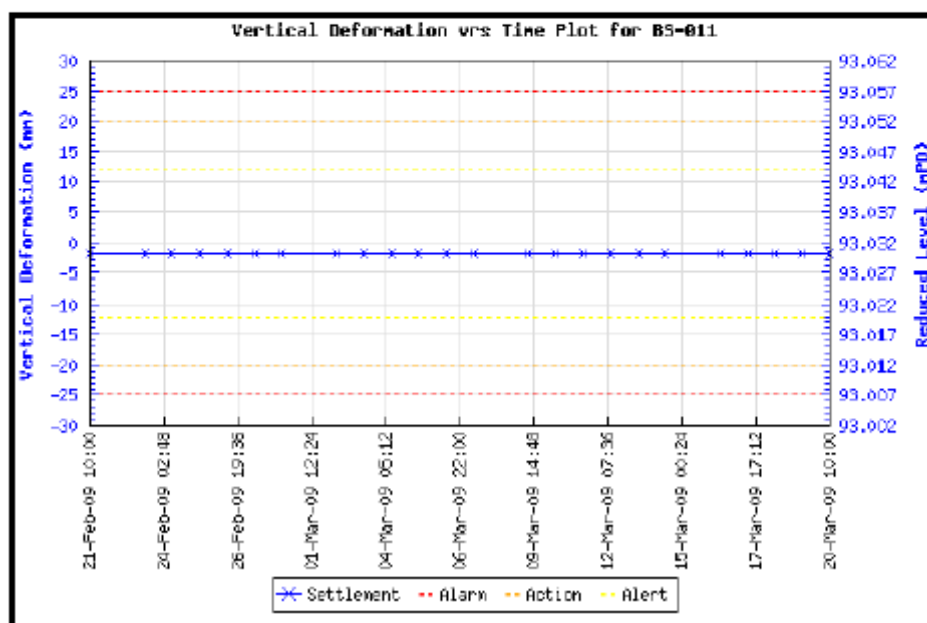
Instrument ID : BS-011

SETTLEMENT MONITORING RECORD SHEET

Initial Level : 93.032 mPD
