Reprovisioning and Upgrading of Salt
Water Service Reservoirs in Western
District for Water Supplies Department:
*Twentieth Monthly Environmental
Monitoring and Audit Report*

April 2009

MONTHLY ENVIRONMENTAL
MONITORING & AUDIT REPORT

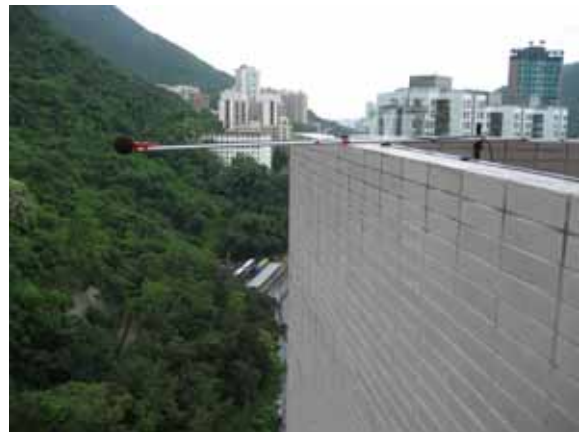
Baseline Noise Monitoring Station (NM2)
