Monthly Environmental Monitoring & Auditing report for

Contract No.DC/2006/11

Drainage Improvement in Southern Lantau

March 2009

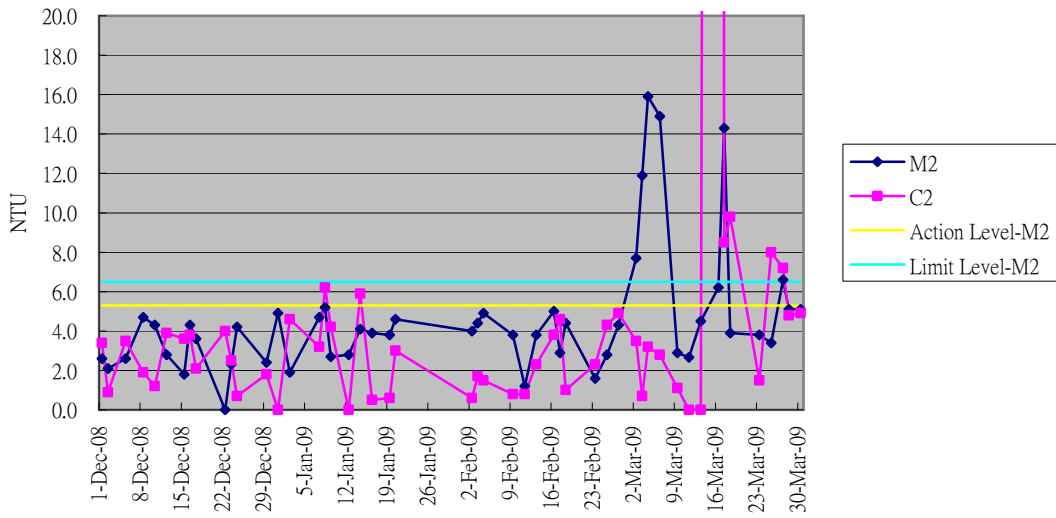
Graphical Plot of Turbidity Trend M2&C2 (Dec 08-Mar 09)

Remarks: The reading of C2 on Mar 16th 2009 is 329.6, which was over the range of the plot.

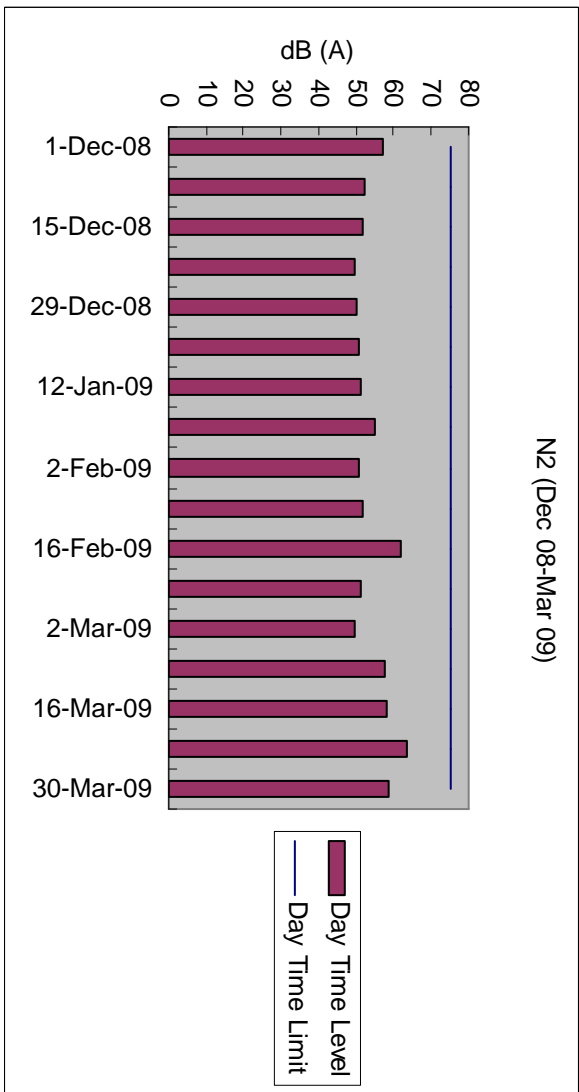
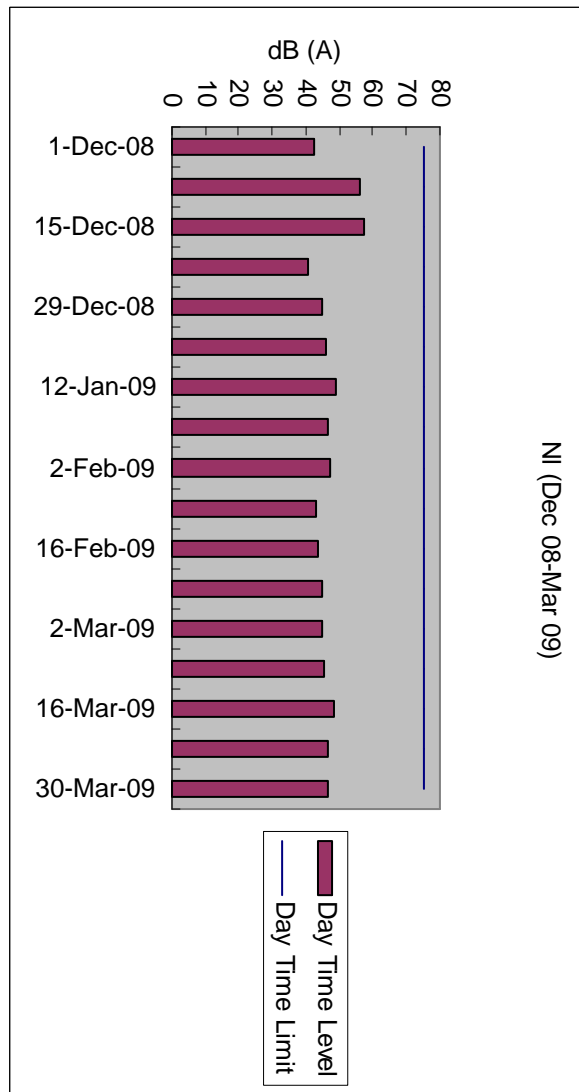
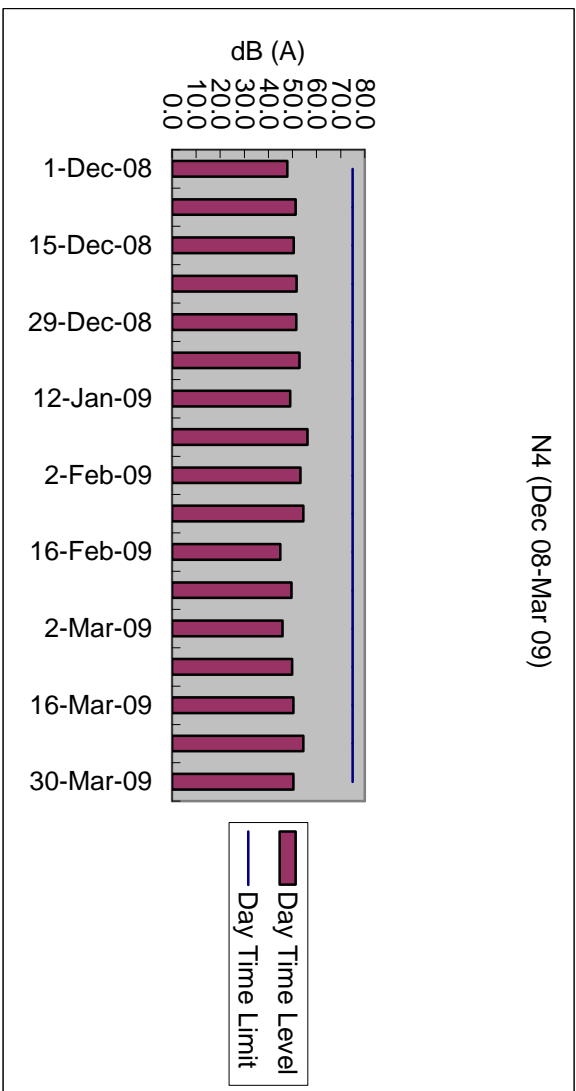
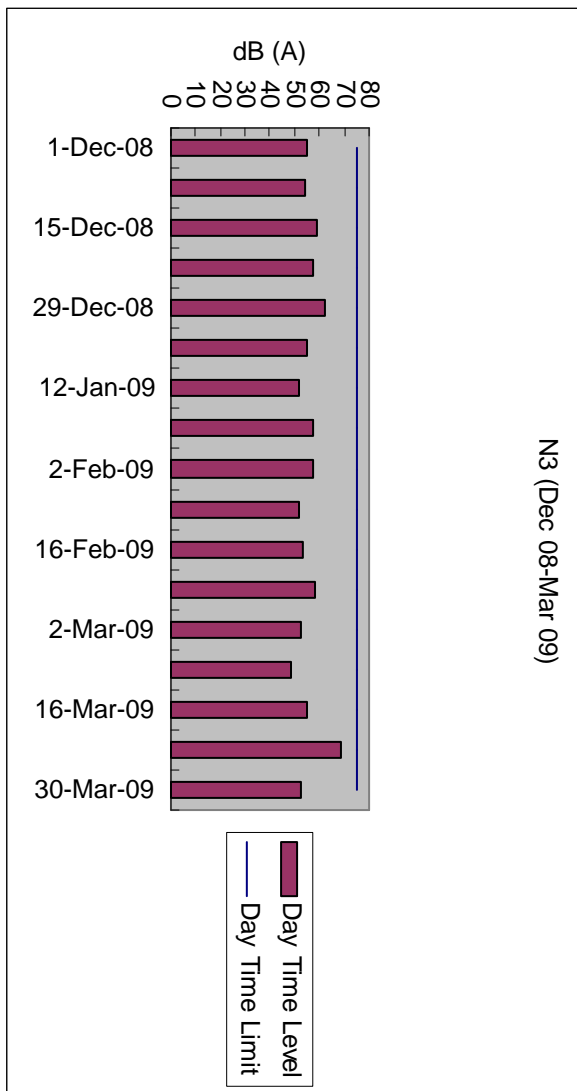
Graphical plot of noise
monitoring results

Relevant details of the noise monitoring results are presented in table 4.4.1. The results, ranged between 44.8 dB (A) and 68.4 dB (A), were within the limit levels and therefore, no exceedance was found.
