Monthly Environmental Monitoring & Auditing report for

Contract No.DC/2006/11

Drainage Improvement in Southern Lantau

March 2010

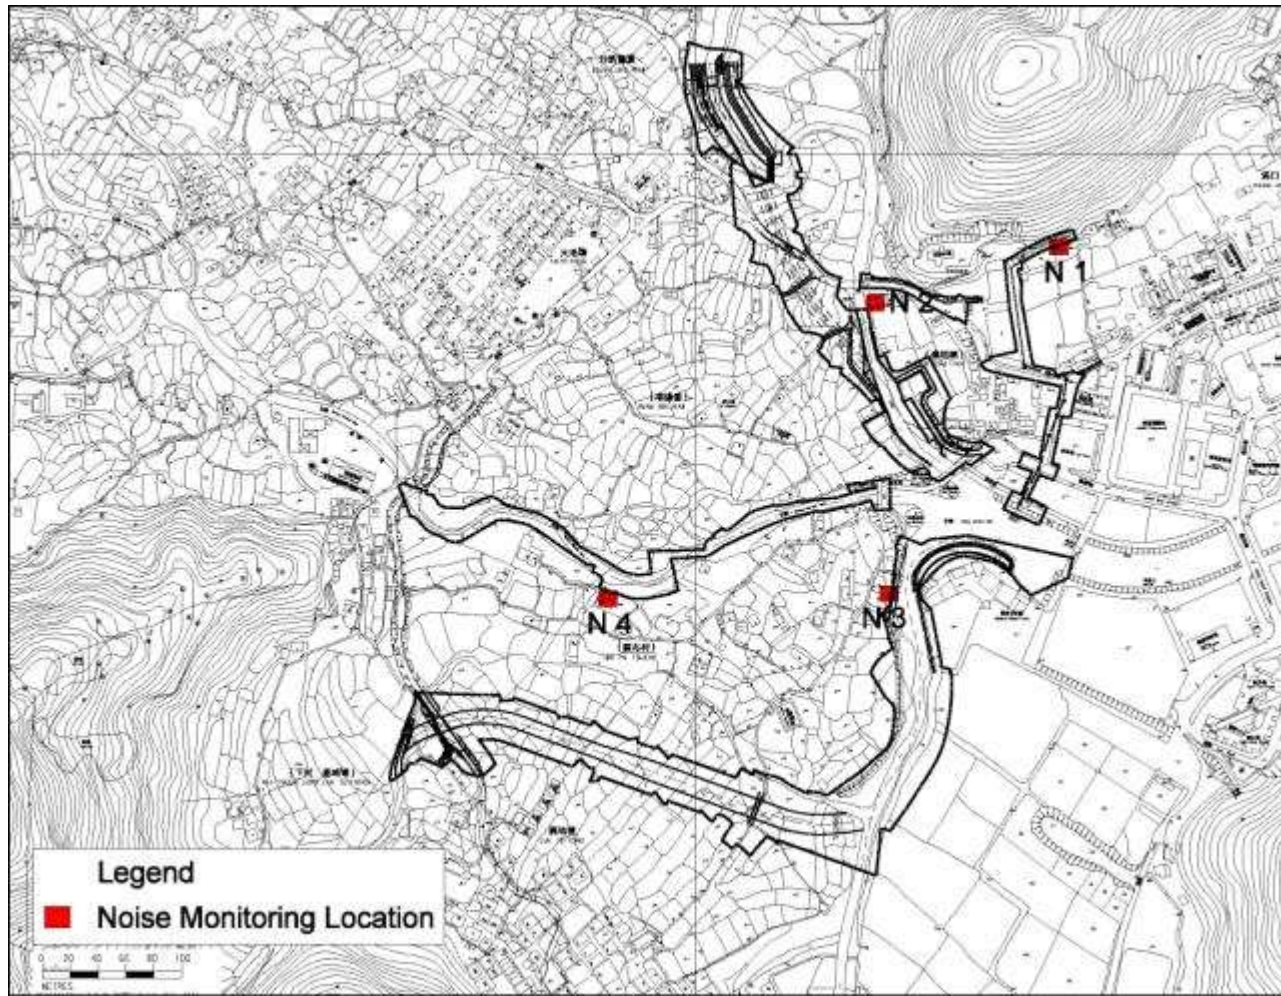
Figure 4.3.1 Impact noise monitoring locations

Identification No.	Noise Monitoring Locations
N1	No. 73, Village House, Ling Tsui Tau Tsuen (ground level)
N2	No. 31, Village House, Ling Tsui Tau Tsuen (ground level)
N3	Fence wall outside No. 5 village house adjacent to Luk Tei Tong River Outlet (ground level)
N4	No. 23, Village House, Tai Tei Tong River (ground level)
