Monthly Environmental Monitoring & Auditing report for

Contract No.DC/2006/11

Drainage Improvement in Southern Lantau

June 2010

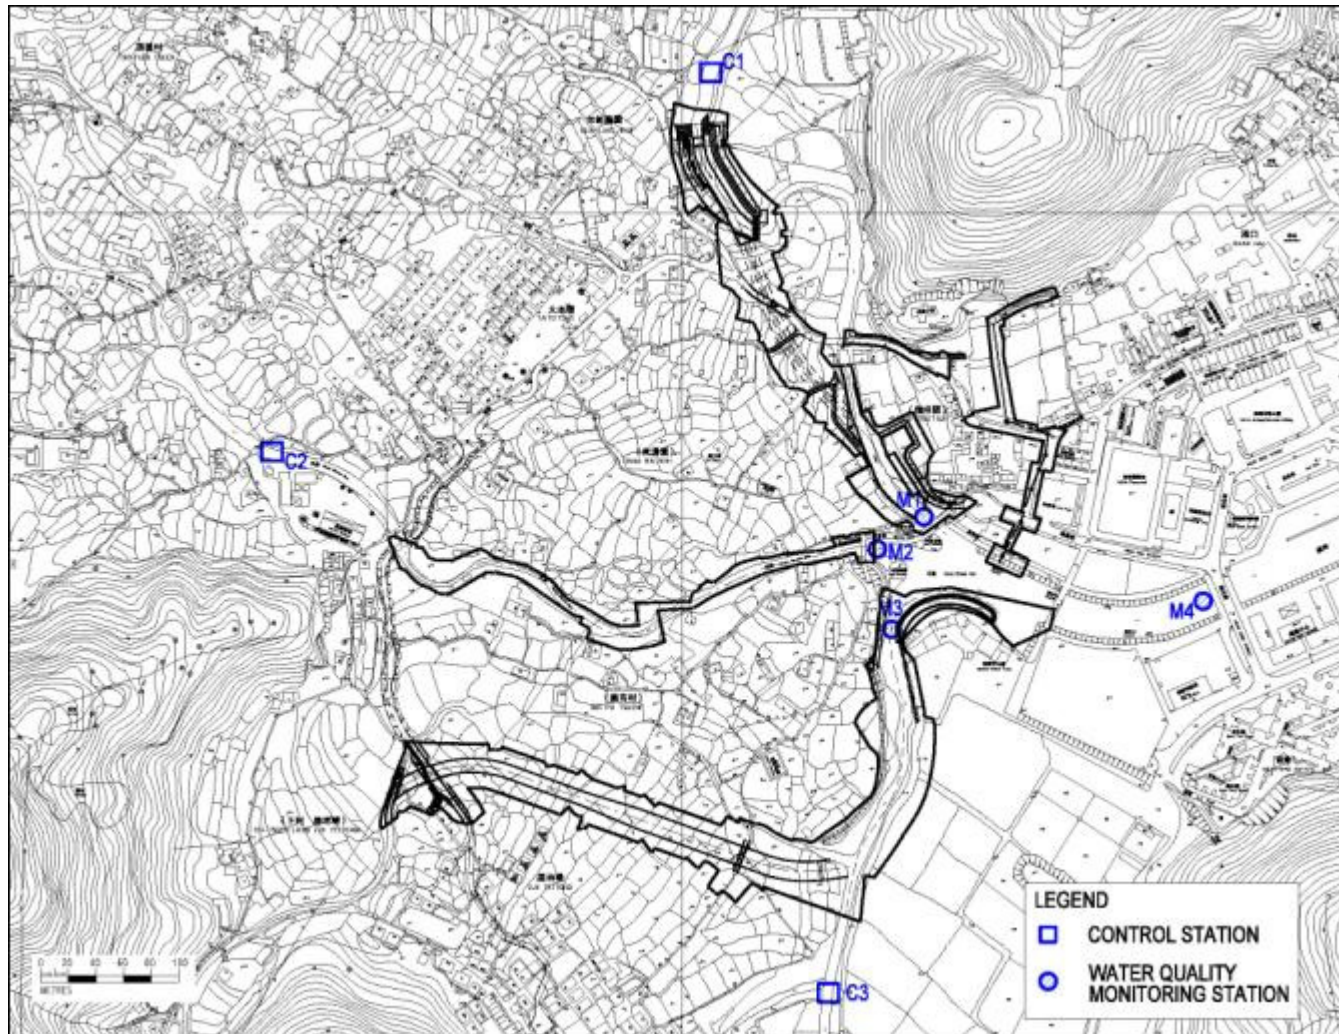
Figure 5.3.1 Water Quality Monitoring Locations

Seven locations included a control station in upstream of each stream/ river, a monitoring station at the end of each stream/ river of the works area and a monitoring station at Silver River were proposed for the impact water quality monitoring. Water samples were collected at mid-depth of each proposed monitoring stations for measurements and sample collection. The Location Plan is shown in Figure 5.3.1 for reference.

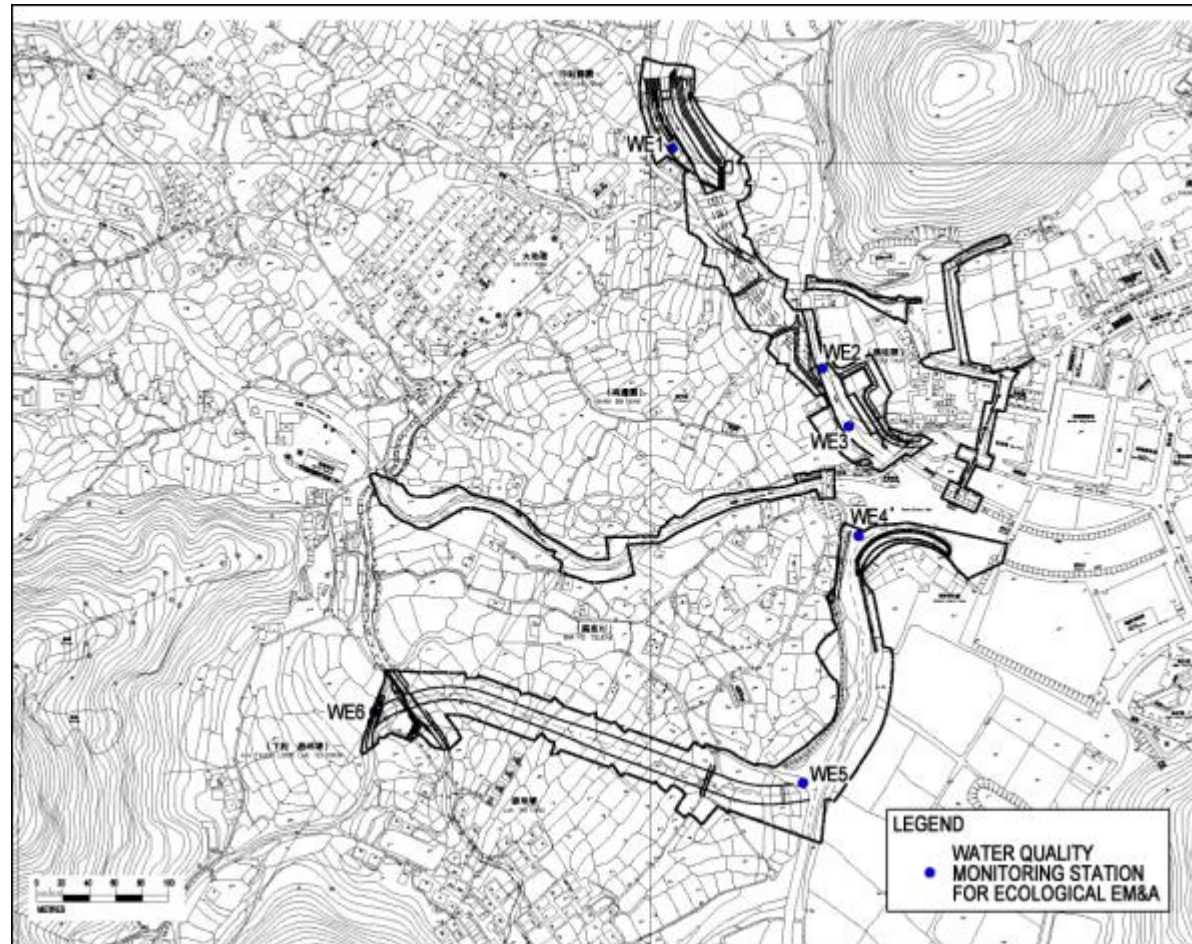
Figure 6.2 Ecological Water Quality monitoring locations

- Three points for existing of PNH river
- Three points for existing of Luk Tei Tong River

The Location Plan for ecological water monitoring is shown in Figure 6.2 for reference.
