**Preliminary Monthly Environmental Monitoring & Auditing report
for**

**Contract No.DC/2006/11
Drainage Improvement in Southern Lantau**

April 2010

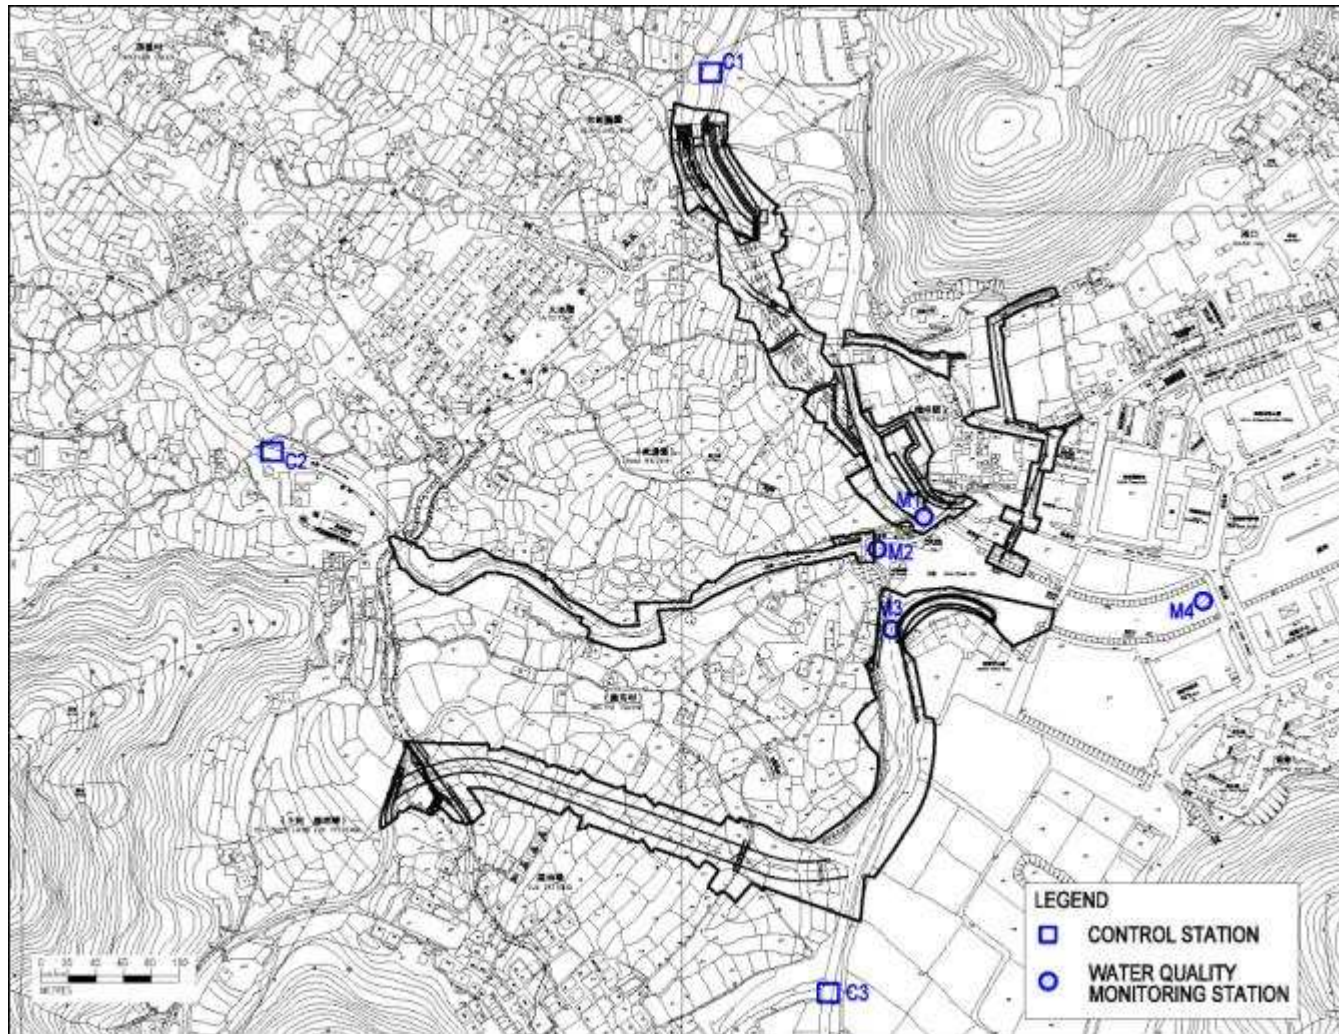
Figure 5.3.1 Water Quality Monitoring Locations

Seven locations included a control station in upstream of each stream/ river, a monitoring station at the end of each stream/ river of the works area and a monitoring station at Silver River were proposed for the impact water quality monitoring. Water samples were collected at mid-depth of each proposed monitoring stations for measurements and sample collection. The Location Plan is shown in Figure 5.3.1 for reference.

Total 60 exceedance events on parameters of turbidity and suspended solids were recorded in this reporting month according to the established level. Findings from the investigations showed most of the exceedance events were mainly caused by natural fluctuation and deficiencies of site practice.

As 17 events were suspected to be related to improper site practices, contractor was seriously reminded to review the site conditions and implement corrective actions as well as mitigation measures as soon as possible to minimize further deterioration of water quality.

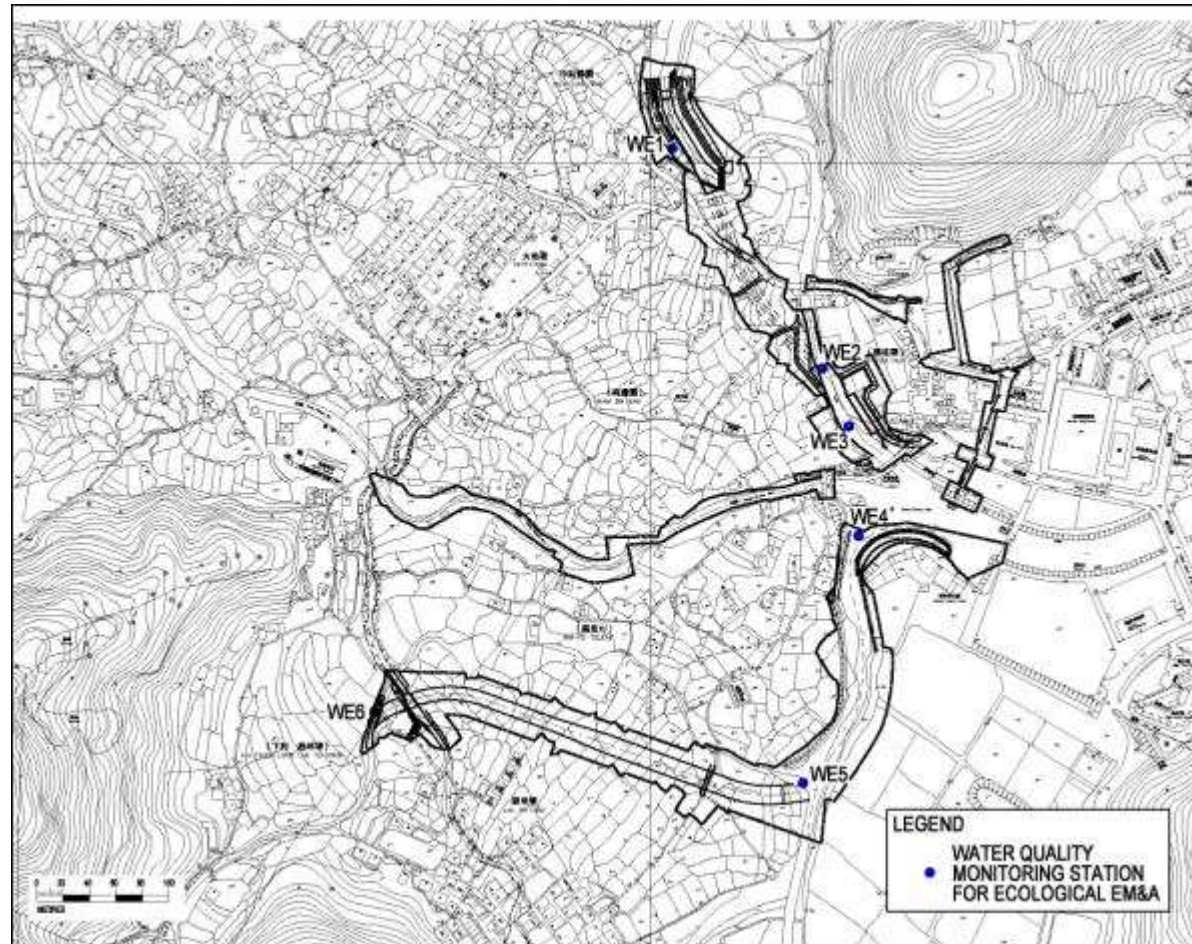
Figure 6.2 Ecological Water Quality monitoring locations

The Location Plan for ecological water monitoring is shown in Figure 6.2 for reference.

To review the results in Table 6.9 in general, the measured results of Suspended Solids and Turbidity measured in WE3 (PNH River) and WE4 (LTT River) was found higher than the previous months. Such facts were believed to be caused by disturbance of sediments, and site effluent discharge due to construction activities.
