Monthly Environmental Monitoring & Auditing report for

Contract No.DC/2006/11

Drainage Improvement in Southern Lantau

June 2010

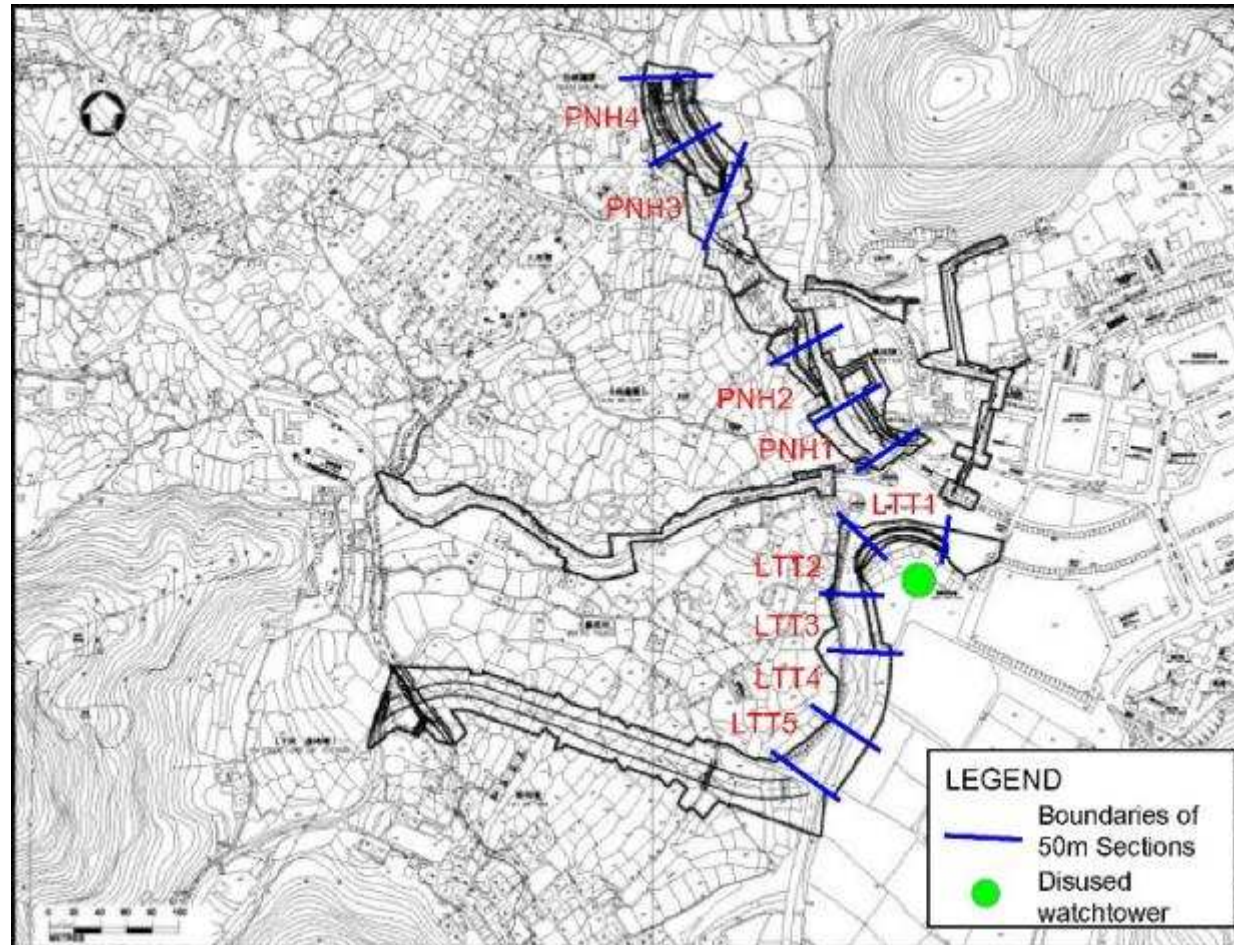
Figure 6.1 Ecological Monitoring Locations

- Three points for existing of PNH river
- Three points for existing of Luk Tei Tong River

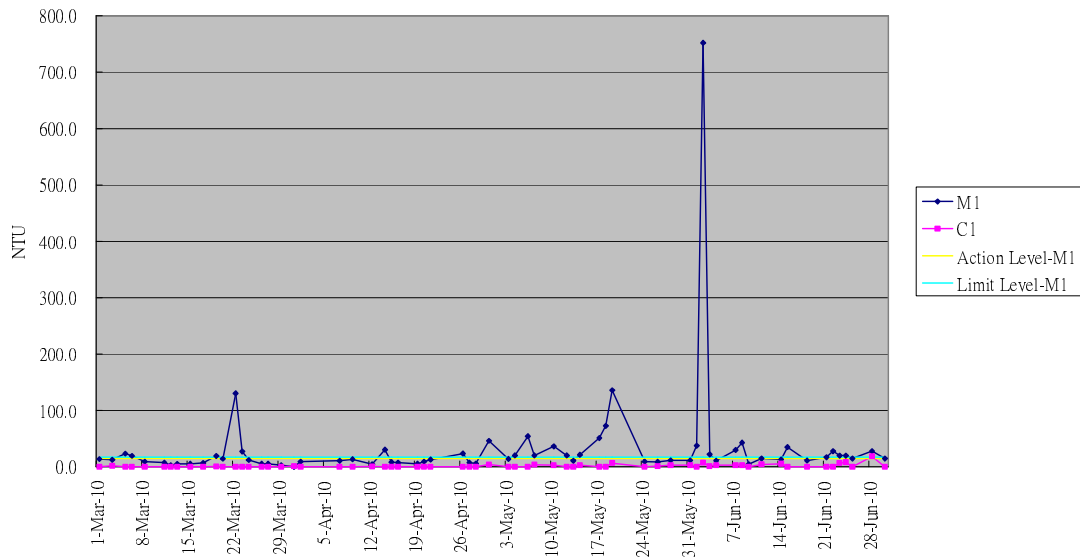
Graphical Plot of Turbidity Trend M1&C1(Mar - Jun 10)

Graphical plot of water
quality monitoring
results (SS, DO,
turbidity)

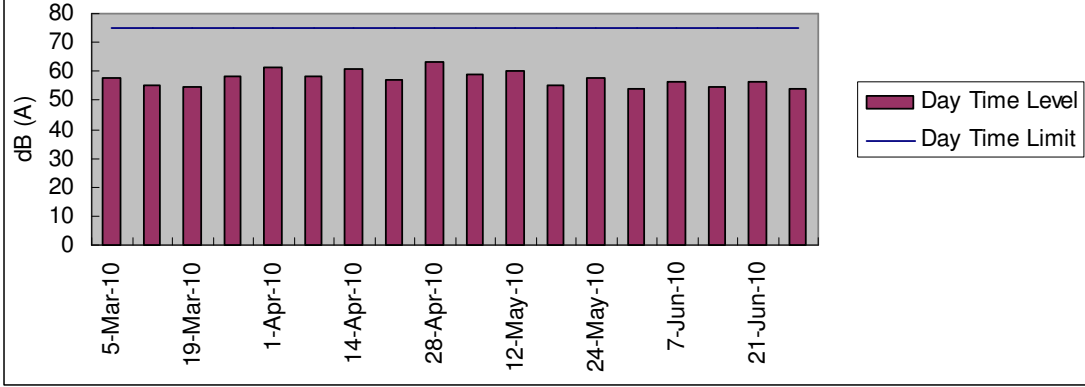
N3 (Mar - June 10)

Graphical plot of noise
monitoring results
