**Monthly Environmental Monitoring & Auditing report for**

**Contract No.DC/2006/11**

**Drainage Improvement in Southern Lantau**

**October 2010**

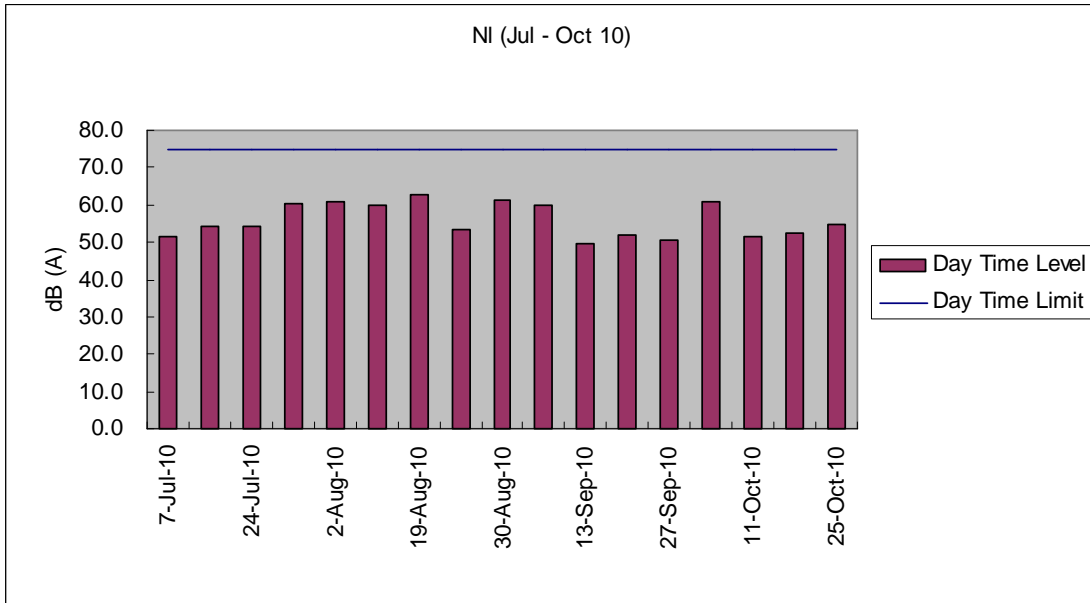
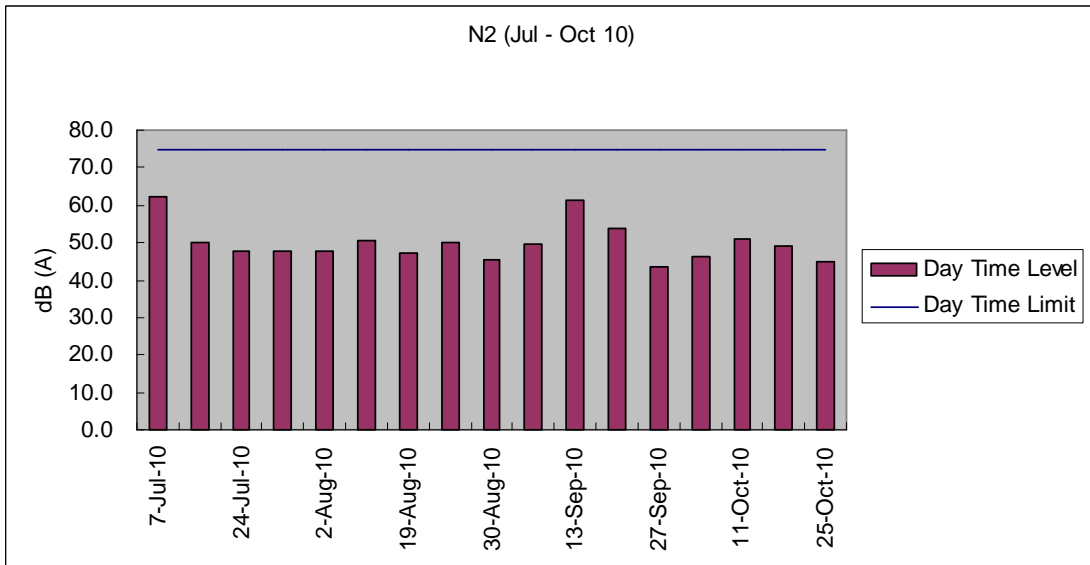
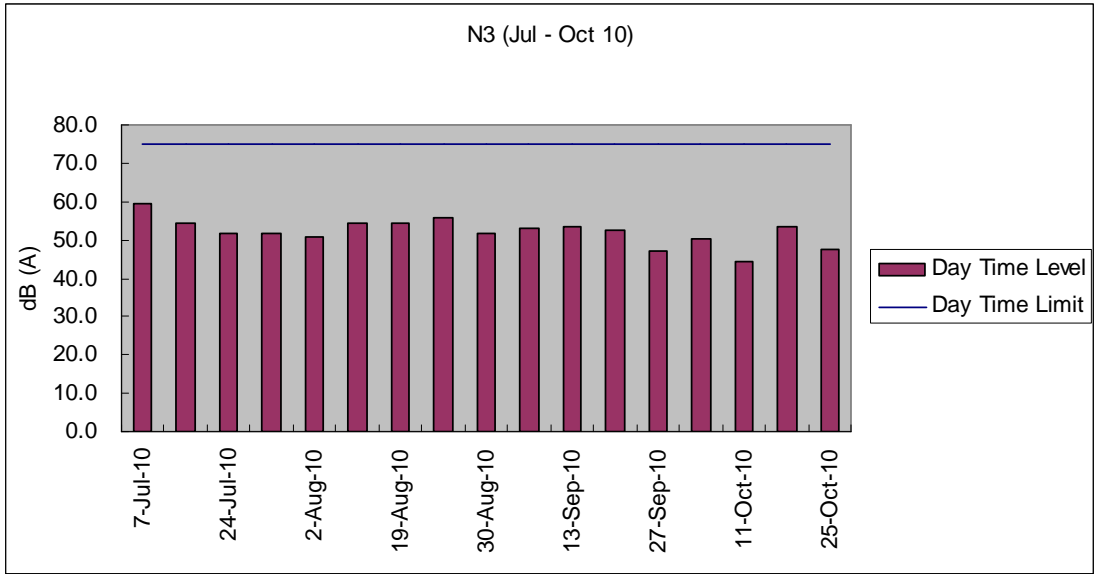
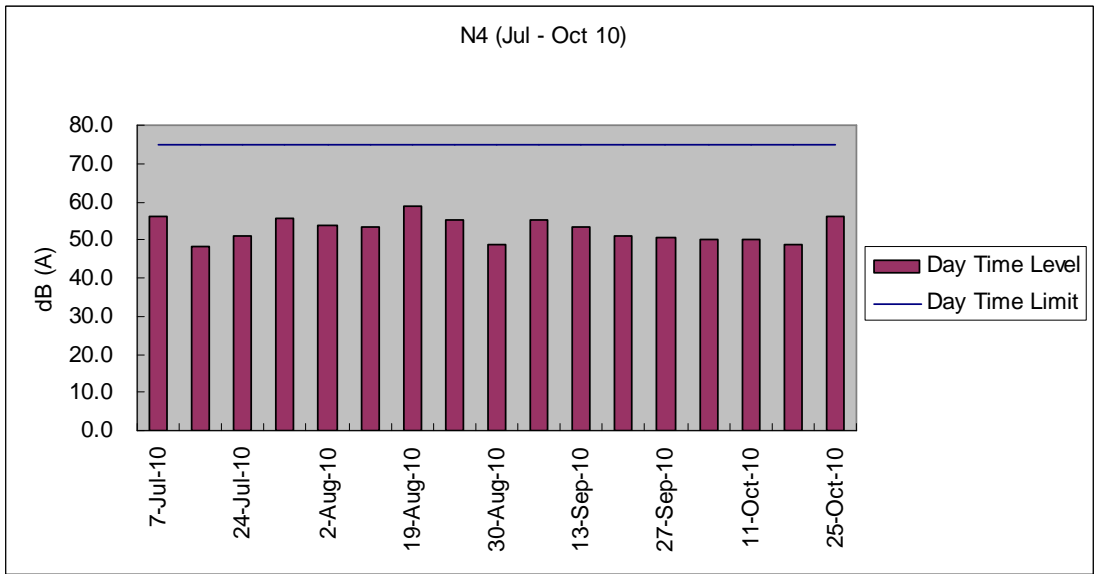
Graphical plot of noise  
monitoring results

Relevant details of the noise monitoring results are presented in Table 4.4.1. The results, ranged between 46.2 dB(A) and 60.7 dB(A), were within the limit levels and therefore, no exceedance was found.
