**CONTRACT NO: KL/2009/01**  
**SITE FORMATION FOR**  
**KAI TAK CRUISE TERMINAL DEVELOPMENT**

**QUARTERLY ENVIRONMENTAL MONITORING & AUDIT**  
**REPORT**

- SEPTEMBER TO NOVEMBER 2010 -

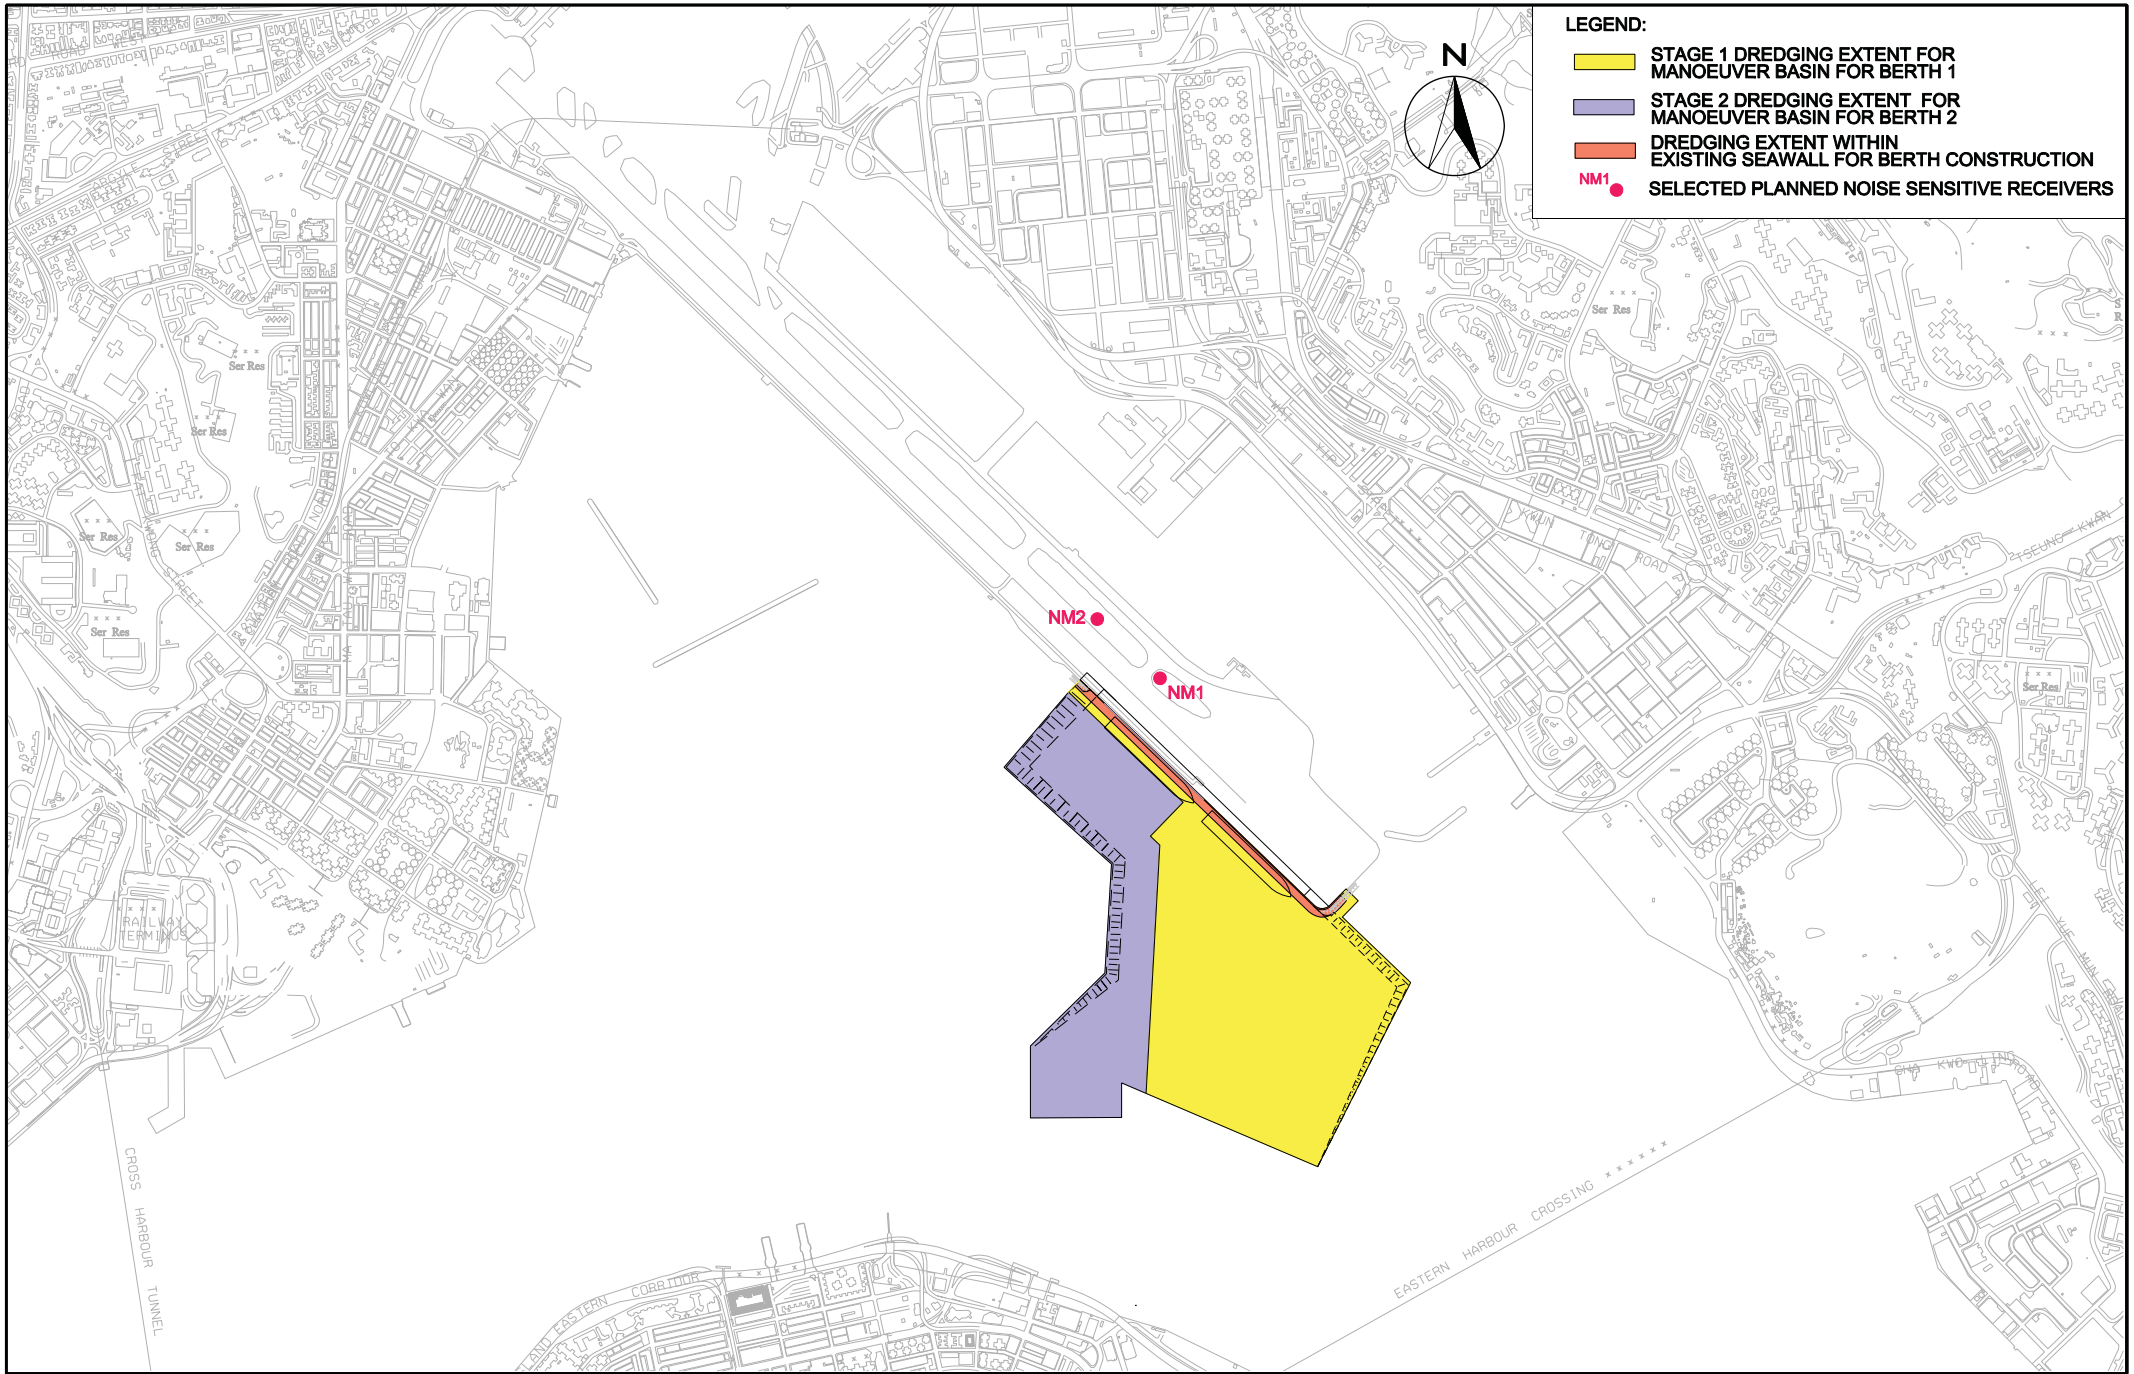
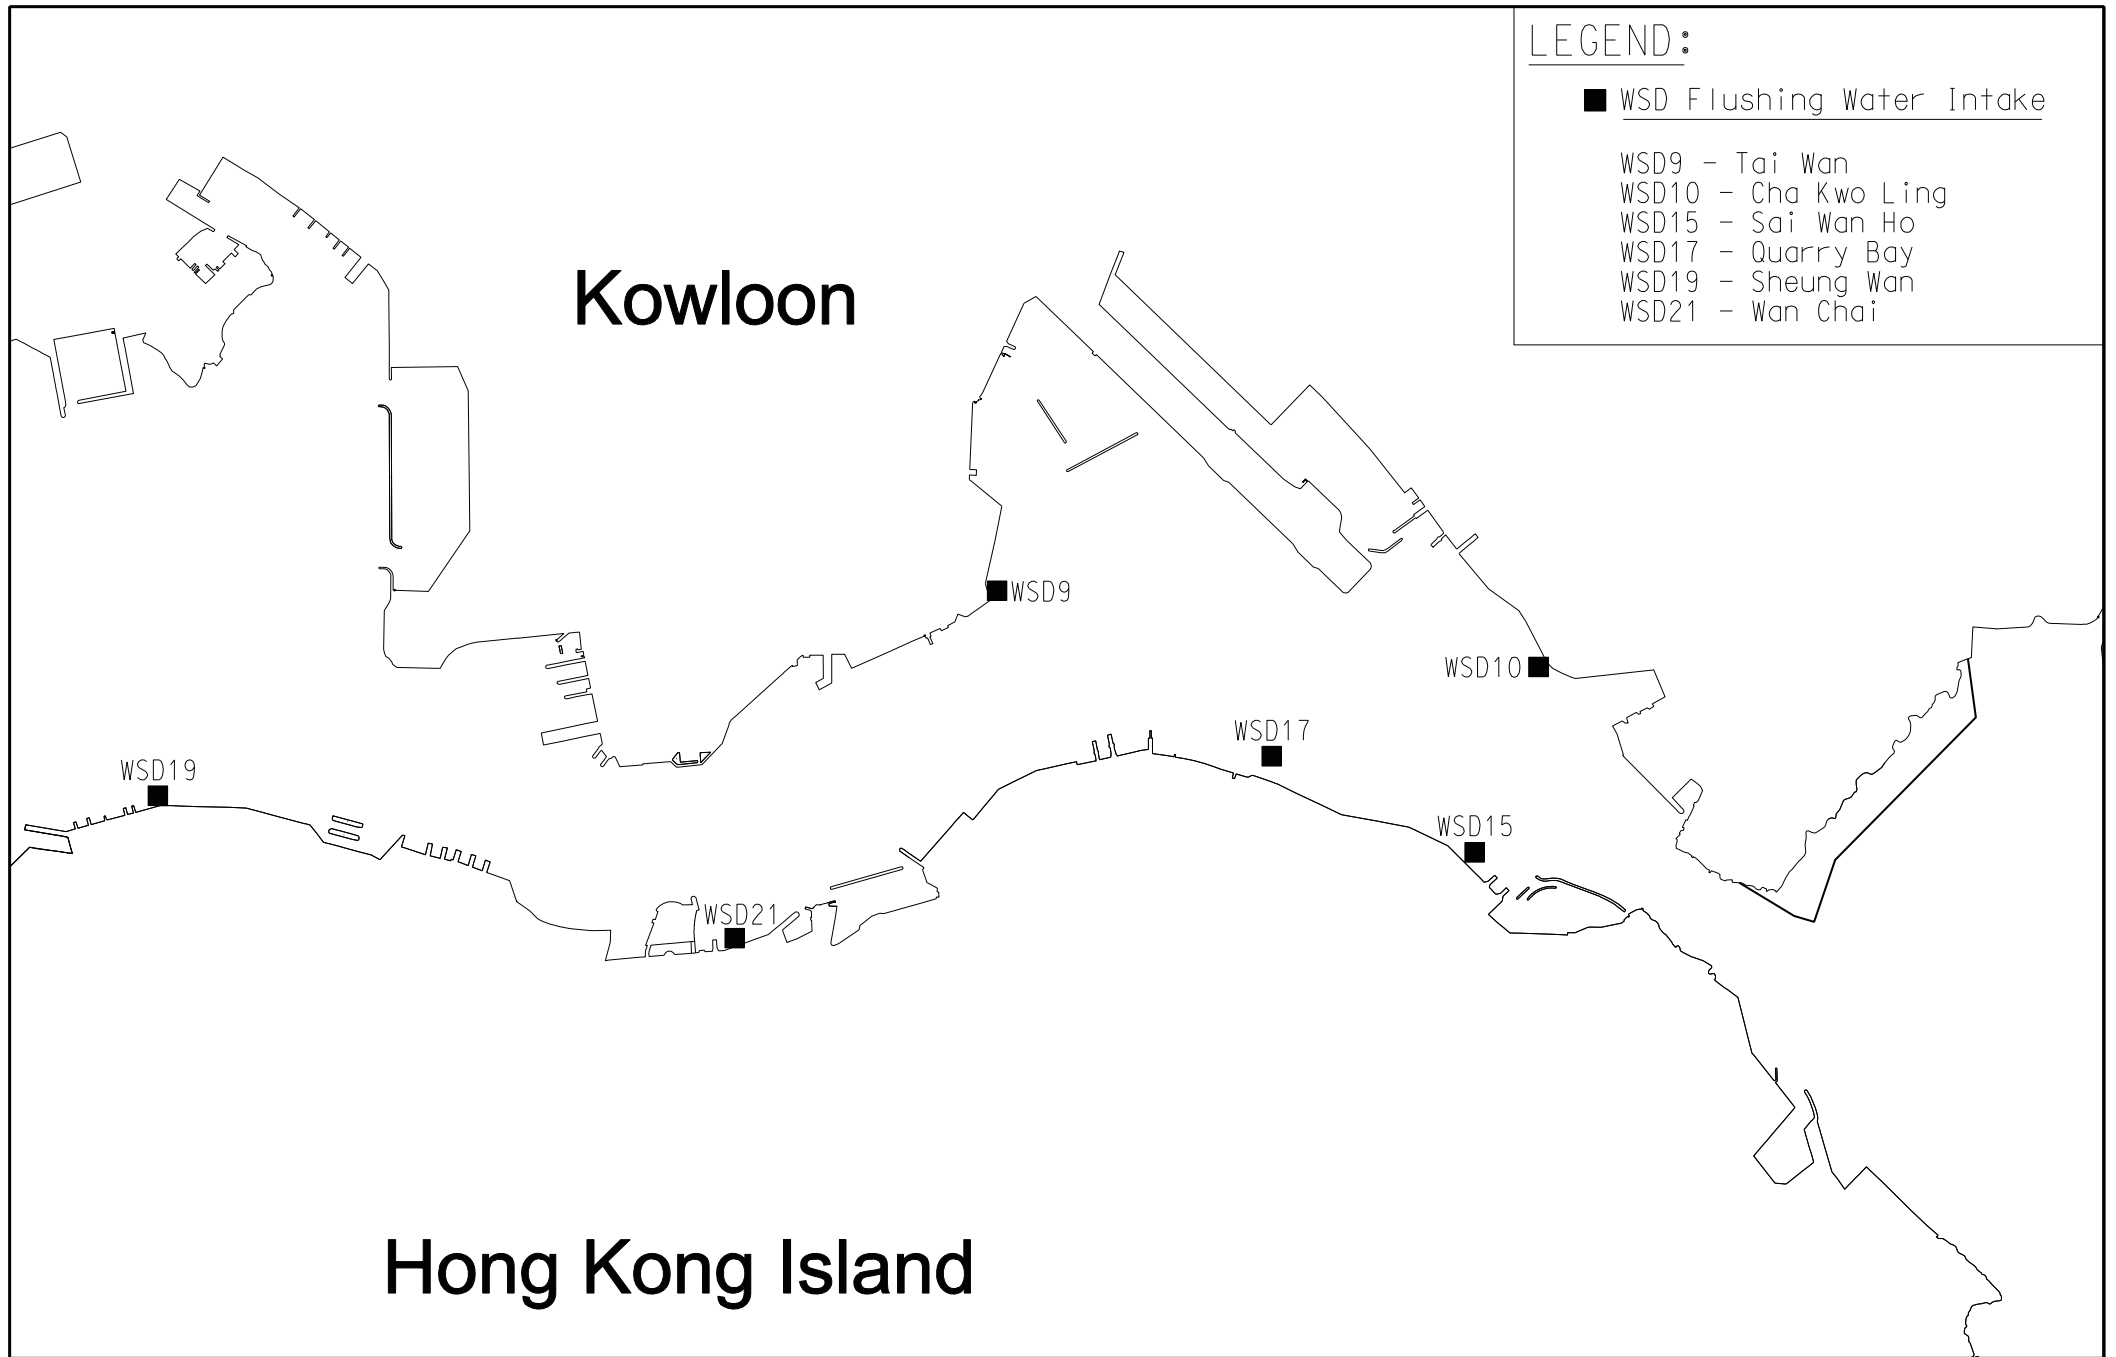
**Figure 3.1**

3.2.2. It is proposed to monitor the water quality at six WSD flushing water intakes along the seafront of the Victoria Harbour. The proposed water quality monitoring stations are shown in **Table 3.2** and **Figure 3.1**.

Station Ref.	WSD Flushing Water Intake	Easting	Northing
WSD9	Tai Wan	837921.0	818330.0
WSD10	Cha Kwo Ling	841900.9	817700.1
WSD15	Sai Wan Ho	841110.4	816450.1
WSD17	Quarry Bay	839790.3	817032.2
WSD21	Wan Chai	836220.8	815940.1
WSD19	Sheung Wan	833415.0	816771.0

***Layout of Environmental Monitoring Stations***

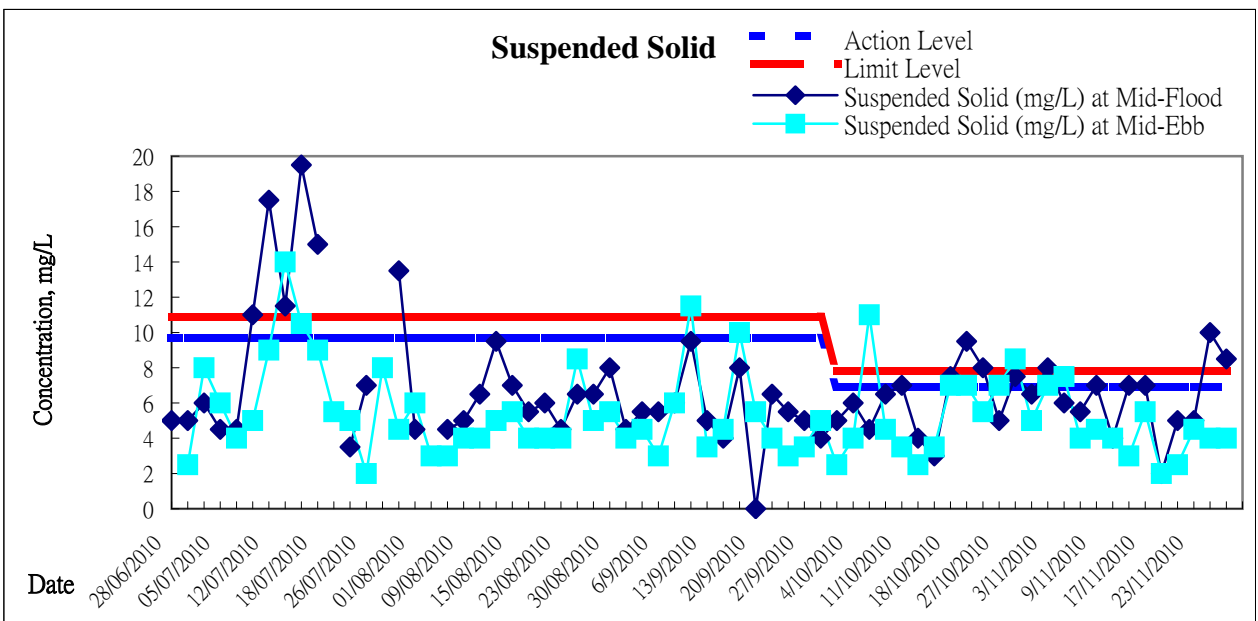
***Graphical Presentation of Water Quality Monitoring Results***

4.1.3. Water monitoring results measured in this reporting period are reviewed and summarized. Details of graphical presentation can be referred in [Appendix 4.1](#). The details of exceedances are summarized in **Table 4.1.1**.

- Two sets of Suspended Solid Action and Limit levels for the dry season (the period from October to March) and wet season (the period from April to September).
