**SITE FORMATION FOR
KAI TAK CRUISE TERMINAL DEVELOPMENT**

**ENVIRONMENTAL MONITORING & AUDIT
MONTHLY REPORT**

- OCTOBER 2010 -

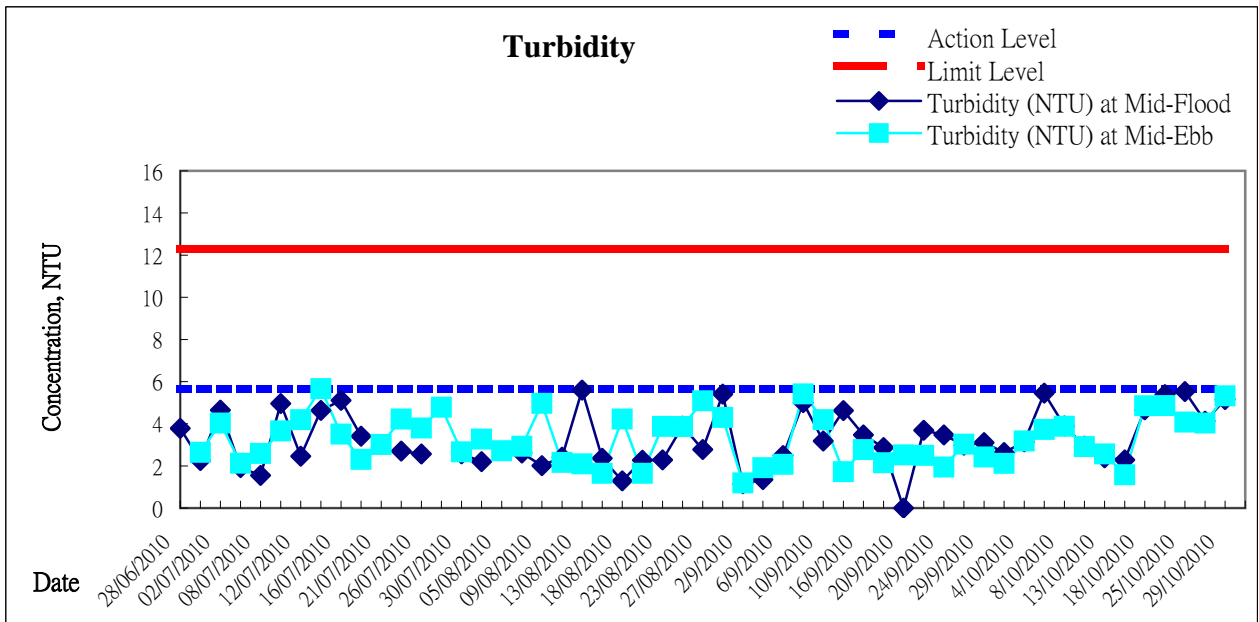
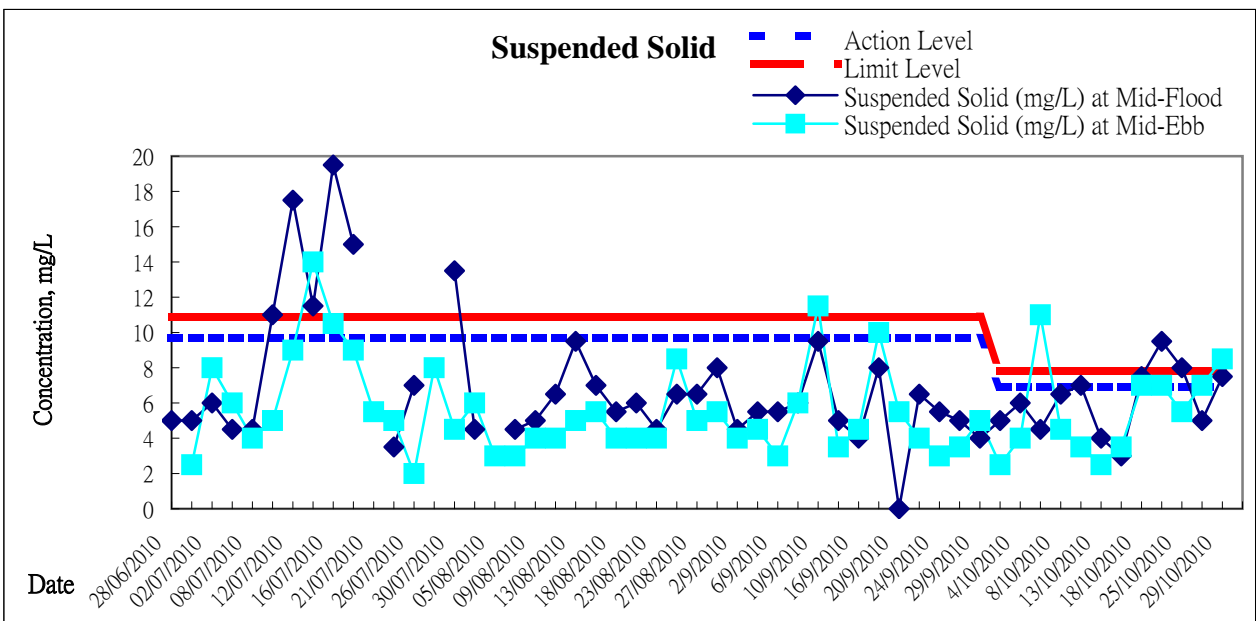
- Wet season is from April to September.
- Dry season is from October to April.
- Two sets of Suspended Solid action and limit levels for the period of dry season and wet season.
