CONTRACT NO: KL/2009/01

SITE FORMATION FOR KAI TAK CRUISE TERMINAL DEVELOPMENT

ENVIRONMENTAL MONITORING & AUDIT MONTHLY REPORT

- OCTOBER 2013 -

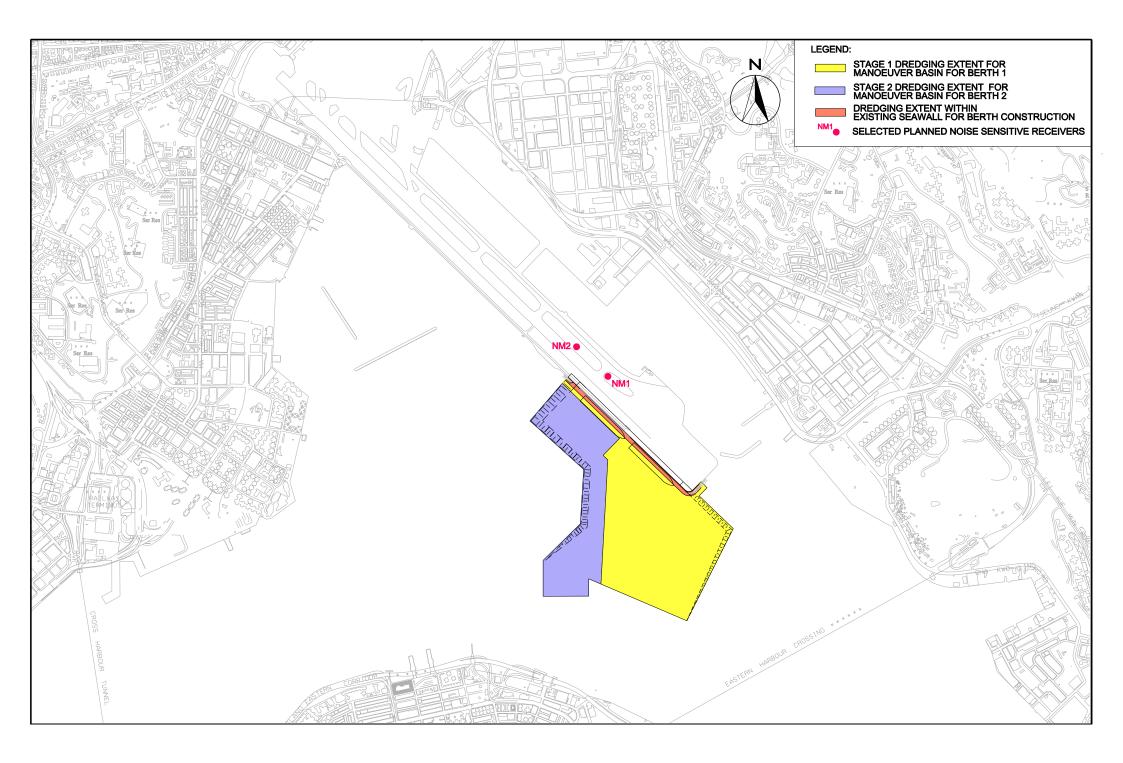
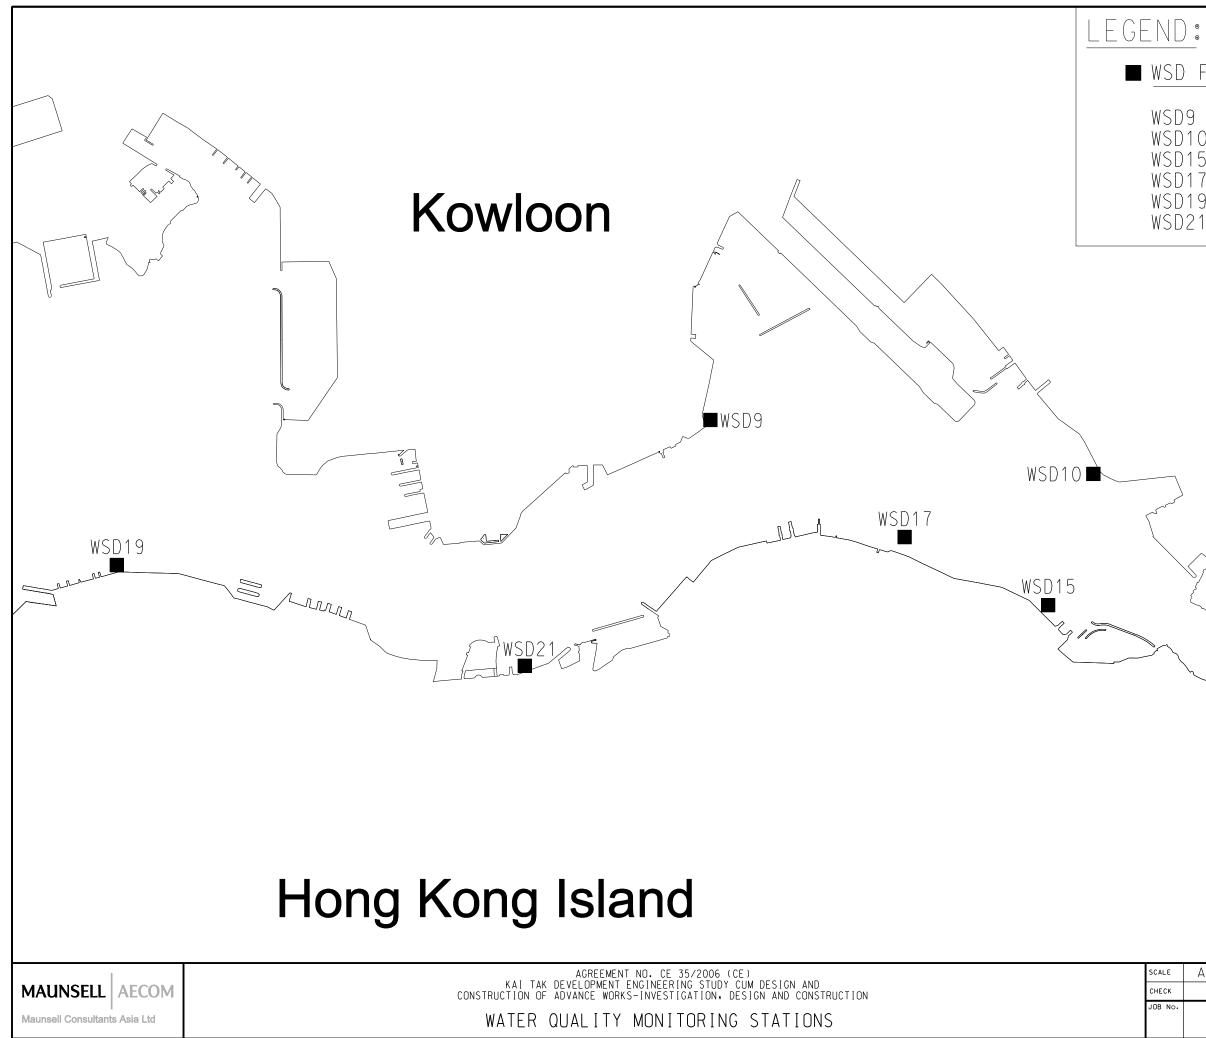
Figure 4.1

Layout of Environmental Monitoring Stations

■ WSD Flushing Water Intake WSD9 - Tai Wan WSD10 - Cha Kwo Ling WSD15 - Sai Wan Ho WSD17 - Quarry Bay WSD19 - Sheung Wan WSD21 - Wan Chai 1:35000 AЗ DATE AUG 07 SCALE СНЕСК АКҮС DRAWN WCM JOB No. DRAWING No. REV 60022503 4.1 _

- 4.2.1. The EIA Report has identified that suspended solids (SS) would be the most critical water quality parameter during the dredging operations. Water quality monitoring for SS and turbidity is therefore recommended to be carried out at selected WSD flushing water intakes. The impact monitoring should be carried out during the proposed dredging works for cruise terminal construction to ensure the compliance with the water quality standards.
- 4.2.2. It is proposed to monitor the water quality at six WSD flushing water intakes along the seafront of the Victoria Harbour. The proposed water quality monitoring stations are shown in *Table 4.2* and *Figure 4.1*.

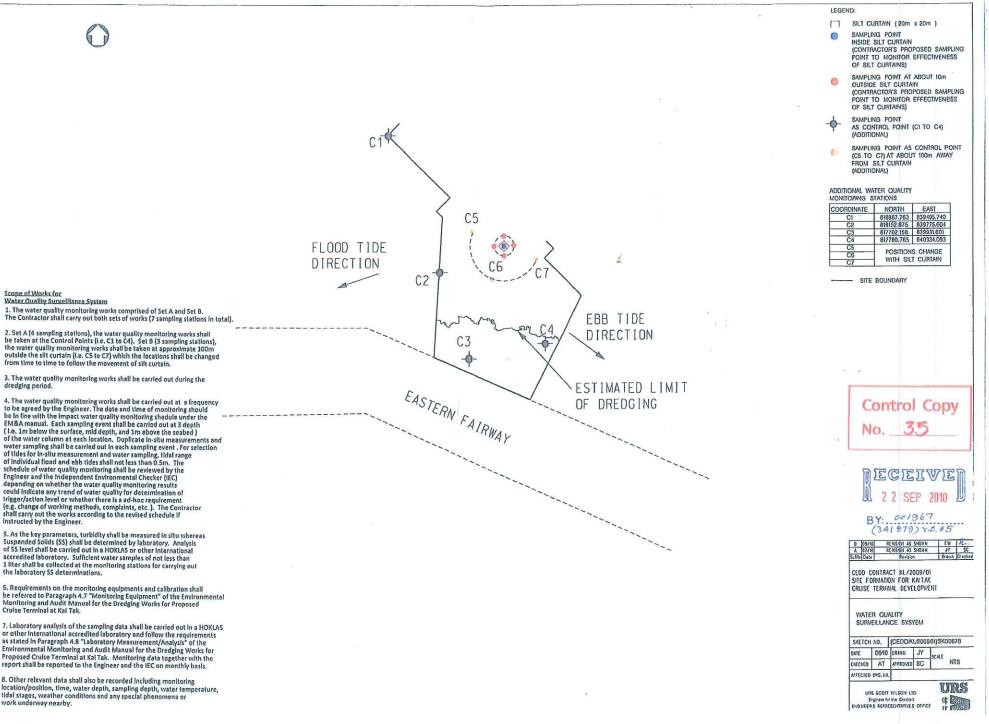
Figure 6.1

Layout of Monitoring Stations for Water Quality Surveillance System

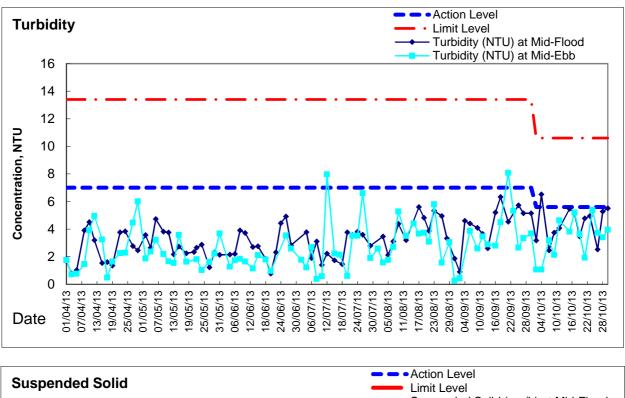
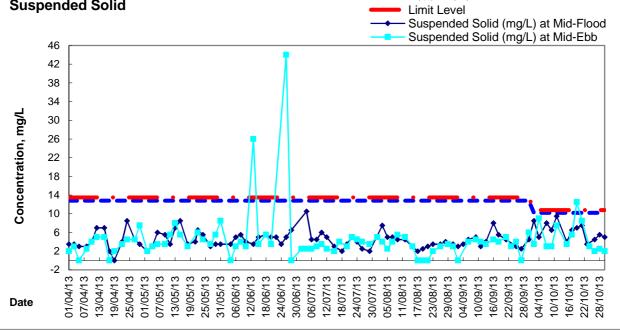
Graphic Presentation of Water Quality Result of WSD9 - Tai Wan

- Two sets of Suspended Solid Action and Limit levels for the dry season (October to March) and wet season (April to September).

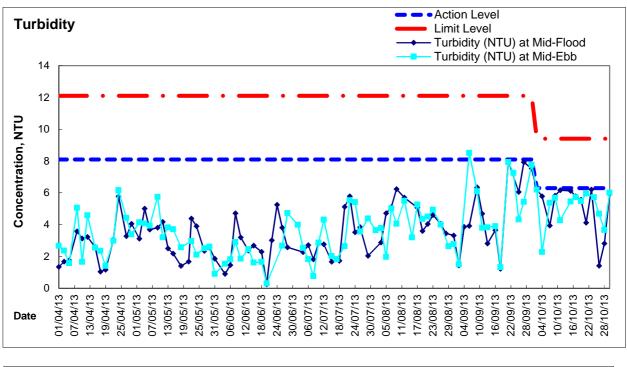
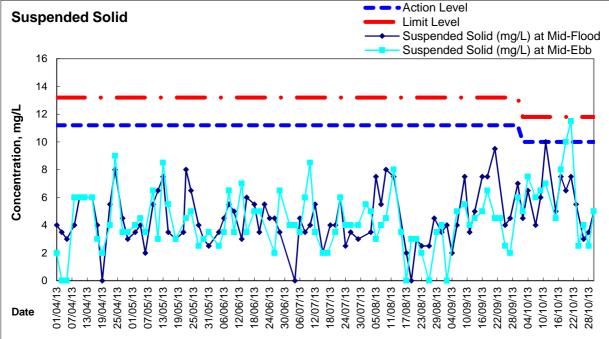
Graphic Presentation of Water Quality Result of WSD10 - Cha Kwo Ling

- Two sets of Suspended Solid Action and Limit levels for the dry season (October to March) and wet season (April to September).

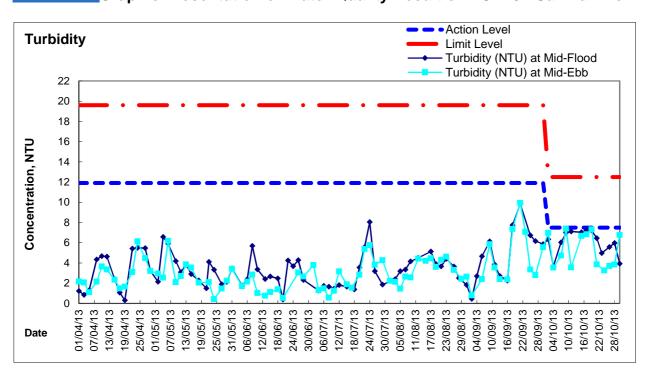
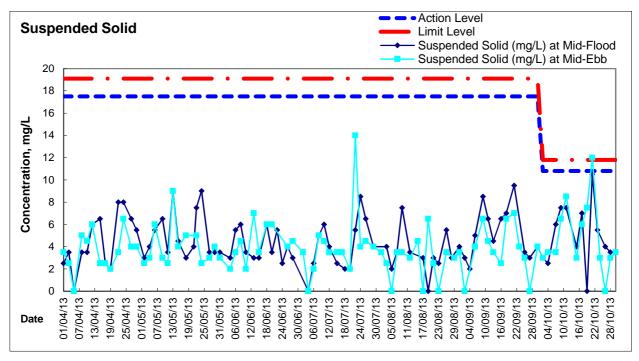
am Graphic Presentation of Water Quality Result of WSD15 - Sai Wan Ho

- Two sets of Suspended Solid Action and Limit levels for the dry season (October to March) and wet season (April to September).

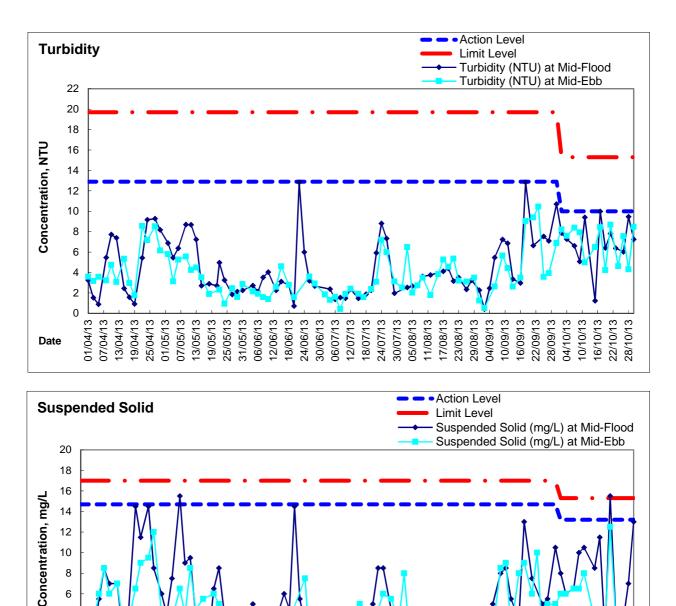
am Graphic Presentation of Water Quality Result of WSD17 - Quarry Bay

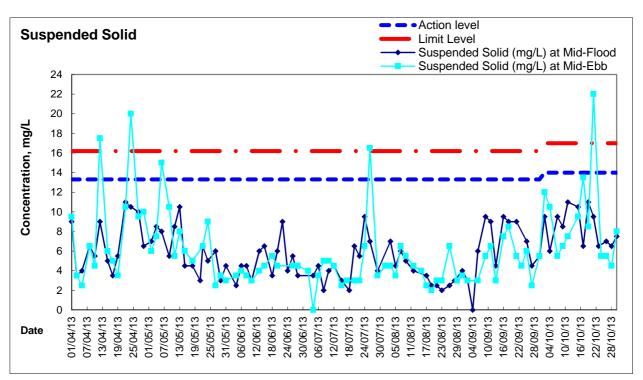
Graphic Presentation of Water Quality Result of WSD19 - Sheung Wan

- Two sets of Suspended Solid Action and Limit levels for the dry season (October to March) and wet season (April to September).

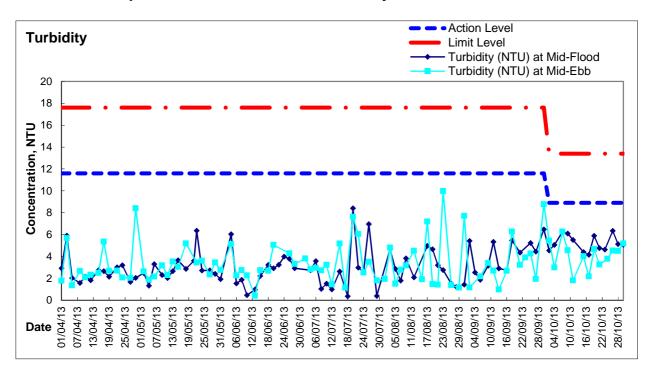
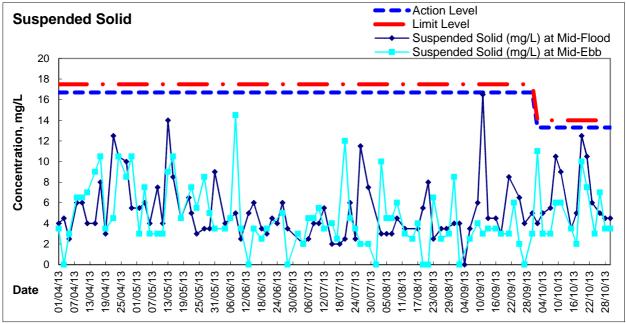
Graphic Presentation of Water Quality Result of WSD21 - Wan Chai

- Two sets of Suspended Solid Action and Limit levels for the dry season (October to March) and wet season (April to September).

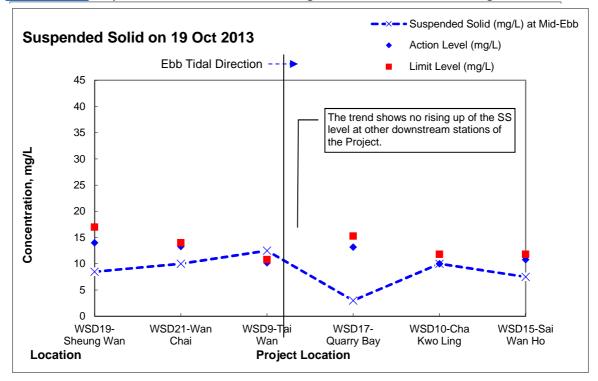
Graphic Presentation of SS Results Against the Tidal Movement along Victoria Harbour

- 6.3.2 Moreover, a comparison of the monitoring station at project downstream stations with the upstream monitoring stations can also indicate whether the extent of exceedance in SS content recorded at the WSD intakes downstream to the project is likely to be caused by upstream source or not. If the SS values of the upstream and downstream show similar levels, the impact at the project downstream stations shall probably be due to the project upstream source and the contribution from project work can be eliminated. A review on the tidal movement across the Victoria Harbour is plotted against the SS results and graphical presentation is presented in *Appendix 5.4*.

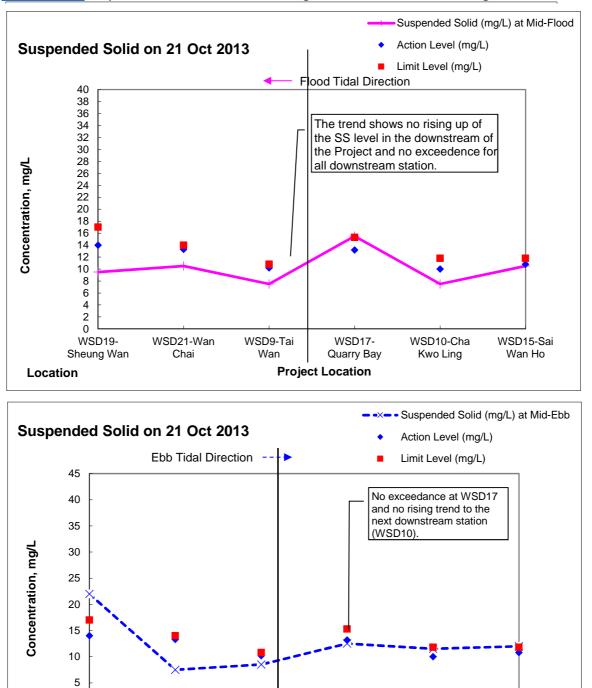
Graphic Presentation of SS Results Against the Tidal Movement along Victoria Harbour

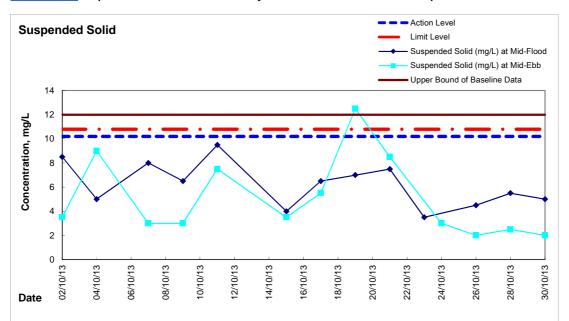
Graphic Presentation of Water Quality Result of WSD9 - Tai Wan with respect to Local Variation

Remarks: WSD9 is located at upstream during the ebb tides while at downstream during flood tides.

- 6.3.3 For the recorded exceedance (SS) on 19 October 2013, WSD9 (Mid-ebb) was upstream of project location, no rising of SS was observed at downstream stations. It is concluded that no water quality impact was arising from the Project works.

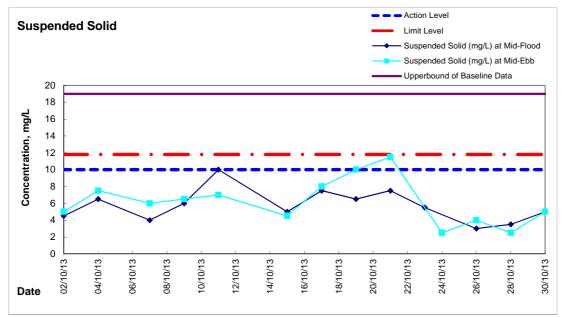
Graphic Presentation of Water Quality Result of WSD10 - Cha Kwo Ling with respect to Local Variation

Remarks: WSD10 is located at upstream during the flood tides while at downstream during ebb tides.

- 6.3.4 On 21 October 2013, the recorded exceedances at WSD10 and WSD15 (Mid-ebb) are considered as not project related. At WSD17, the immediate downstream station, no exceedance of SS and similar magnitude of SS compared with WSD10 and WSD15. No rising of SS was observed at downstream stations. Furthermore, there were no marine works conducted by the contractor on that day. It is concluded that no water quality impact was arising from the Project works.

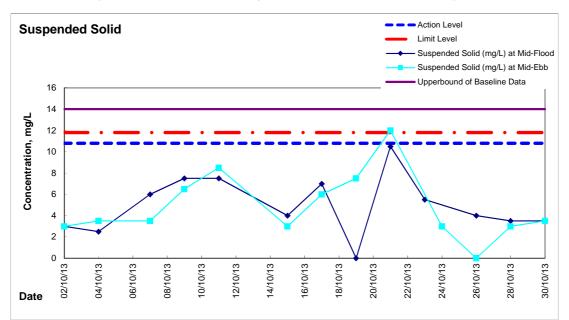
Graphic Presentation of Water Quality Result of WSD15 - Sai Wan Ho with respect to Local Variation

Remarks: WSD15 is located at upstream during the flood tides while at downstream during ebb tides.

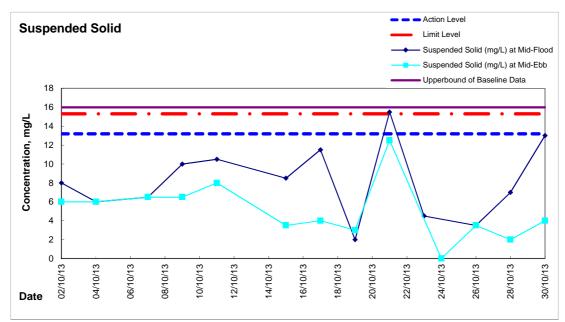
Graphic Presentation of Water Quality Result of WSD17 - Quarry Bay with respect to Local Variation

Remarks: WSD17 is located at upstream during the flood tides while at downstream during ebb tides.

- 6.3.6 The recorded exceedance (SS) on 21 October 2013 at WSD17 (Mid-flood) was upstream from project location, no rising of SS was observed at downstream stations. It is concluded that no water quality impact was arising from the Project works.

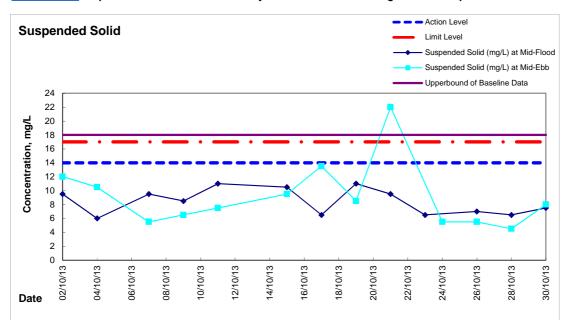
Graphic Presentation of Water Quality Result of WSD19 - Sheung Wan with respect to Local Variation

Remarks: WSD19 is located at upstream during the ebb tides while at downstream during flood tides.

- 6.3.5 For the other recorded exceedance (SS) on 21 October 2013 at WSD19 (Midebb). It was located at upstream of project location. Silt screen washing conducted by WSD workers was observed during sampling. Hence, it is concluded that the source of impact was due to silt screen washing activities at WSD19 and not related to the Project works. No exceedance in SS was recorded at the next tide on the same day (21 Oct flood-tide was 9.5mg/L). It is concluded that no water quality impact was arising from the Project works.

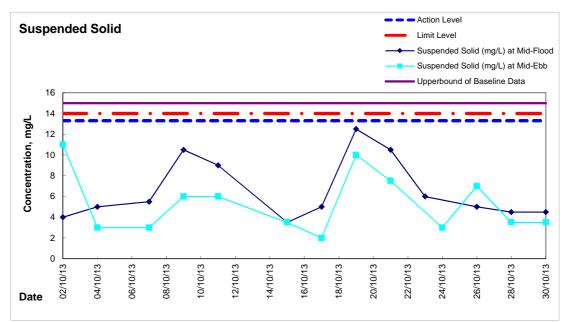
Graphic Presentation of Water Quality Result of WSD21 - Wan Chai with respect to Local Variation

Remarks: WSD21 is located at upstream during the ebb tides while at downstream during flood tides.

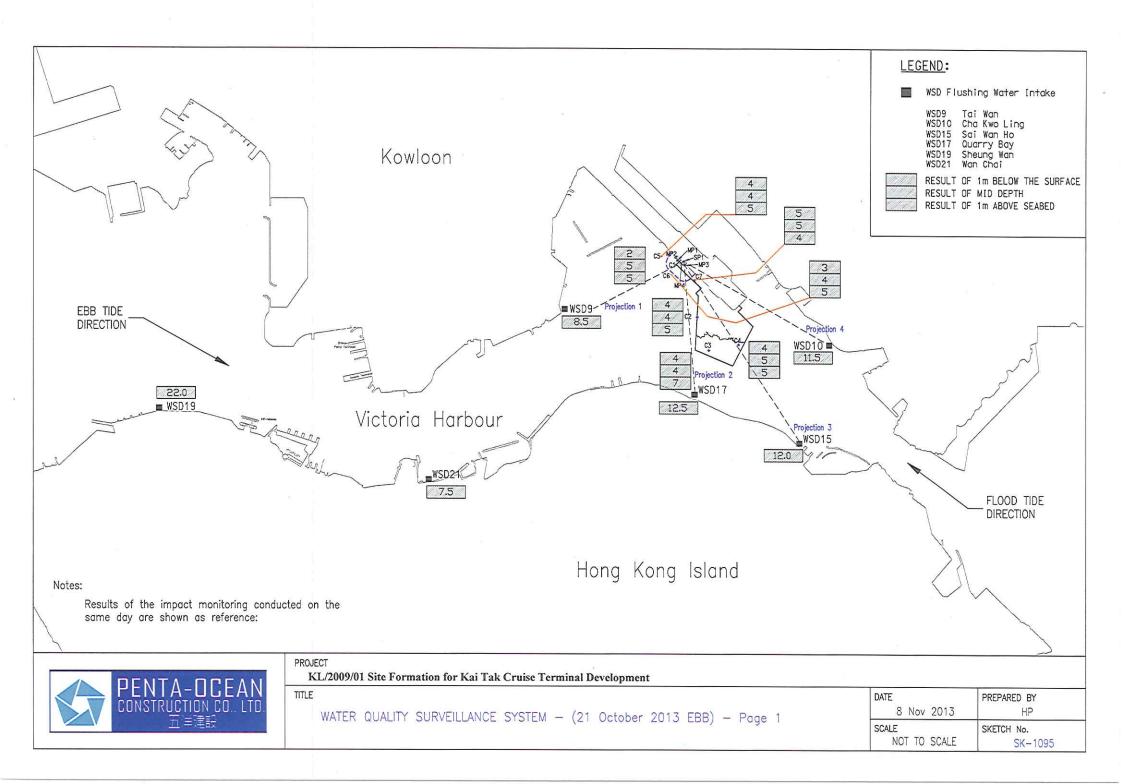
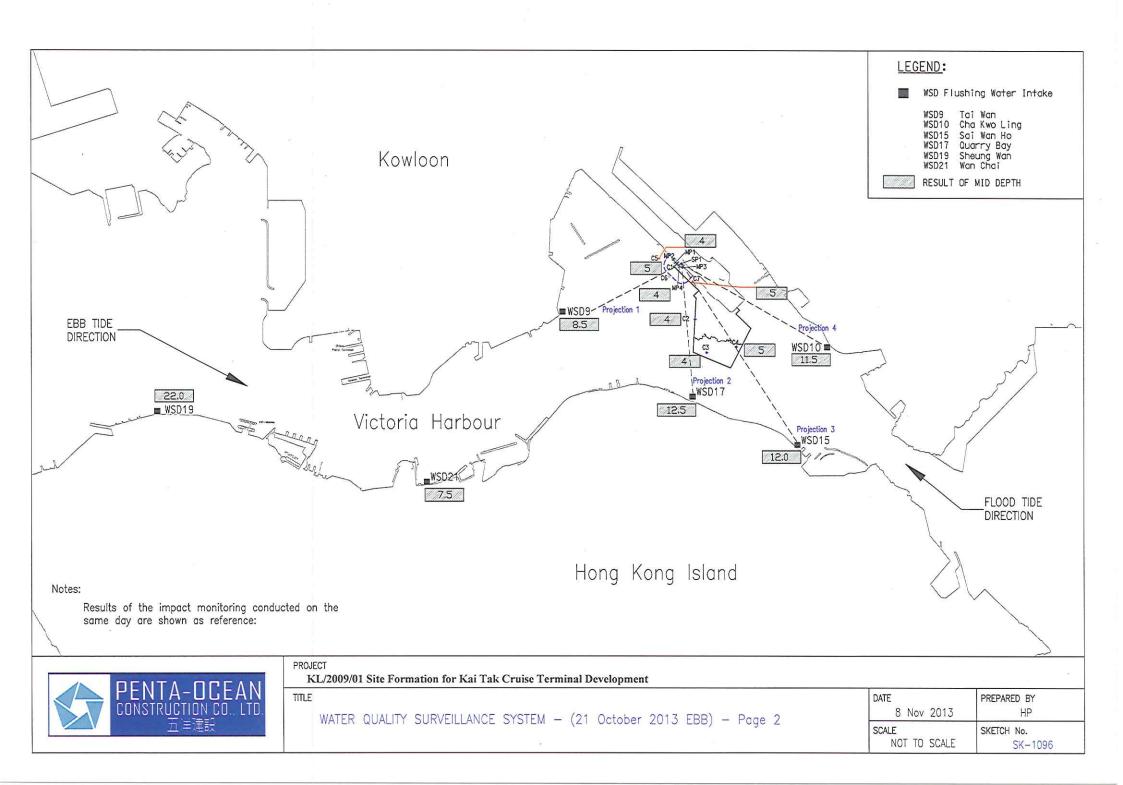
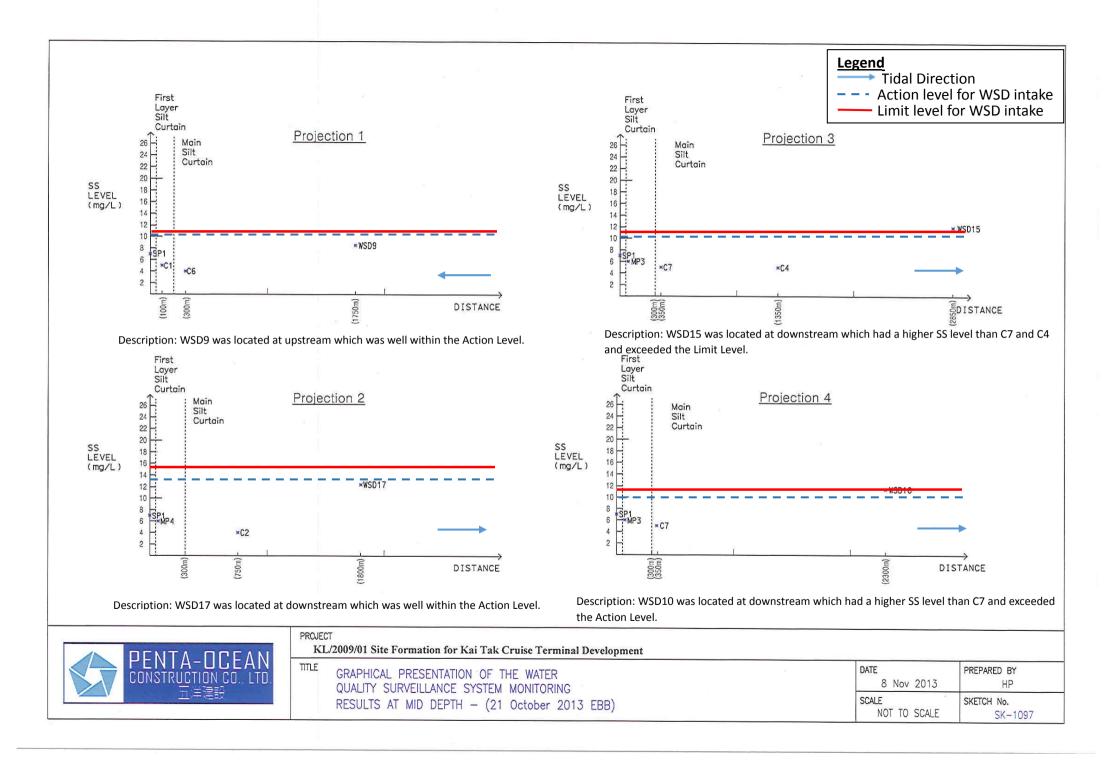
Water Quality Surveillance System Monitoring Results - 21 October 2013 (Ebb Tide)

Control	Trigger Level for Turbidity in	Trigger Level for SS in mg/L for Dry Season
Point 🔗	NTU for All Season	(October - March)
C1	12.3 for Flood Tide	
C2	12.3 for Flood Tide	14.0
C3	16.9	14.0
C4	10.5 for Ebb Tide

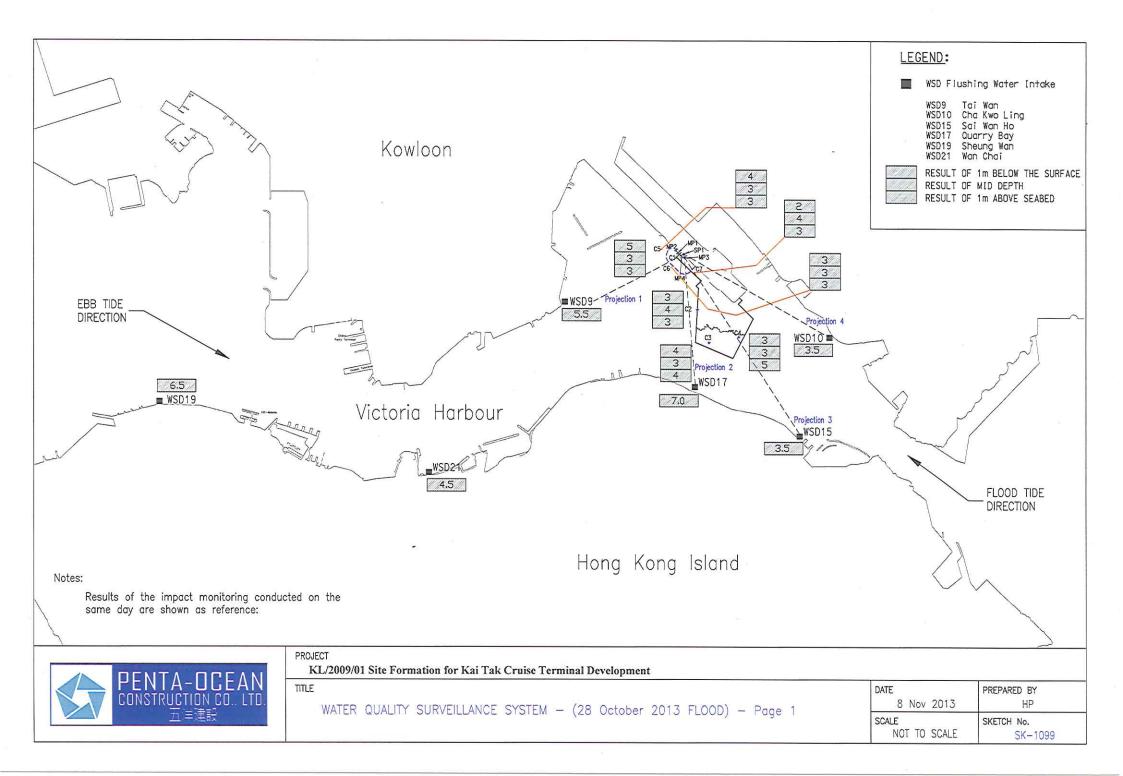
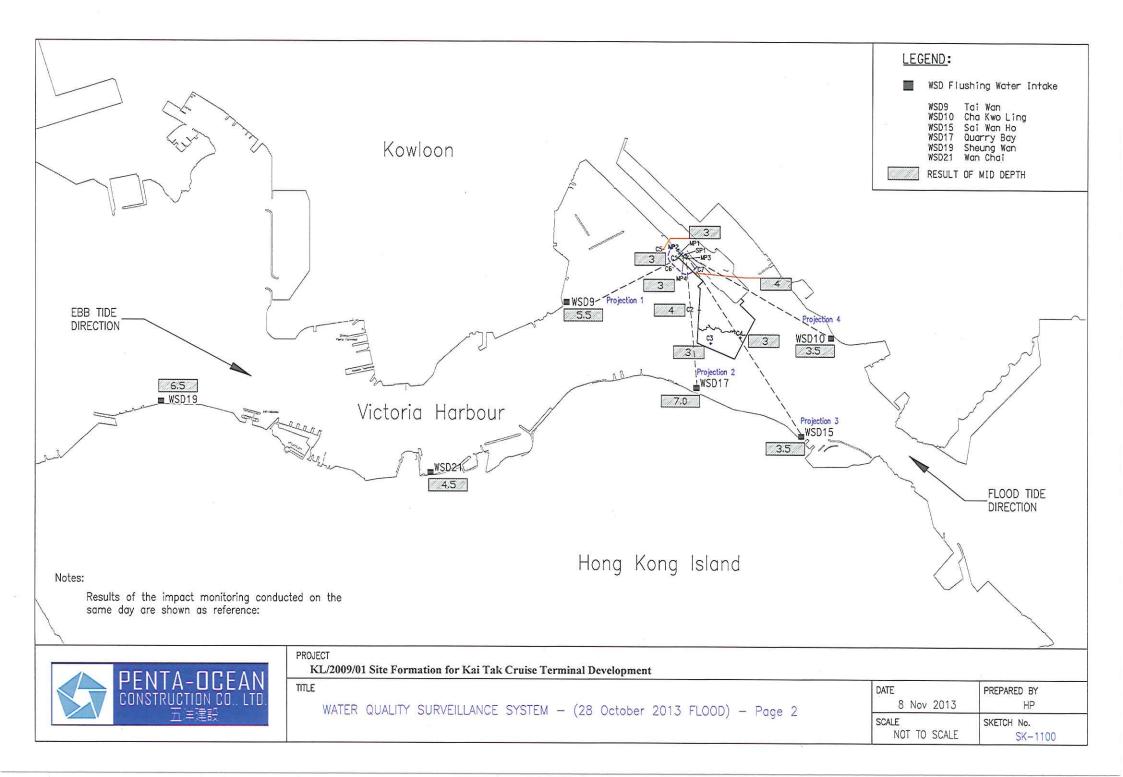
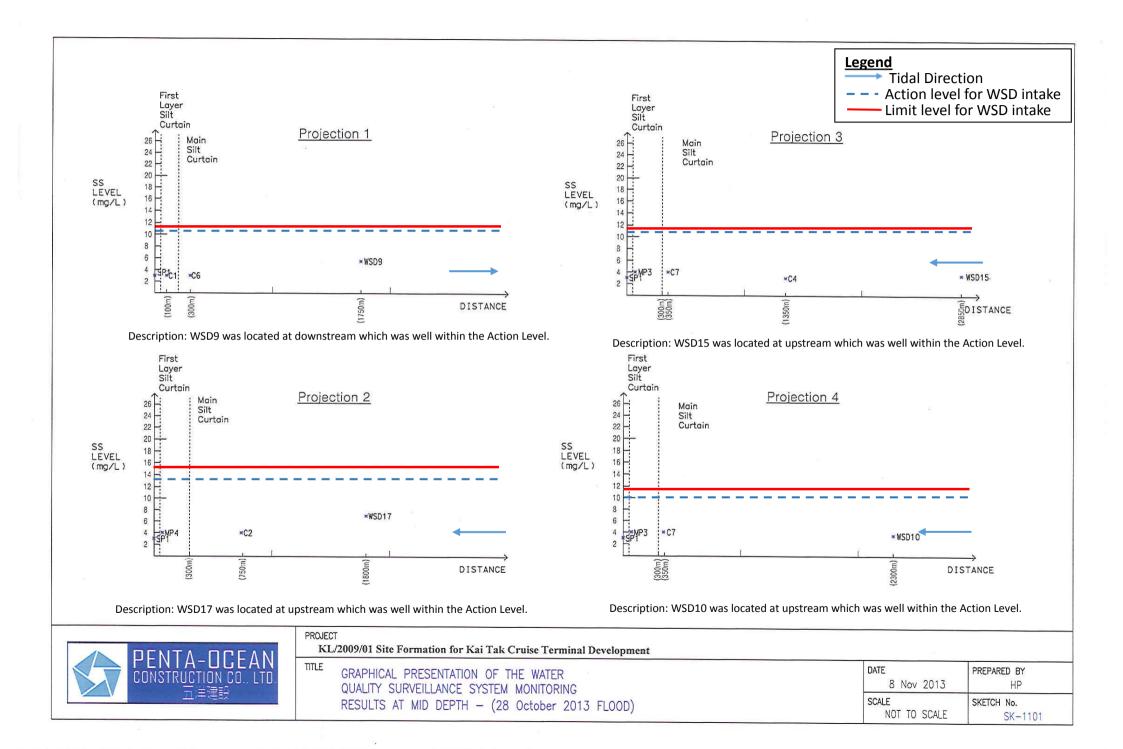
Water Quality Surveillance System Monitoring Results - 28 October 2013 (Flood T	ide)

Мо	onitoring Location	Turbidity in NTU	Compare to Trigger Level	Suspended Solids in mg/L	Compare to Trigger Level
	1m below the surface	3.39	N/A	2	N/A
SP1	mid depth	2.45	N/A	3	N/A
	1m above the seabed	2.57	N/A	3	N/A
	1m below the surface	2.90	N/A	3	N/A
MP1	mid depth	2.72	N/A	4	N/A
	1m above the seabed	2.43	N/A	4	N/A
	1m below the surface	2.64	N/A	4	N/A
MP2	mid depth	2.91	N/A	3	N/A
	1m above the seabed	2.81	N/A	4	N/A
	1m below the surface	3.06	N/A	3	N/A
MP3	mid depth	3.35	N/A	4	N/A
	1m above the seabed	3.29	N/A	4	N/A
	1m below the surface	2.25	N/A	5	N/A
MP4	mid depth	2.62	N/A	4	N/A
	1m above the seabed	3.10	N/A	4	N/A
	1m below the surface	1.85	Lower	5	Lower
C1	mid depth	3.57	Lower	3	Lower
	1m above the seabed	3.58	Lower	3	Lower
	1m below the surface	2.81	Lower	3	Lower
C2	mid depth	2.68	Lower	4	Lower
	1m above the seabed	1.92	Lower	3	Lower
	1m below the surface	3.20	Lower	4	Lower
C3	mid depth	2.62	Lower	3	Lower
	1m above the seabed	3.05	Lower	4	Lower
