CONTRACT NO: KL/2009/01

**SITE FORMATION FOR
KAI TAK CRUISE TERMINAL DEVELOPMENT**

**ENVIRONMENTAL MONITORING & AUDIT
MONTHLY REPORT**

- DECEMBER 2013 -

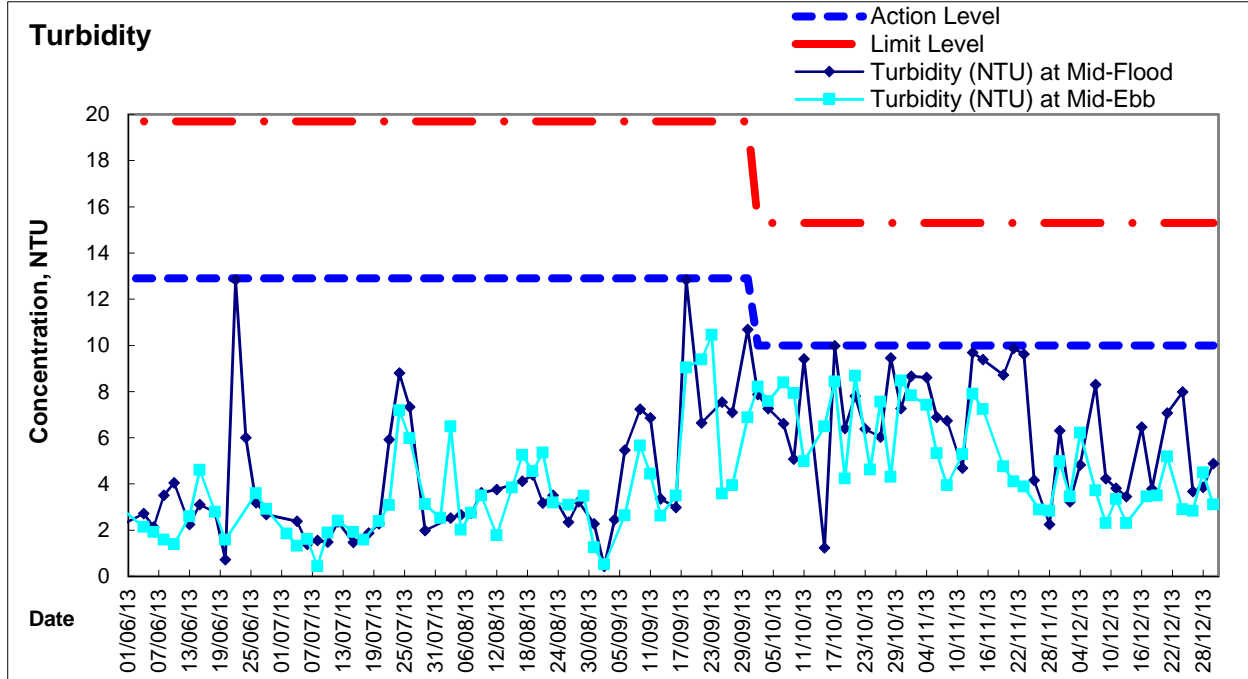
Graphic Presentation of Water Quality Result of WSD17 - Quarry Bay

- Two sets of Suspended Solid Action and Limit levels for the dry season (October to March) and wet season (April to September).
- New sets of Turbidity and SS Action Level and Limit Level for dry and wet season were approved by EPD on 19 Oct 2011

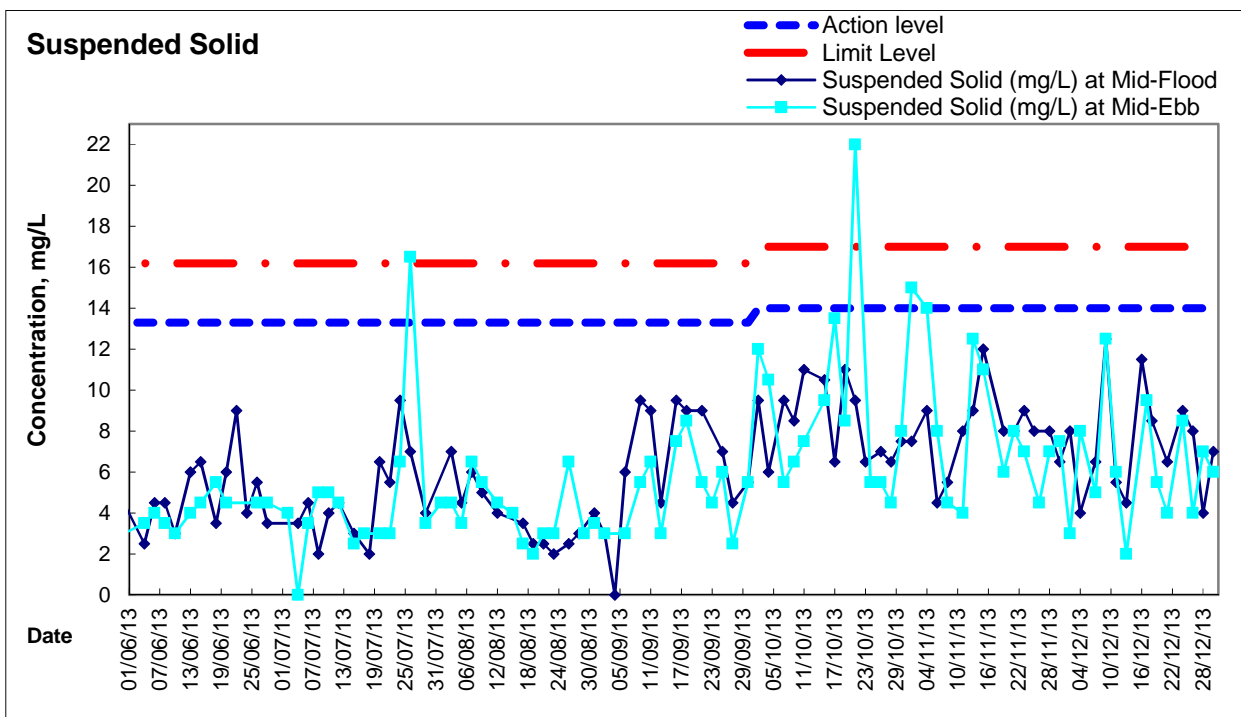
Graphic Presentation of Water Quality Result of WSD19 - Sheung Wan

- Two sets of Suspended Solid Action and Limit levels for the dry season (October to March) and wet season (April to September).
- New sets of Turbidity and SS Action Level and Limit Level for dry and wet season were approved by EPD on 19 Oct 2011

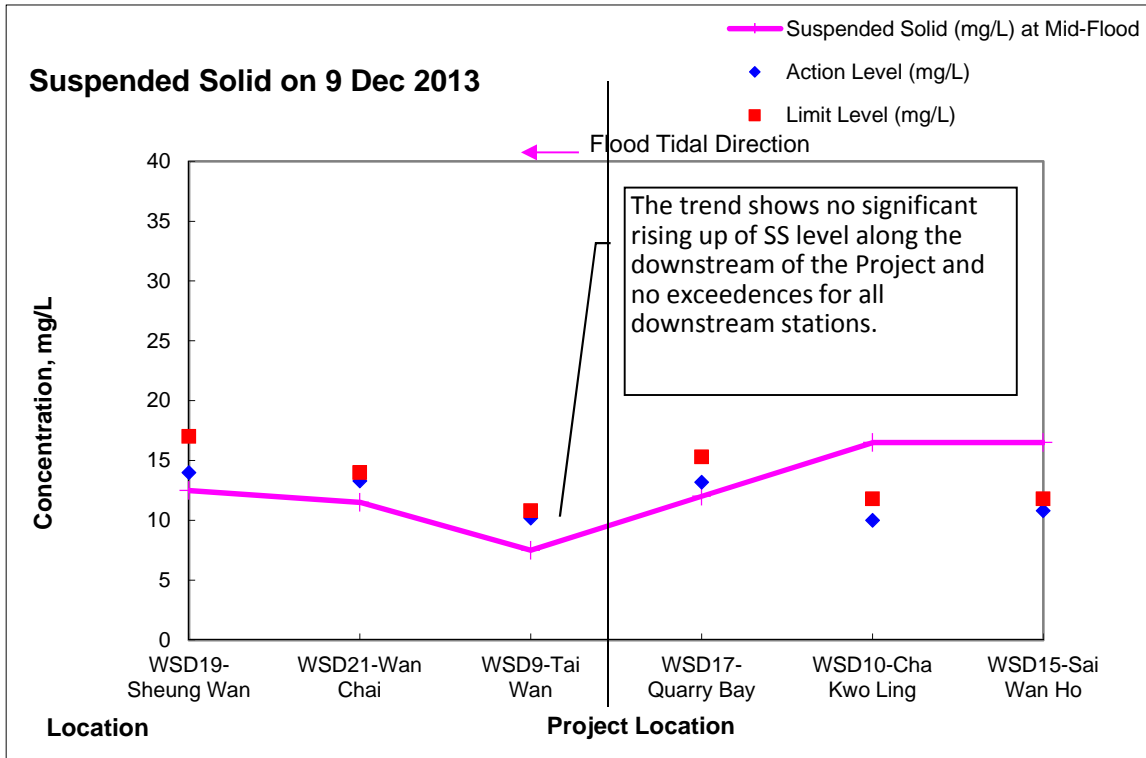
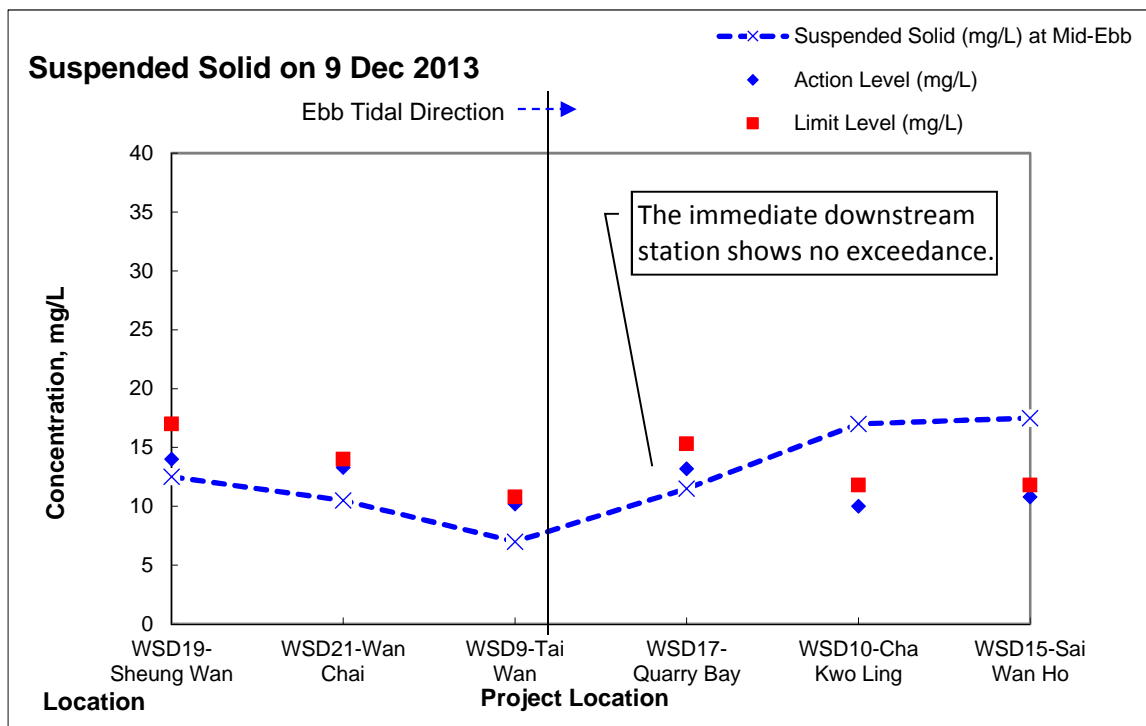
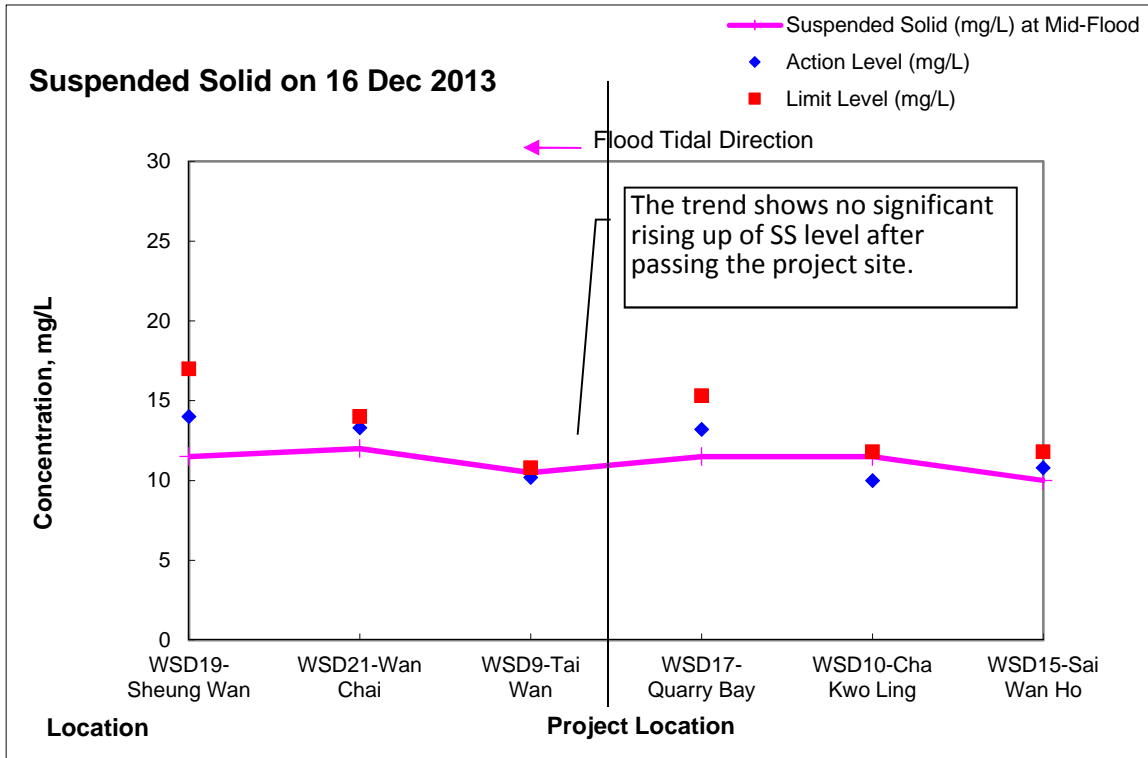
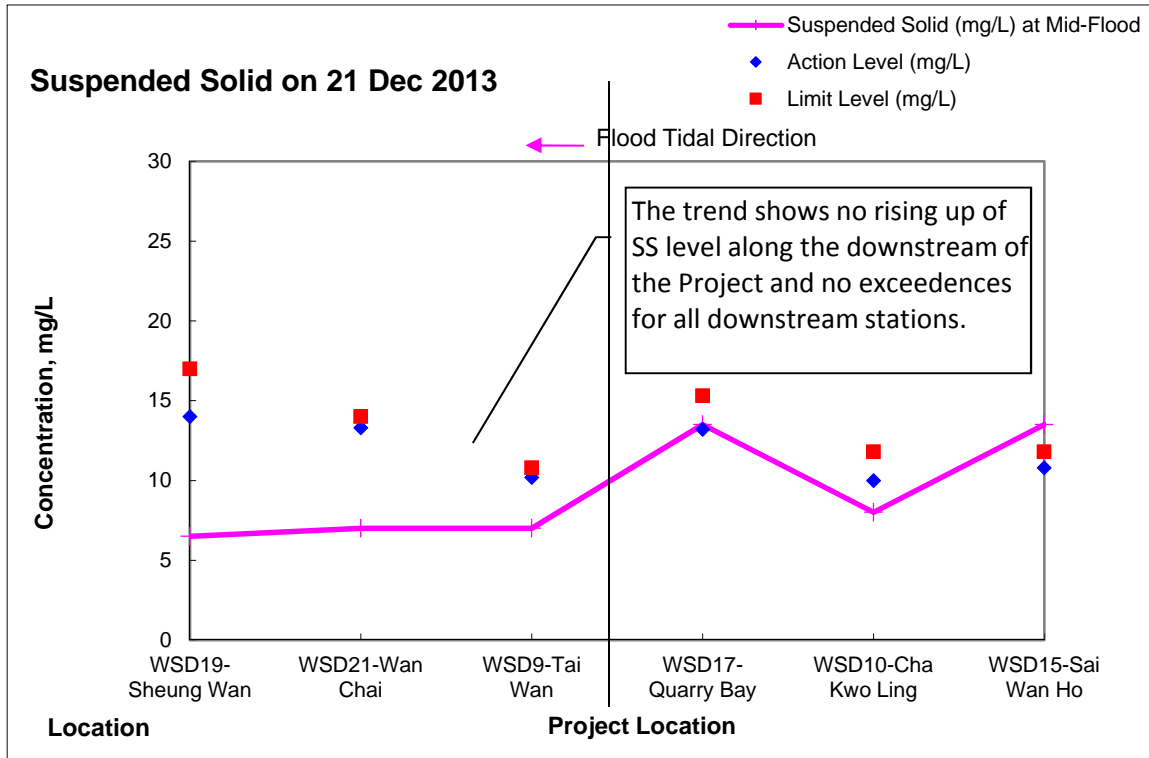
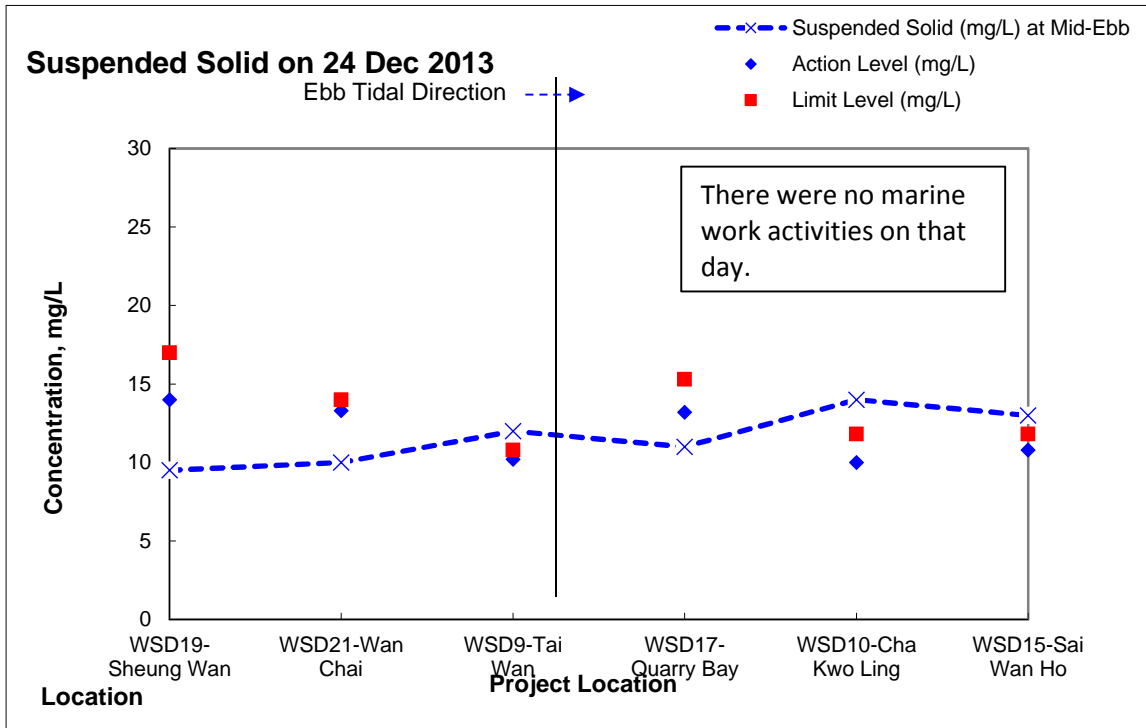
Appendix 5.4

Graphic Presentation of SS Results against to Tidal Movement along Victoria Harbour

- 6.3.1 In order to conclude the cause of an adverse water quality impact, the trend across the 6 monitoring stations is reviewed. Whether the adverse impact is due to project work will be evaluated from the trend of SS level in downstream across the Victoria Harbour after passing the project location. By observing this trend of SS, contribution of the adverse water quality impact from the dredging activities under the project can be evaluated by checking if there is a significant rising up trend in the SS level in the WSD intakes at project downstream.

- 6.3.2 Moreover, a comparison of the monitoring station at project downstream stations with the upstream monitoring stations can also indicate whether the extent of exceedance in SS content recorded at the WSD intakes downstream to the project is likely to be caused by upstream source or not. If the SS values of the upstream and downstream show similar levels, the impact at the project downstream stations shall probably be due to the project upstream source and the contribution from project work can be eliminated. A review on the tidal movement across the Victoria Harbour is plotted against the SS results and graphical presentation is presented in [Appendix 5.4](#).

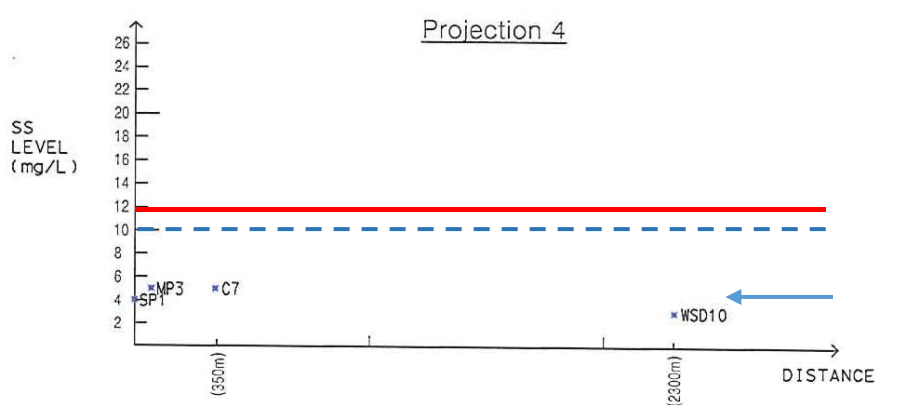
Description: WSD10 was located at upstream which was well within the Action Level.

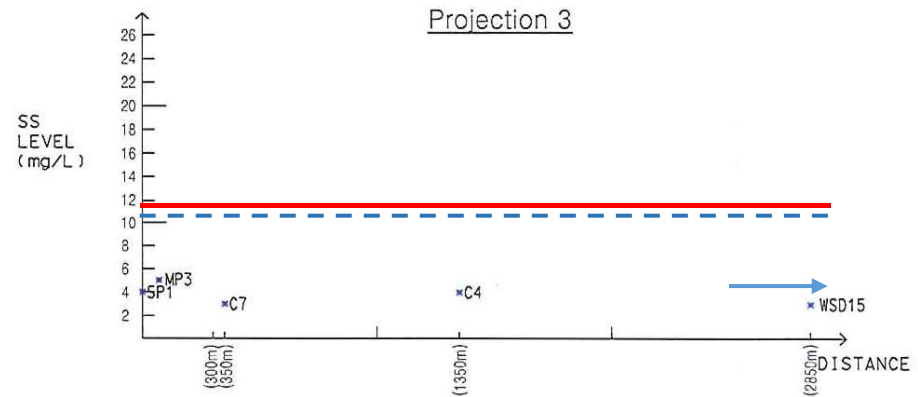
Description: WSD15 was located at downstream which was well within the Action Level.

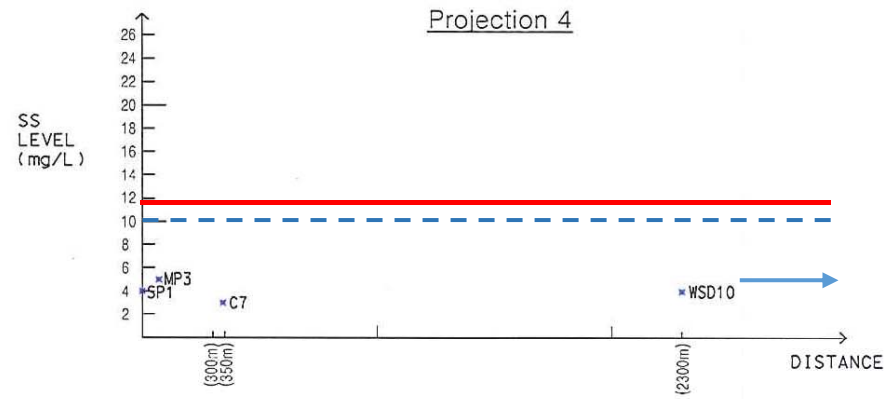
Description: WSD10 was located at downstream which was well within the Action Level.
