Contract No. CV/2013/02

**CEDD Maintenance Contract for Seawalls
and Navigation Channels (2013-2016)
Dredging at Cruise Terminal Stage 2**

Monthly EM&A Report

**August 2014
(Version 1.0)**

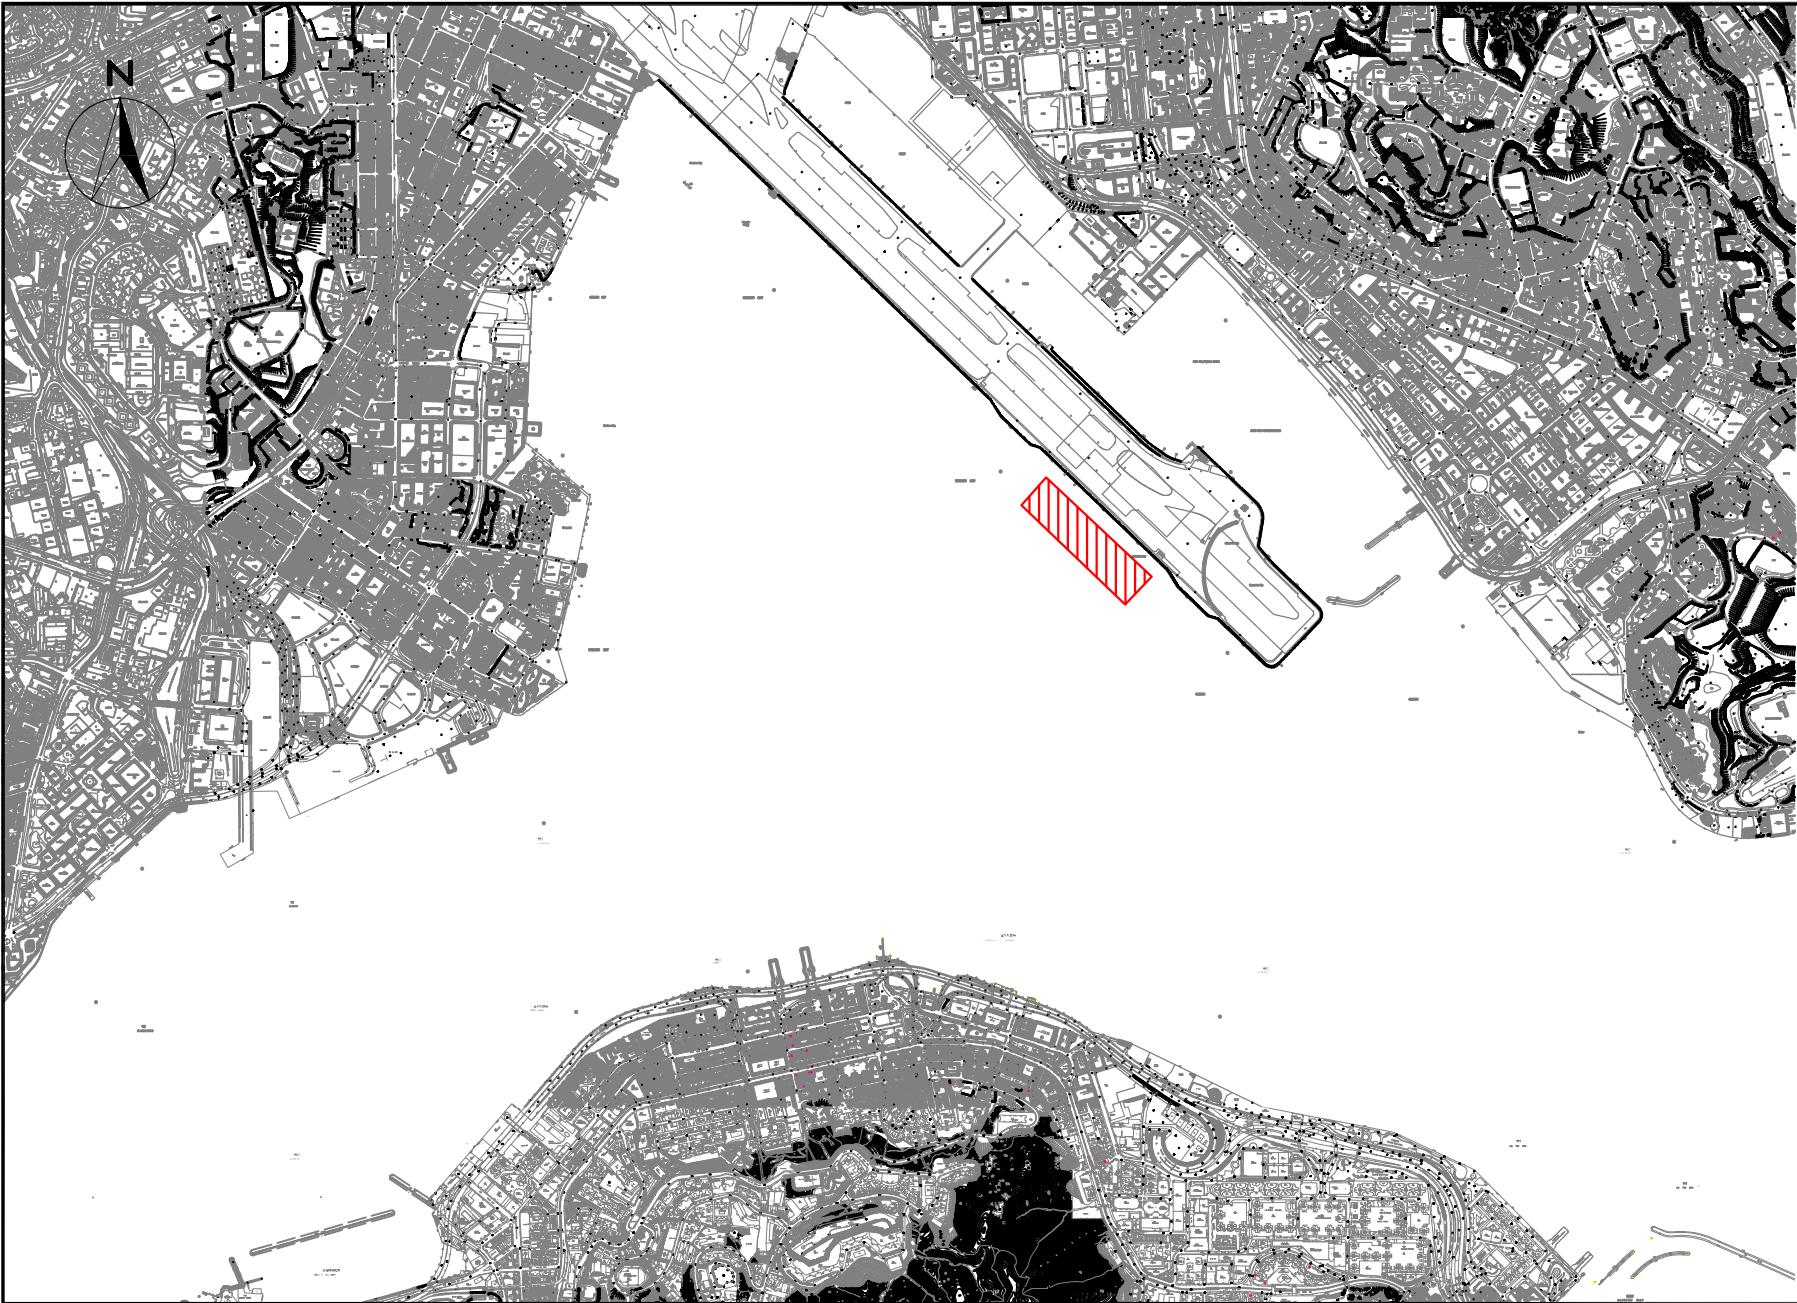
SCALE	1:25000@A4	DATE	MAR 14	
CHECK	IT	DRAWN	JW	
JOB No.	MA14015	FIGURE NO.	1	REV -

- 2.3 Development of the cruise terminal at Kai Tak would require dredging at the existing seawall at the southern tip of the former Kai Tak Airport runway for construction of a quay deck structure for two berths, and dredging the seabed fronting the new quay to provide necessary manoeuvring basin. The general layout of the proposed cruise terminal construction is shown in **Figure 1**.

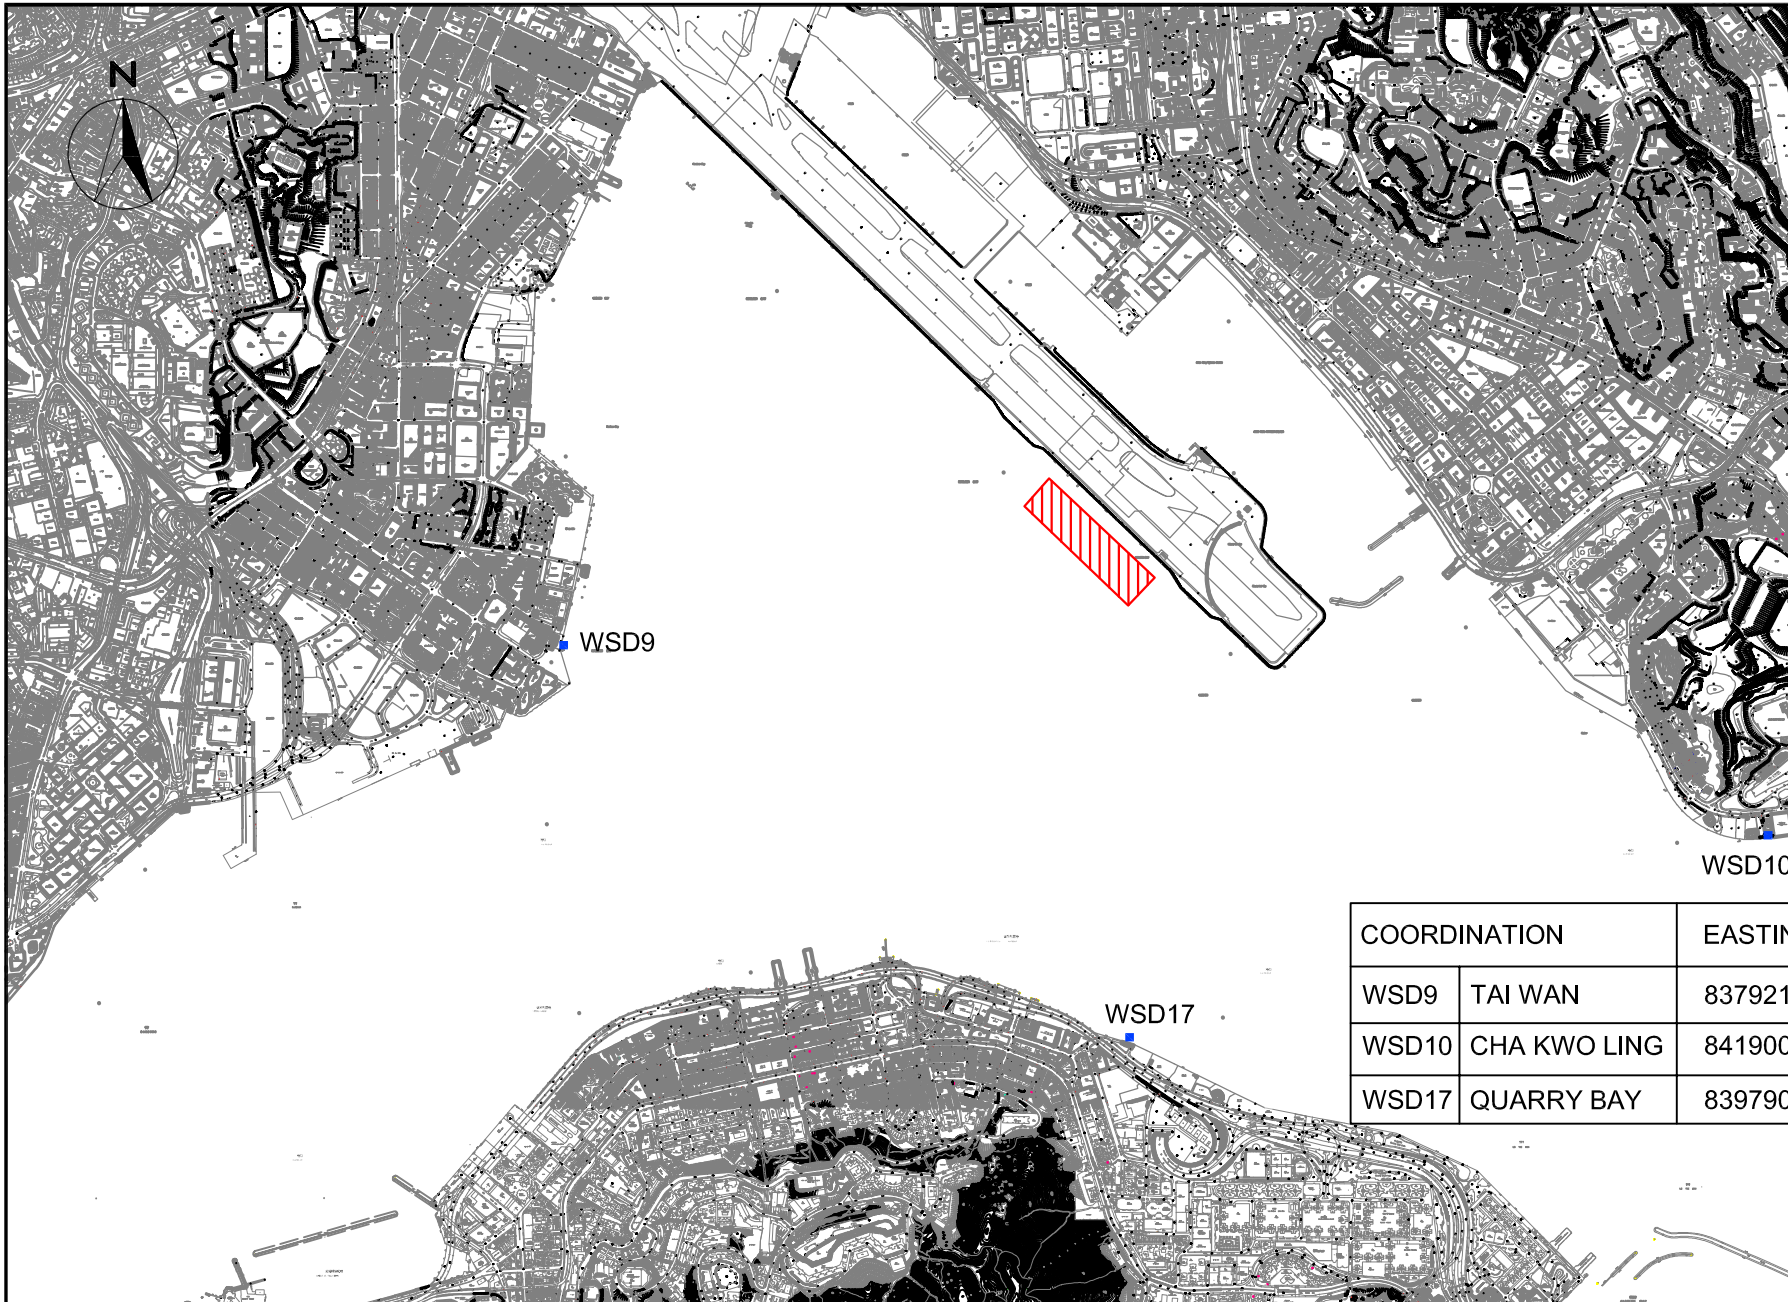
WATER QUALITY MONITORING STATION

COORDINATION		EASTING (m)	NORTHING (m)
WSD9	TAI WAN	837921.0	818330.0
WSD10	CHA KWO LING	841900.9	817700.1
WSD17	QUARRY BAY	839790.3	817032.2

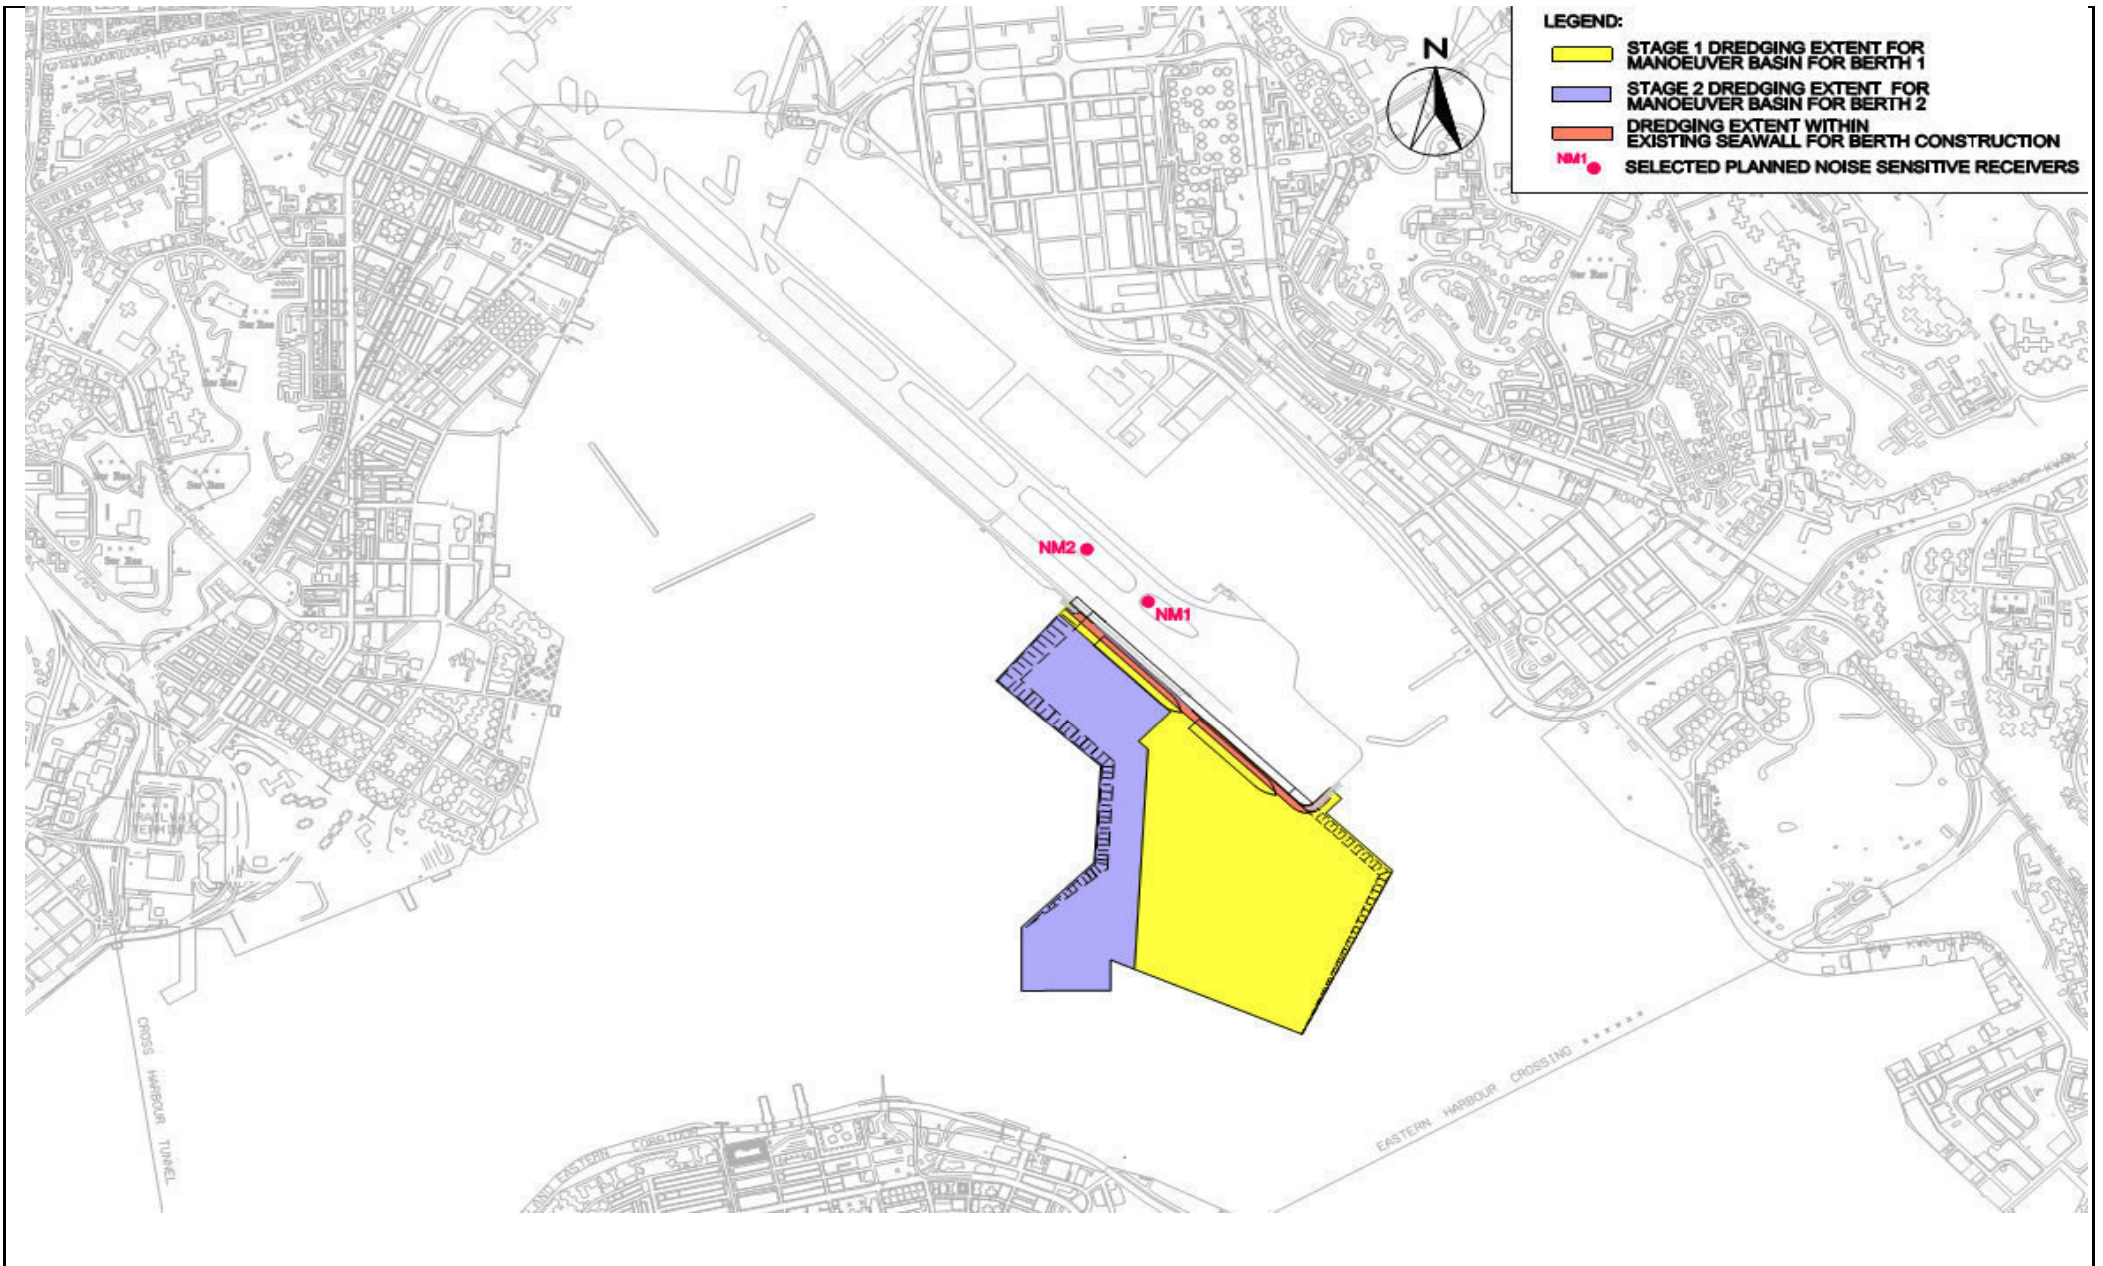
Title	Contract No. CV/2013/02		Scale	Propose No.	MA14015	CINOTECH
	CEDD Maintenance Contract for Seawalls and Navigation Channels (2013-2016)					
	Dredging at Cruise Terminal Stage 2		Date	Figure	3	
	Planned Noise Monitoring Stations during Construction Phase		Apr-14

- 3.1 In accordance with the EIA Report and the EM&A Manual, it is anticipated that construction activities, if unmitigated, would not cause any adverse noise impact to the nearest NSRs in the vicinity of the work site. The predicted noise levels at the NSRs would comply with construction noise criteria.
- 3.2 These nearest NSRs are designated for construction noise monitoring as listed in Table 3.1 and **Figure 3**.

Monitoring Stations	Description
NM1	Planned Residential Development (R3 site)
NM2	Planned Residential Development (R3 site)

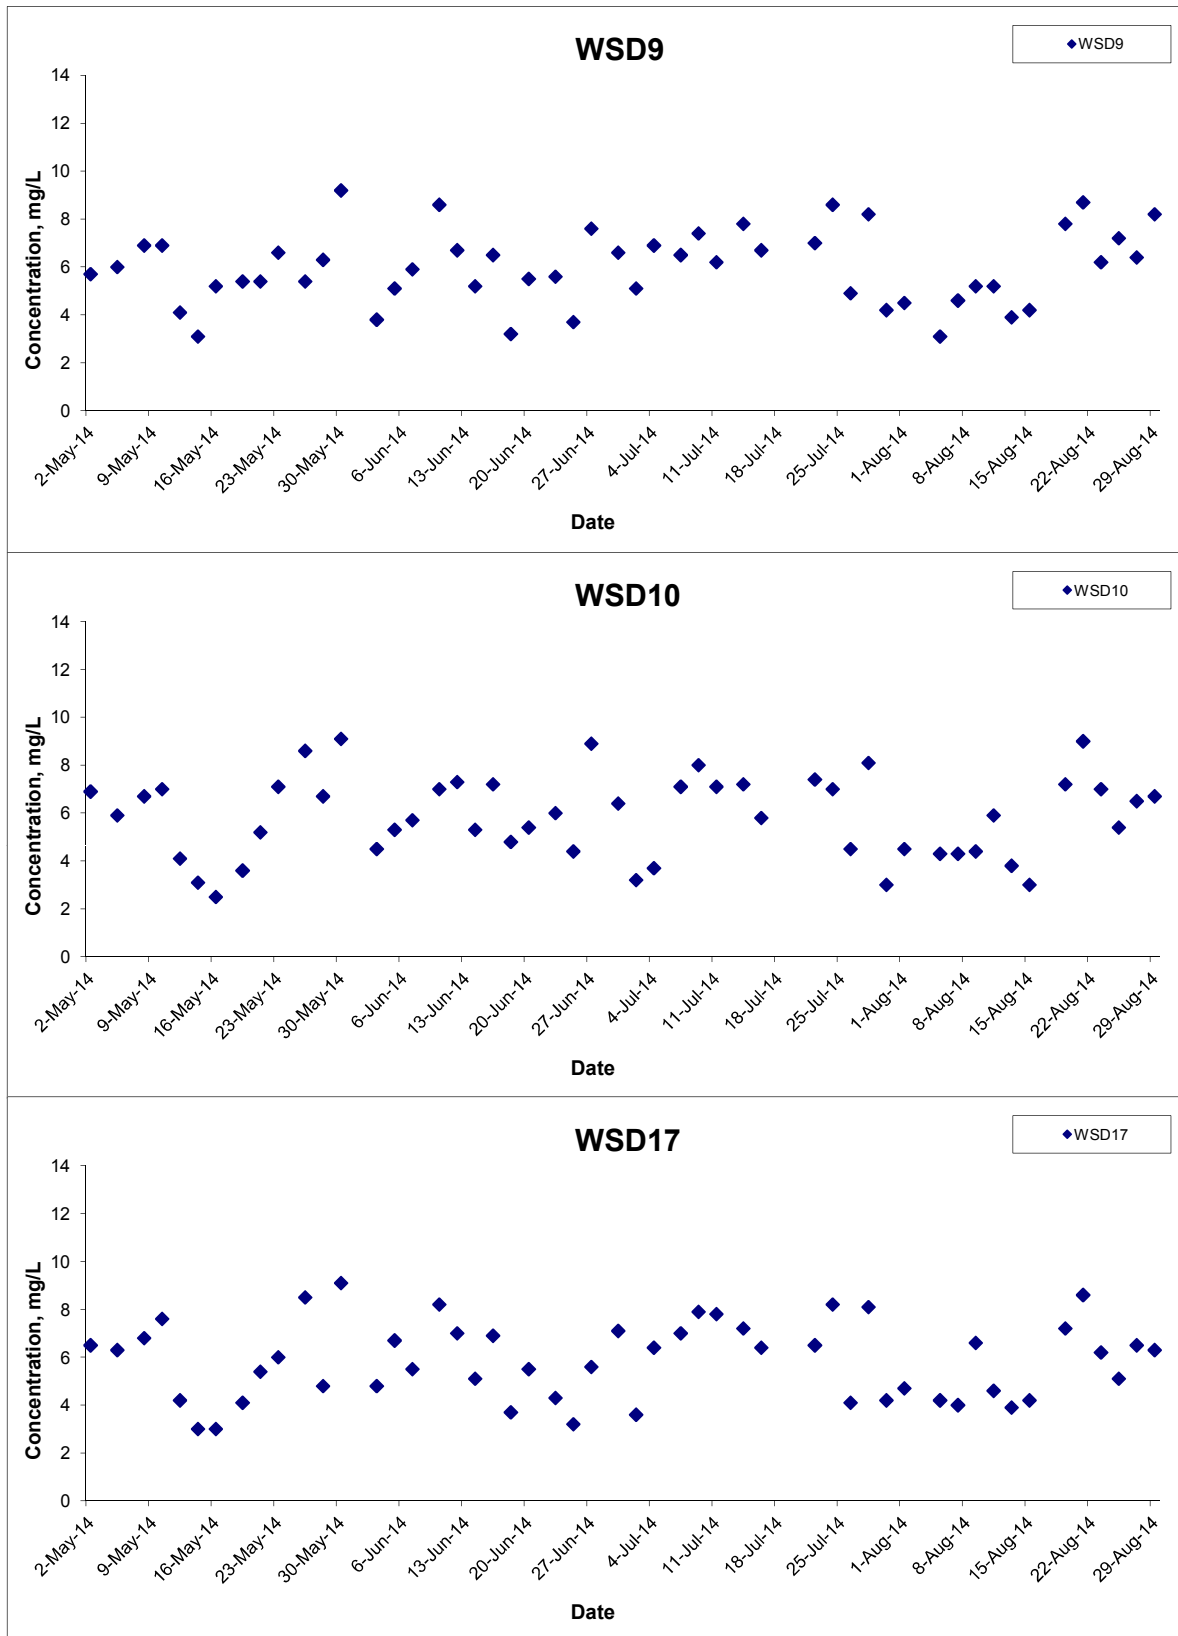
Dissolved Oxygen at Mid-Ebb Tide

Title Contract No. CV/2013/02 - CEDD Maintenance Contract for Seawalls and Navigation Channels (2013-2016) - Dredging at Cruise Terminal Stage 2
Graphical Presentation of Water Quality Monitoring Results

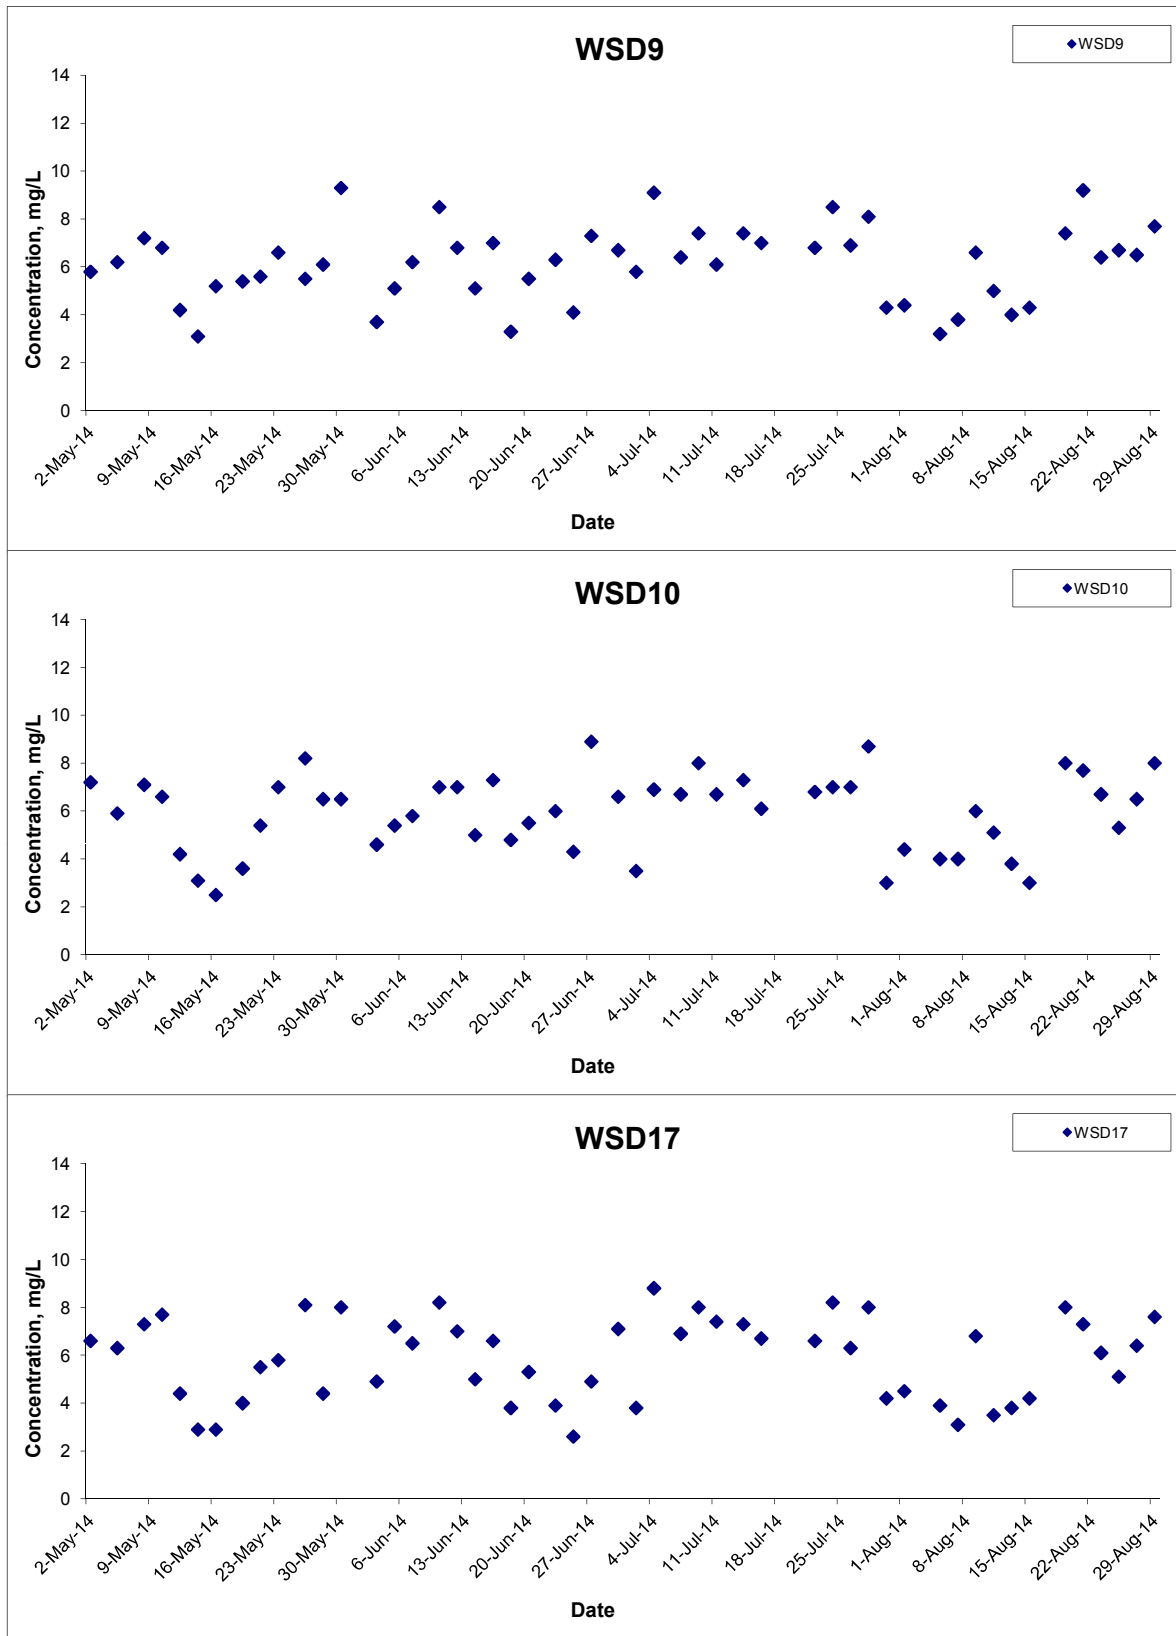
Dissolved Oxygen at Mid-Flood Tide

Graphical Presentation of Water Quality Monitoring Results

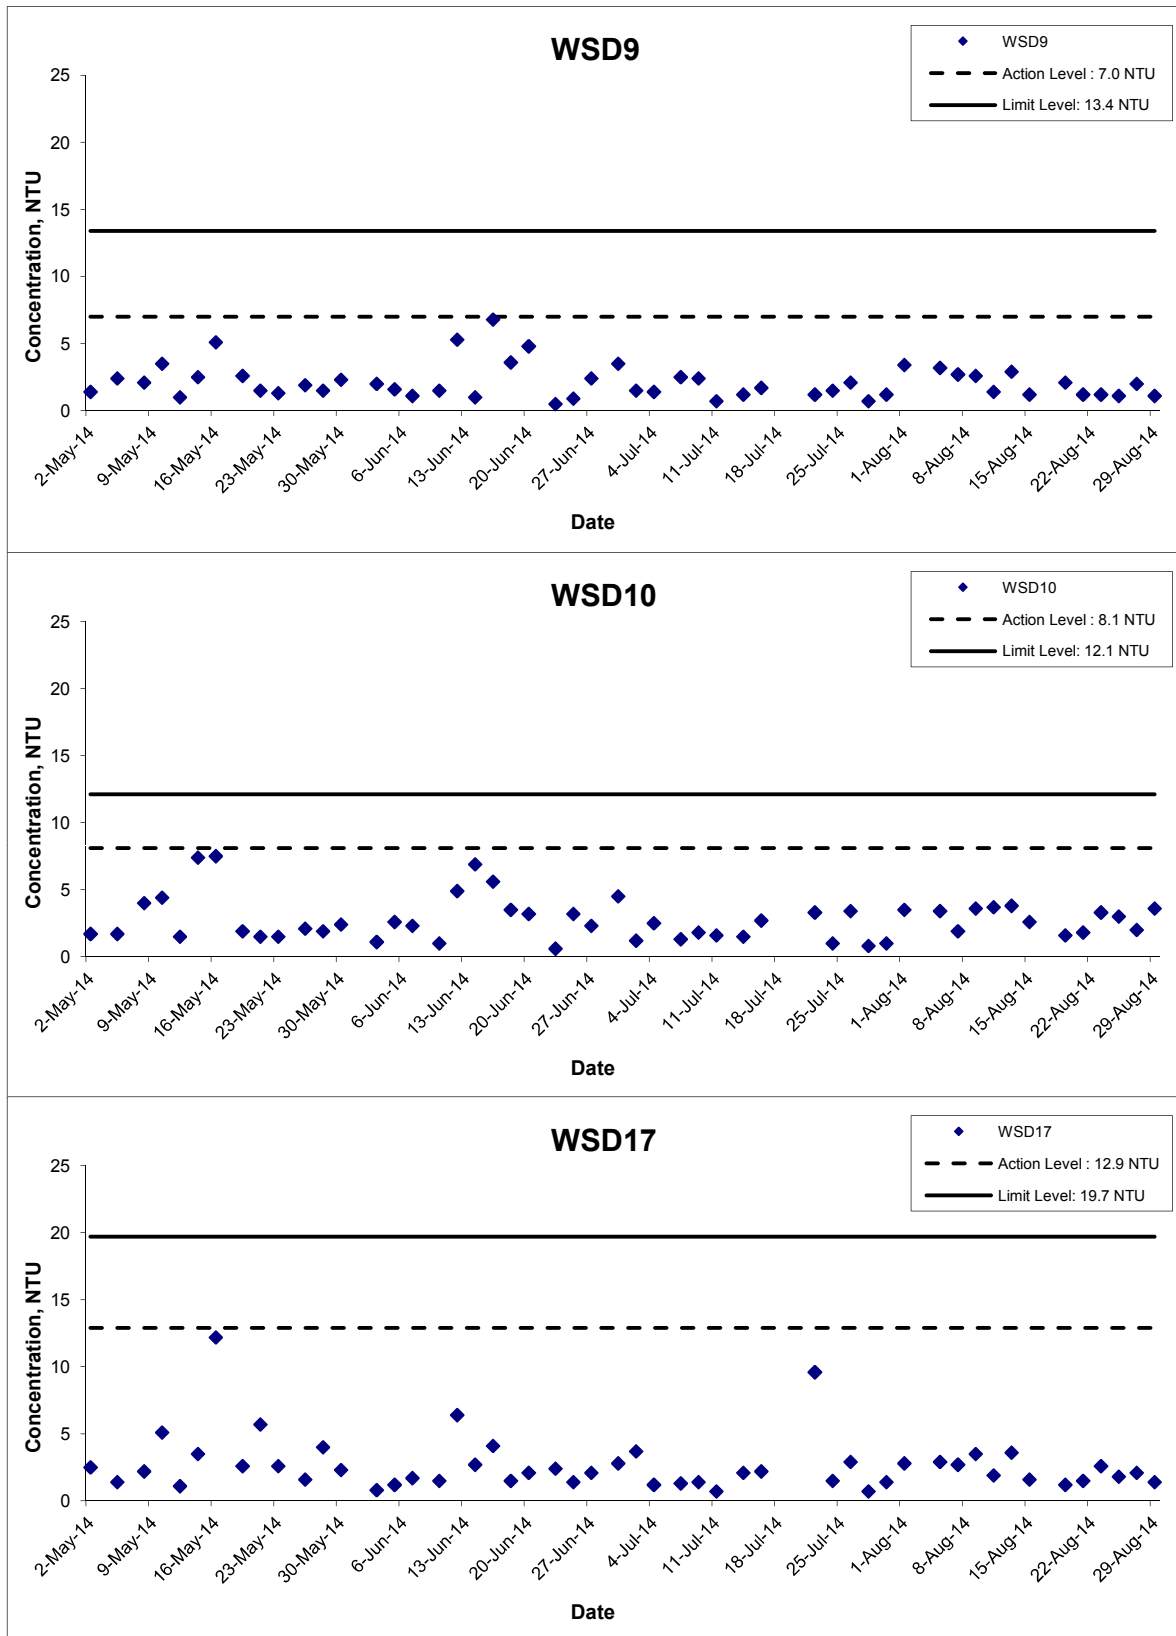
Turbidity at Mid-Ebb Tide

Graphical Presentation of Water Quality Monitoring Results

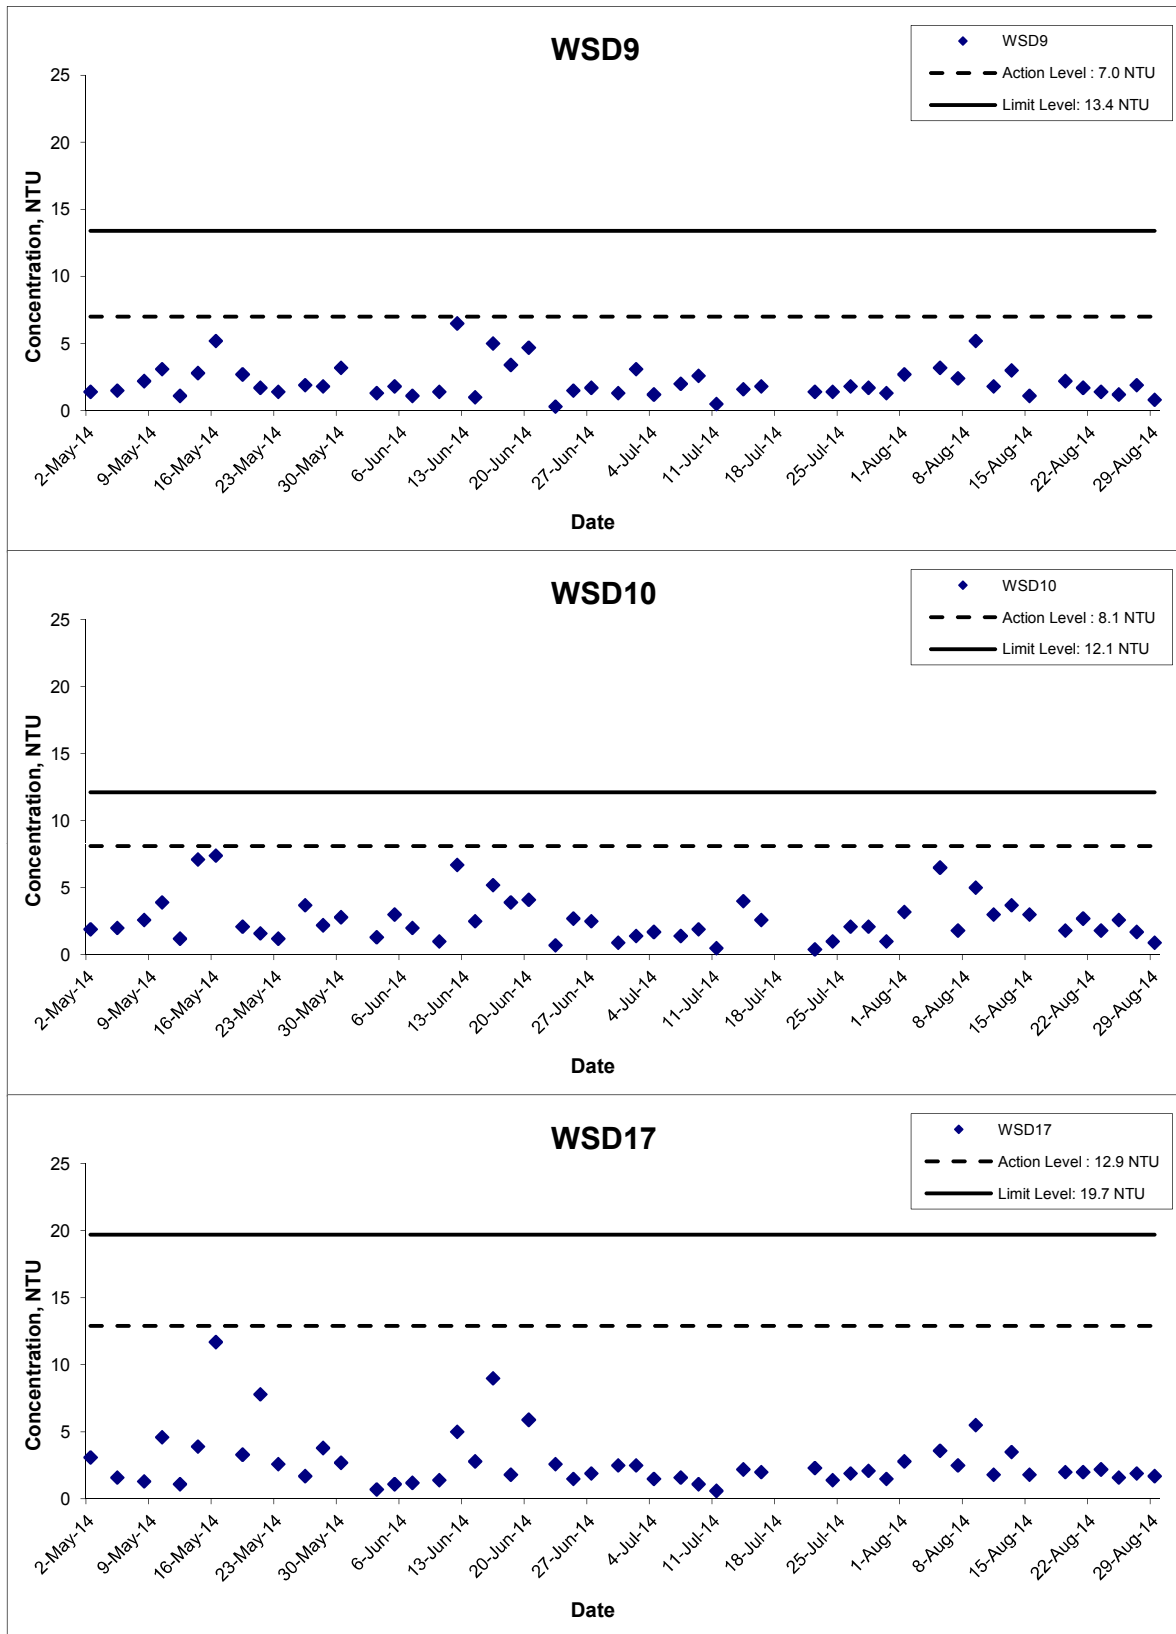
Turbidity at Mid-Flood Tide

Title Contract No. CV/2013/02 - CEDD Maintenance Contract for Seawalls and Navigation Channels (2013-2016) - Dredging at Cruise Terminal Stage 2
Graphical Presentation of Water Quality Monitoring Results

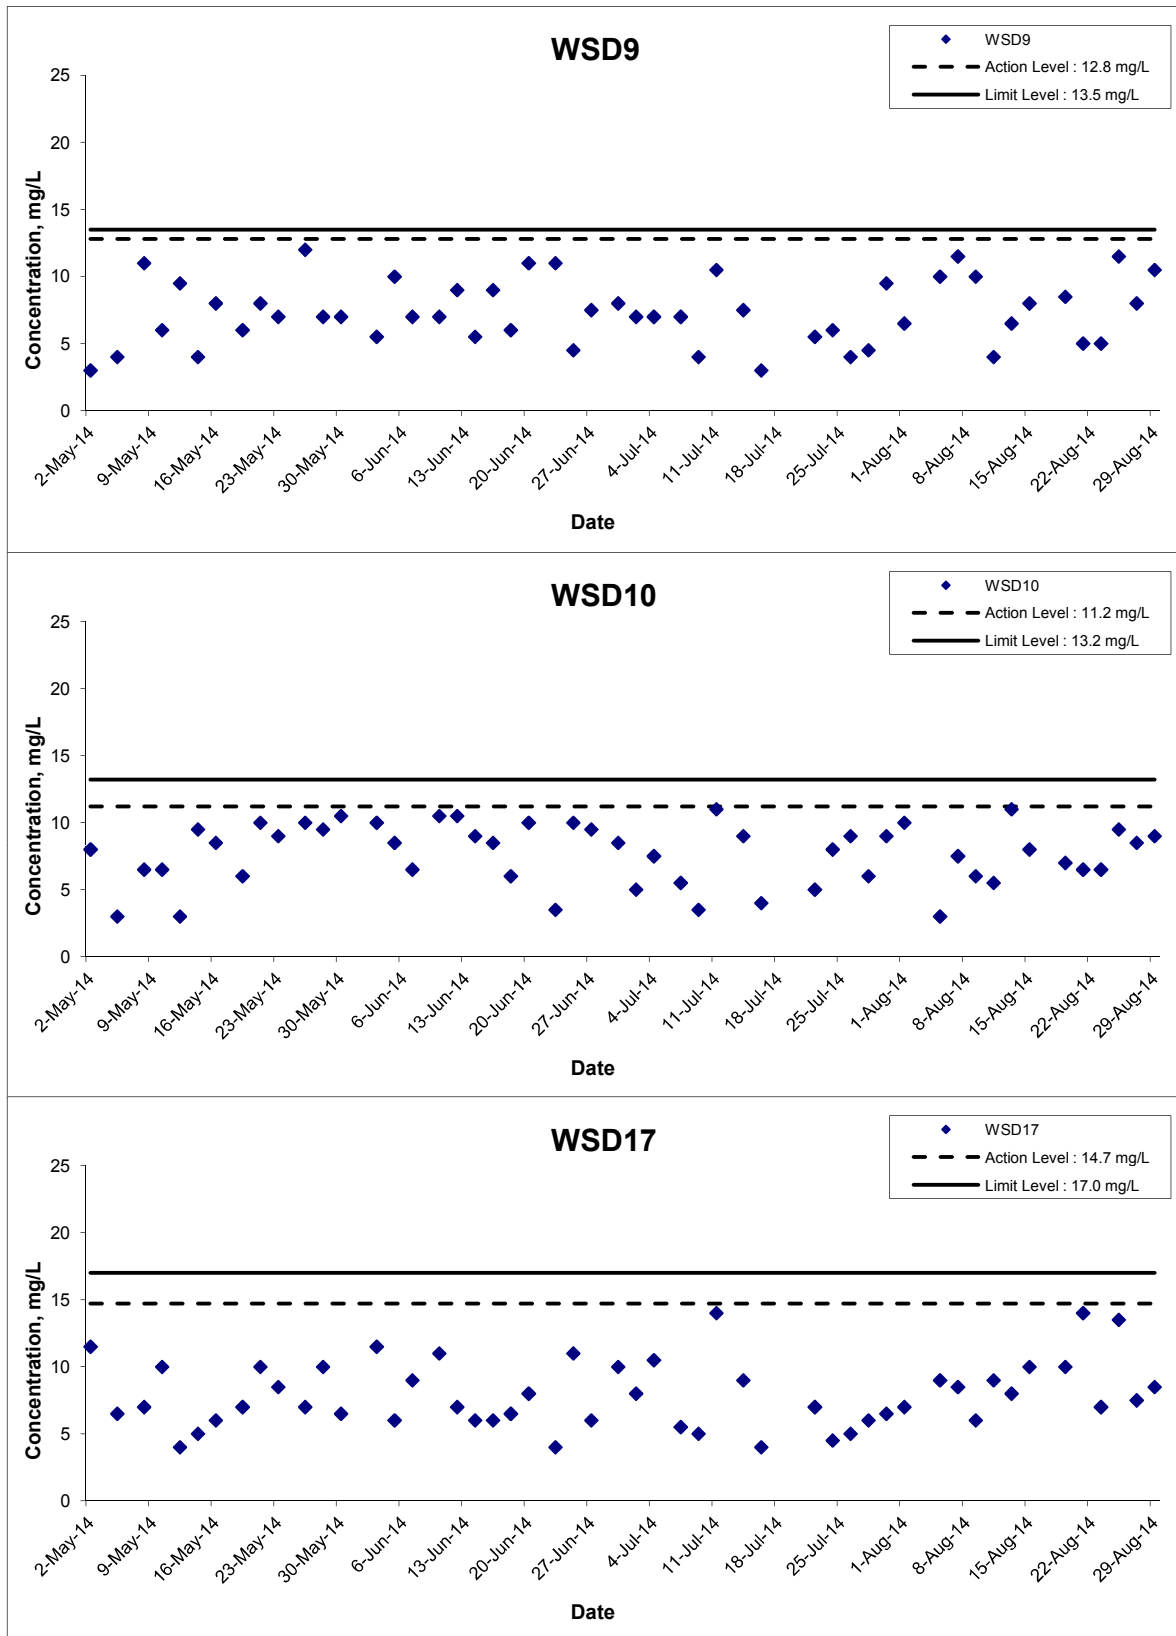
Suspended Solids at Mid-Ebb Tide

Graphical Presentation of Water Quality Monitoring Results

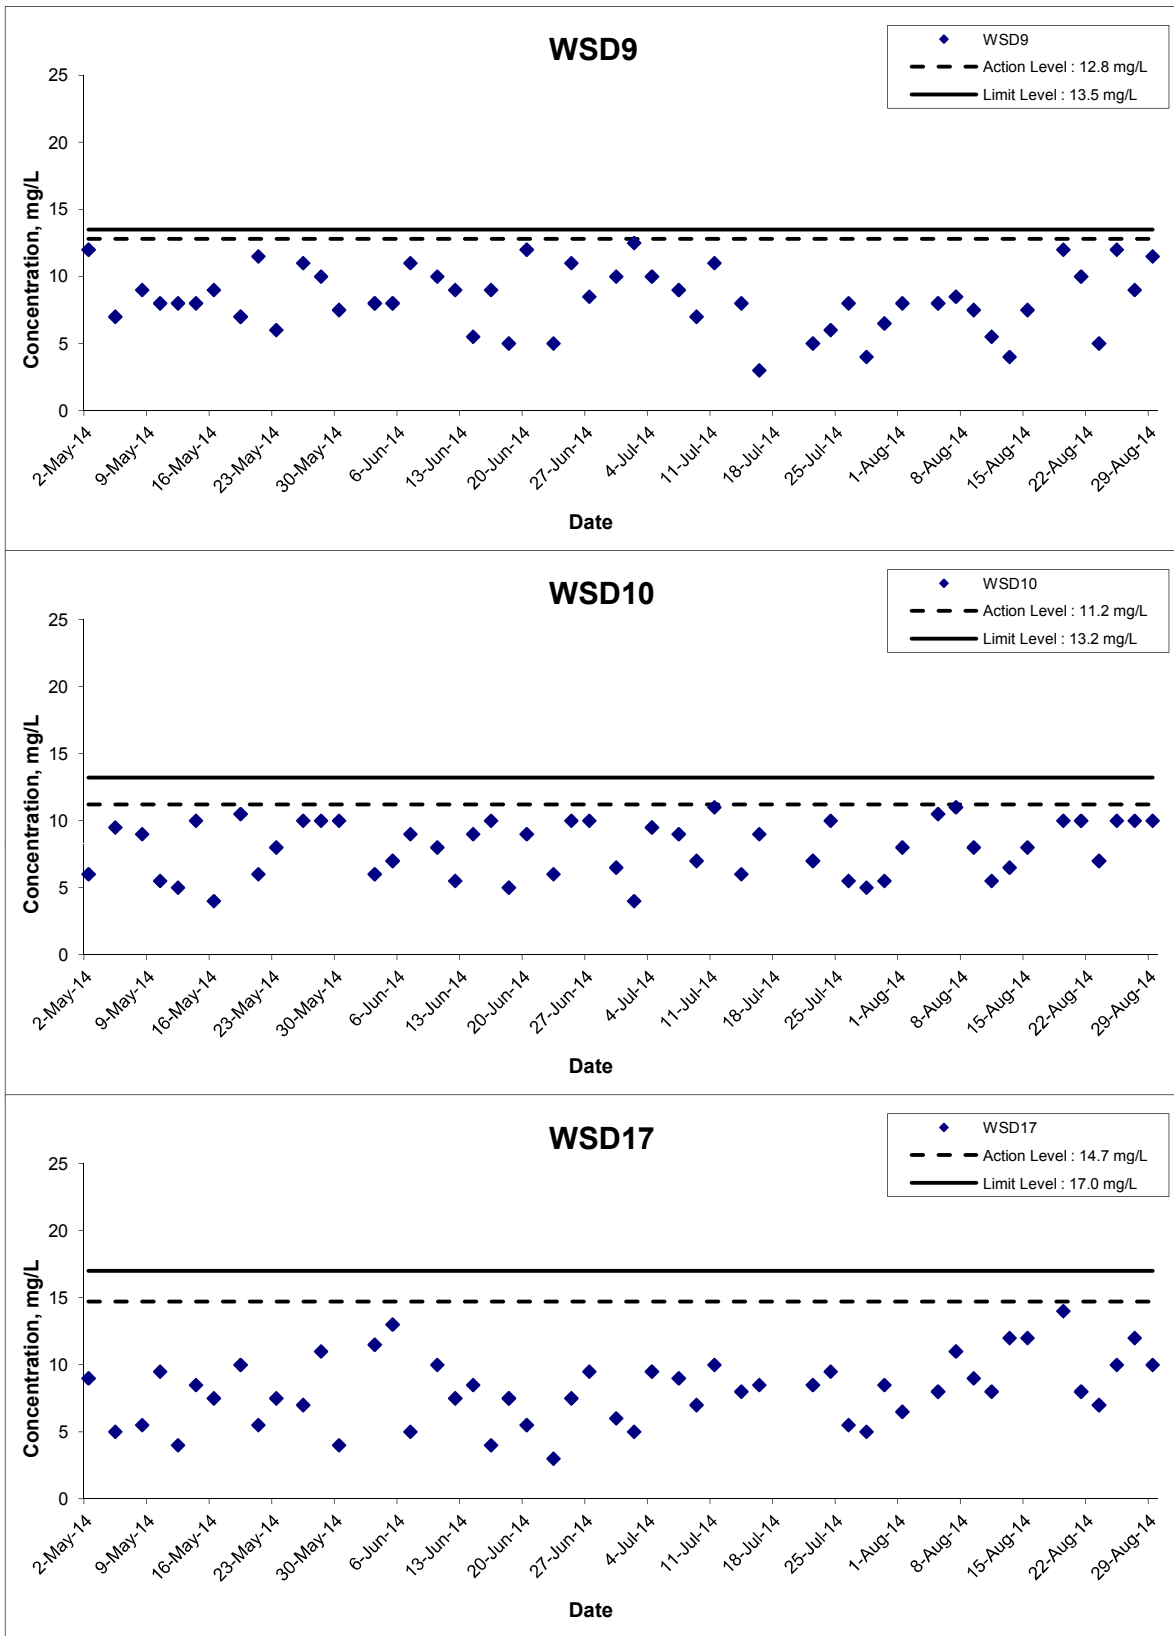
Suspended Solids at Mid-Flood Tide

Graphical Presentation of Water Quality Monitoring Results
