Contract No. KL/2013/01

**Site Formation for Kai Tak Cruise Terminal
Development – Remaining Works**

**Monthly EM&A Report
April 2015
(Version 1.0)**

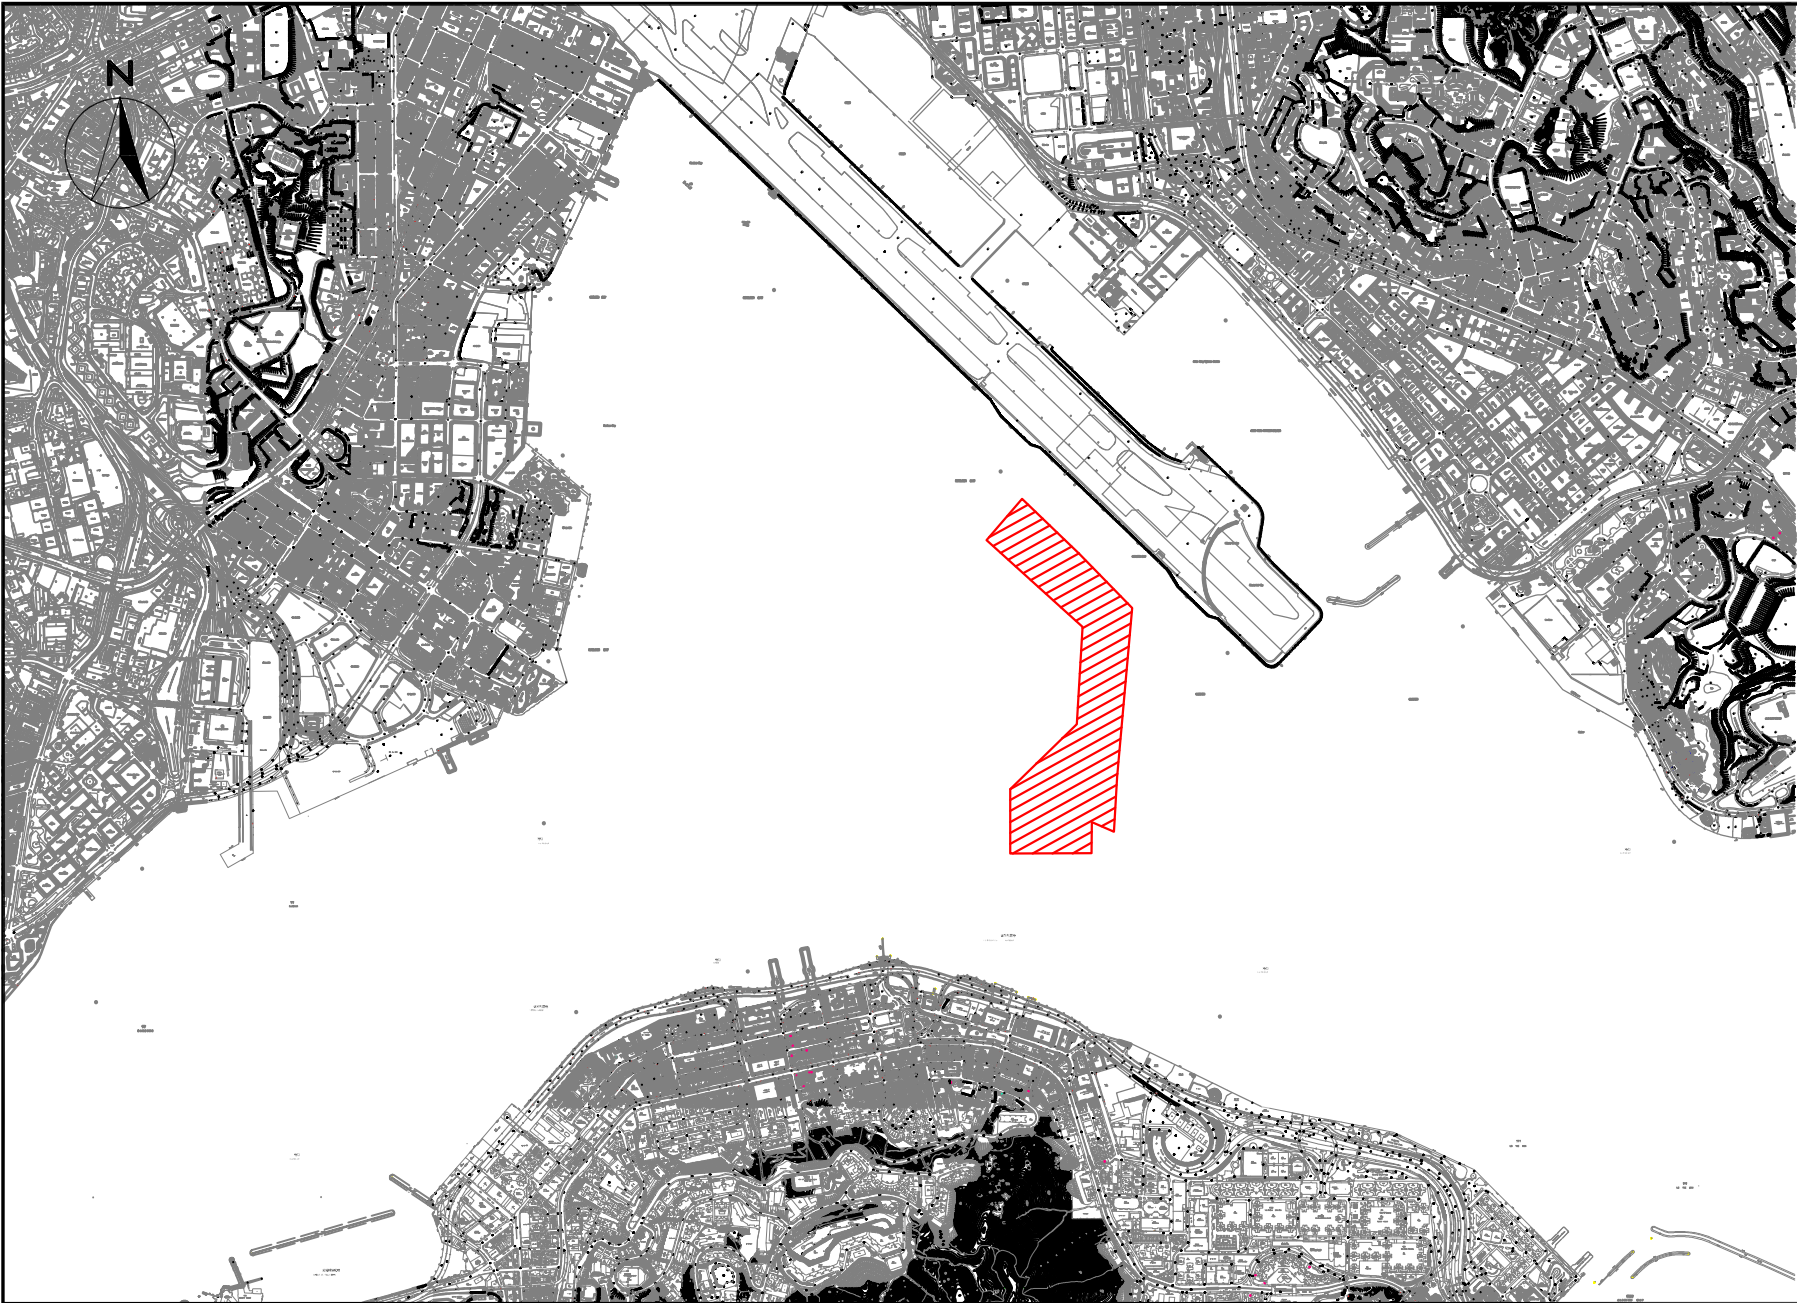
SCALE	1:25000@A4	DATE	APR 14
CHECK	IT	DRAWN	JW
JOB No.	MA15011	FIGURE NO.	1
		REV	-

SITE LAYOUT PLAN

- 2.3 Development of the cruise terminal at Kai Tak would require dredging at the existing seawall at the southern tip of the former Kai Tak Airport runway for construction of a quay deck structure for two berths, and dredging the seabed fronting the new quay to provide necessary manoeuvring basin. The general layout of the proposed cruise terminal construction is shown in **Figure 1**.

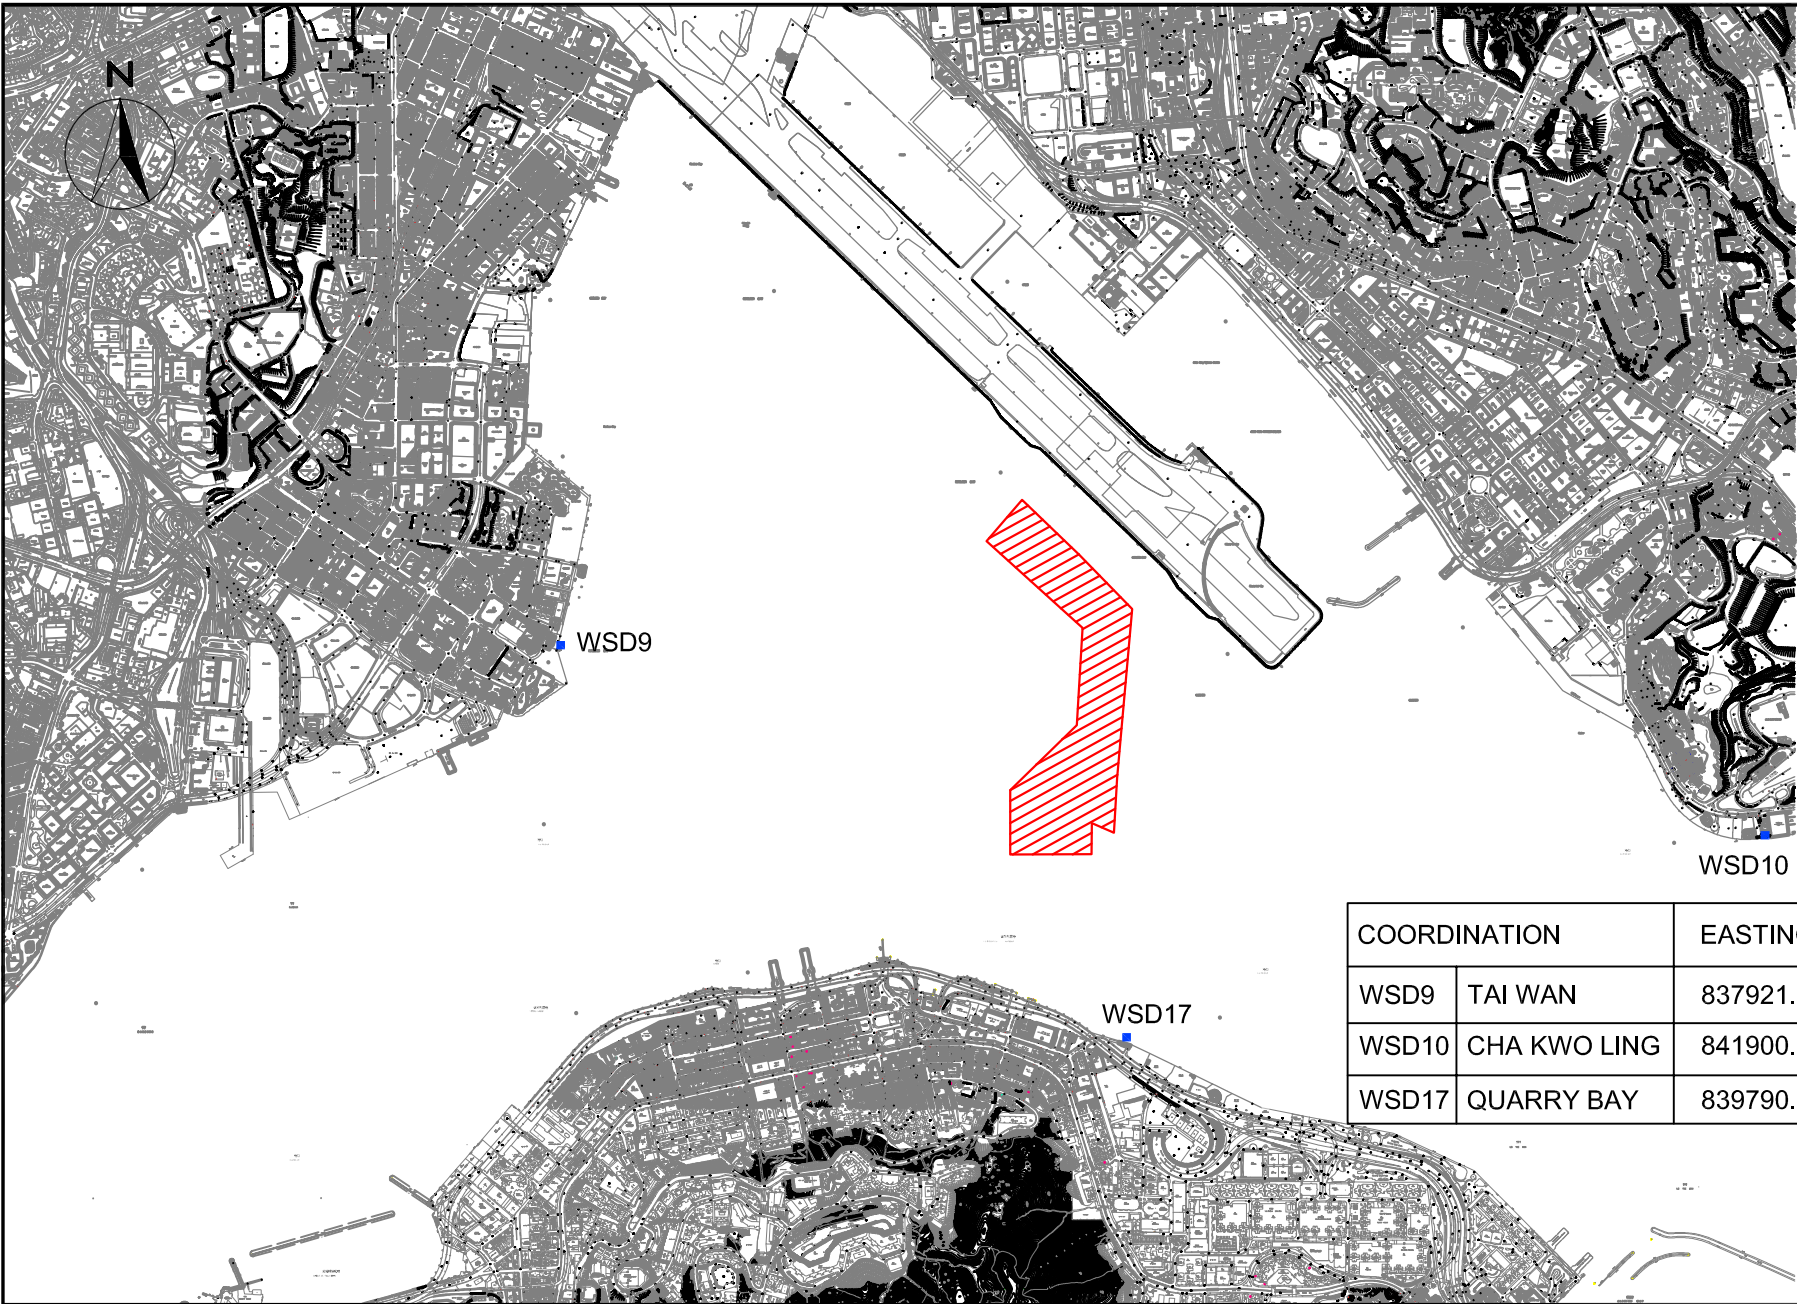
SCALE	1:25000@A4	DATE	APR 14
CHECK	IT	DRAWN	JW
JOB No.	MA15011	FIGURE NO.	2
		REV	-

LOCATION OF WATER QUALITY MONITORING STATIONS

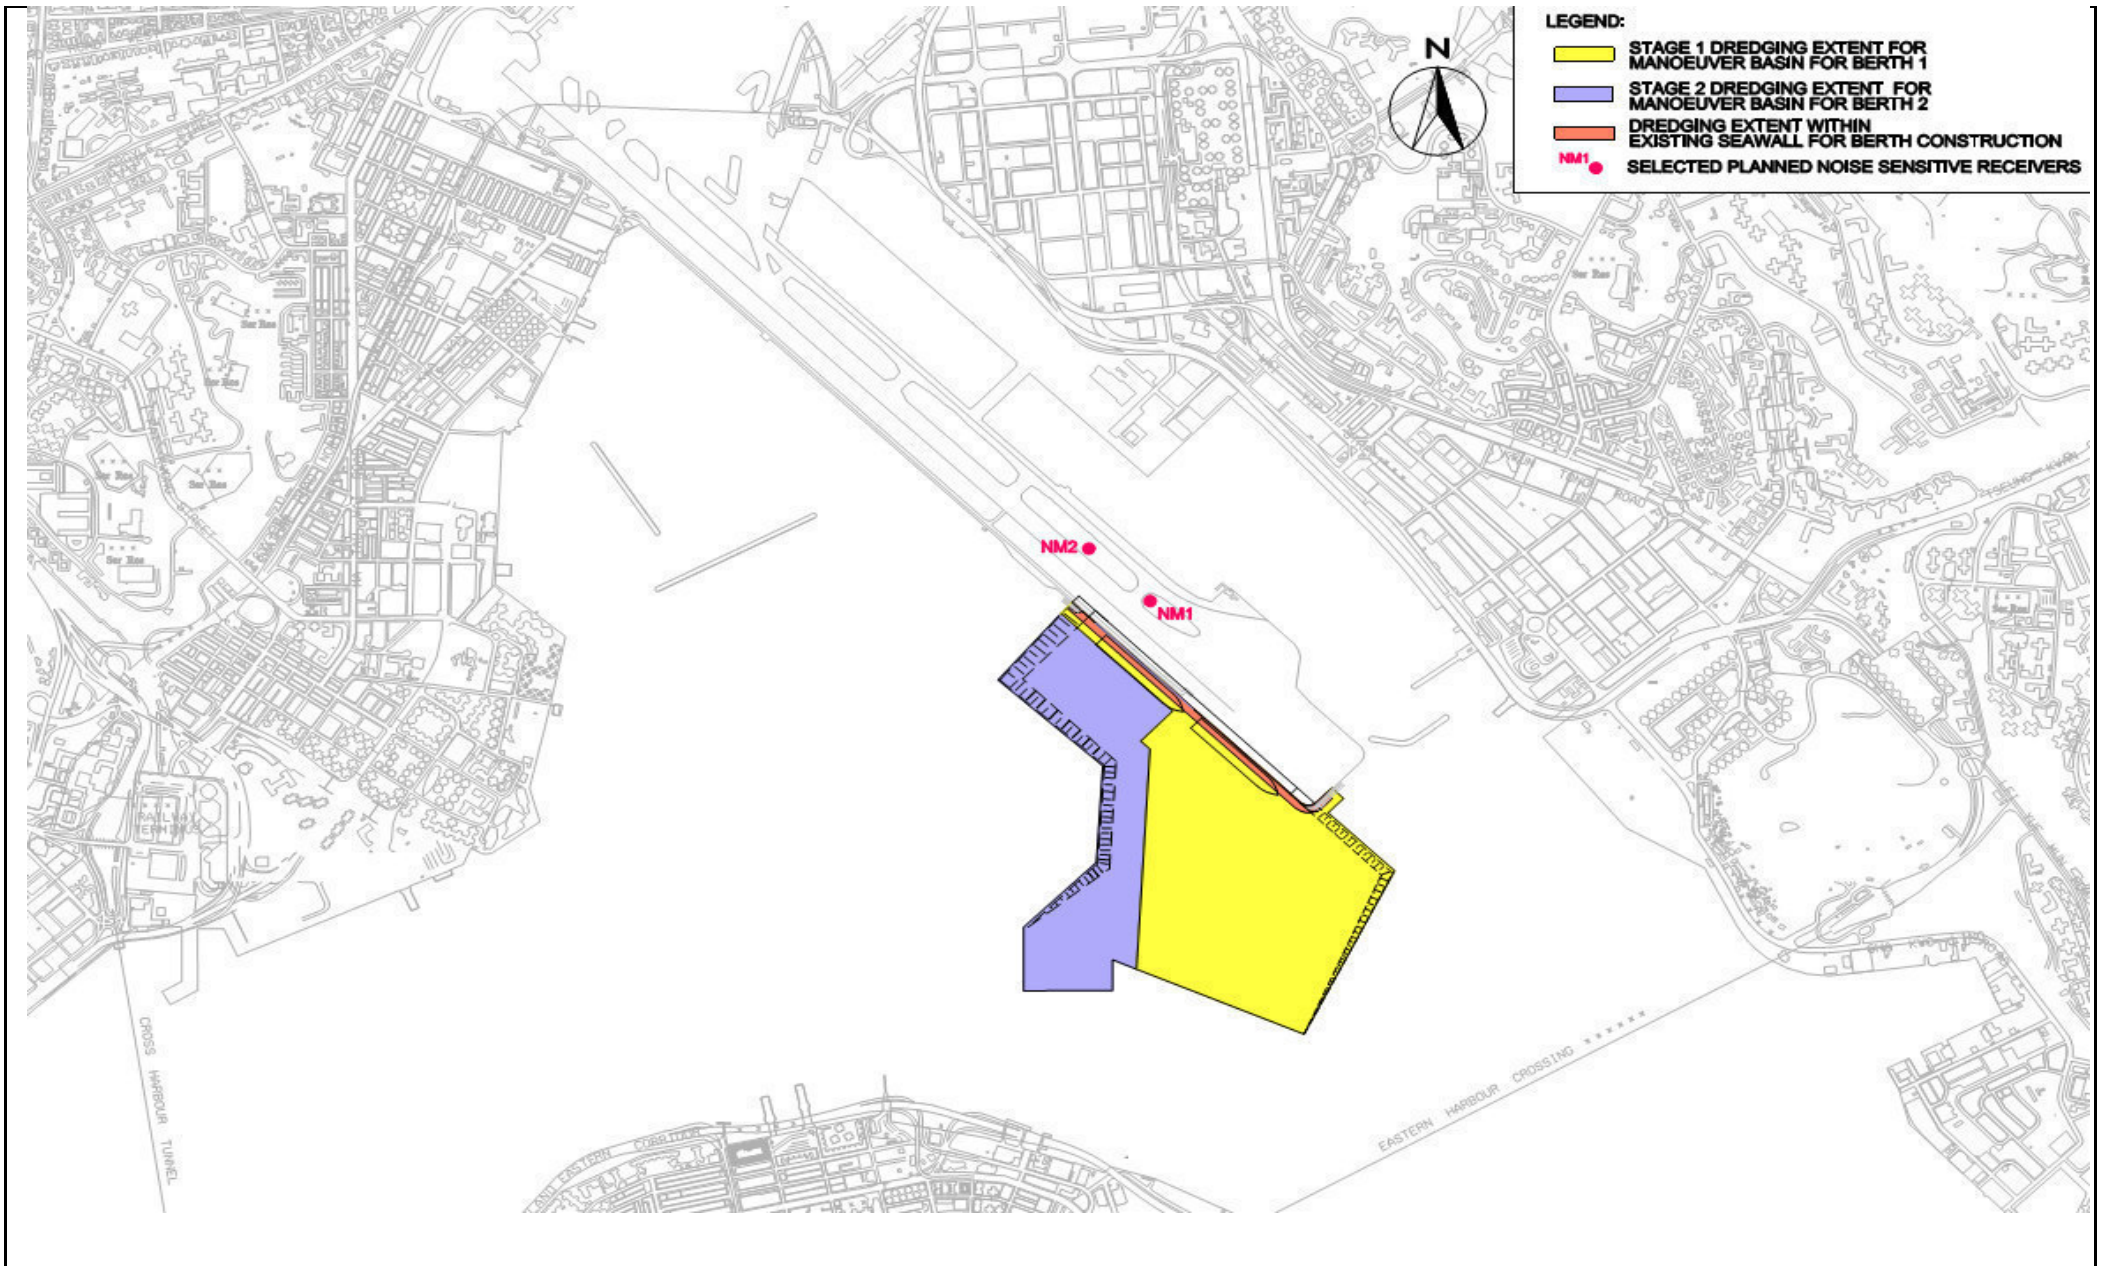
Title	Contract No. KL/2013/01 Site Formation for Kai Tak Cruise Terminal Development - Remaining Works Planned Noise Monitoring Stations during Construction Phase	Scale	N.T.S	Propose No.	MA15011	CINOTECH
		Date	Apr-15	Figure	3

- 3.1 In accordance with the EIA Report and the EM&A Manual, it is anticipated that construction activities, if unmitigated, would not cause any adverse noise impact to the nearest NSRs in the vicinity of the work site. The predicted noise levels at the NSRs would comply with construction noise criteria.
- 3.2 These nearest NSRs are designated for construction noise monitoring as listed in Table 3.1 and **Figure 3**.

Monitoring Stations	Description
NM1	Planned Residential Development (R3 site)
NM2	Planned Residential Development (R3 site)

5. Due to the non-existence of planned NSRs during the reporting period, no noise monitoring was required to be conducted at the planned noise monitoring locations NM1 and NM2.

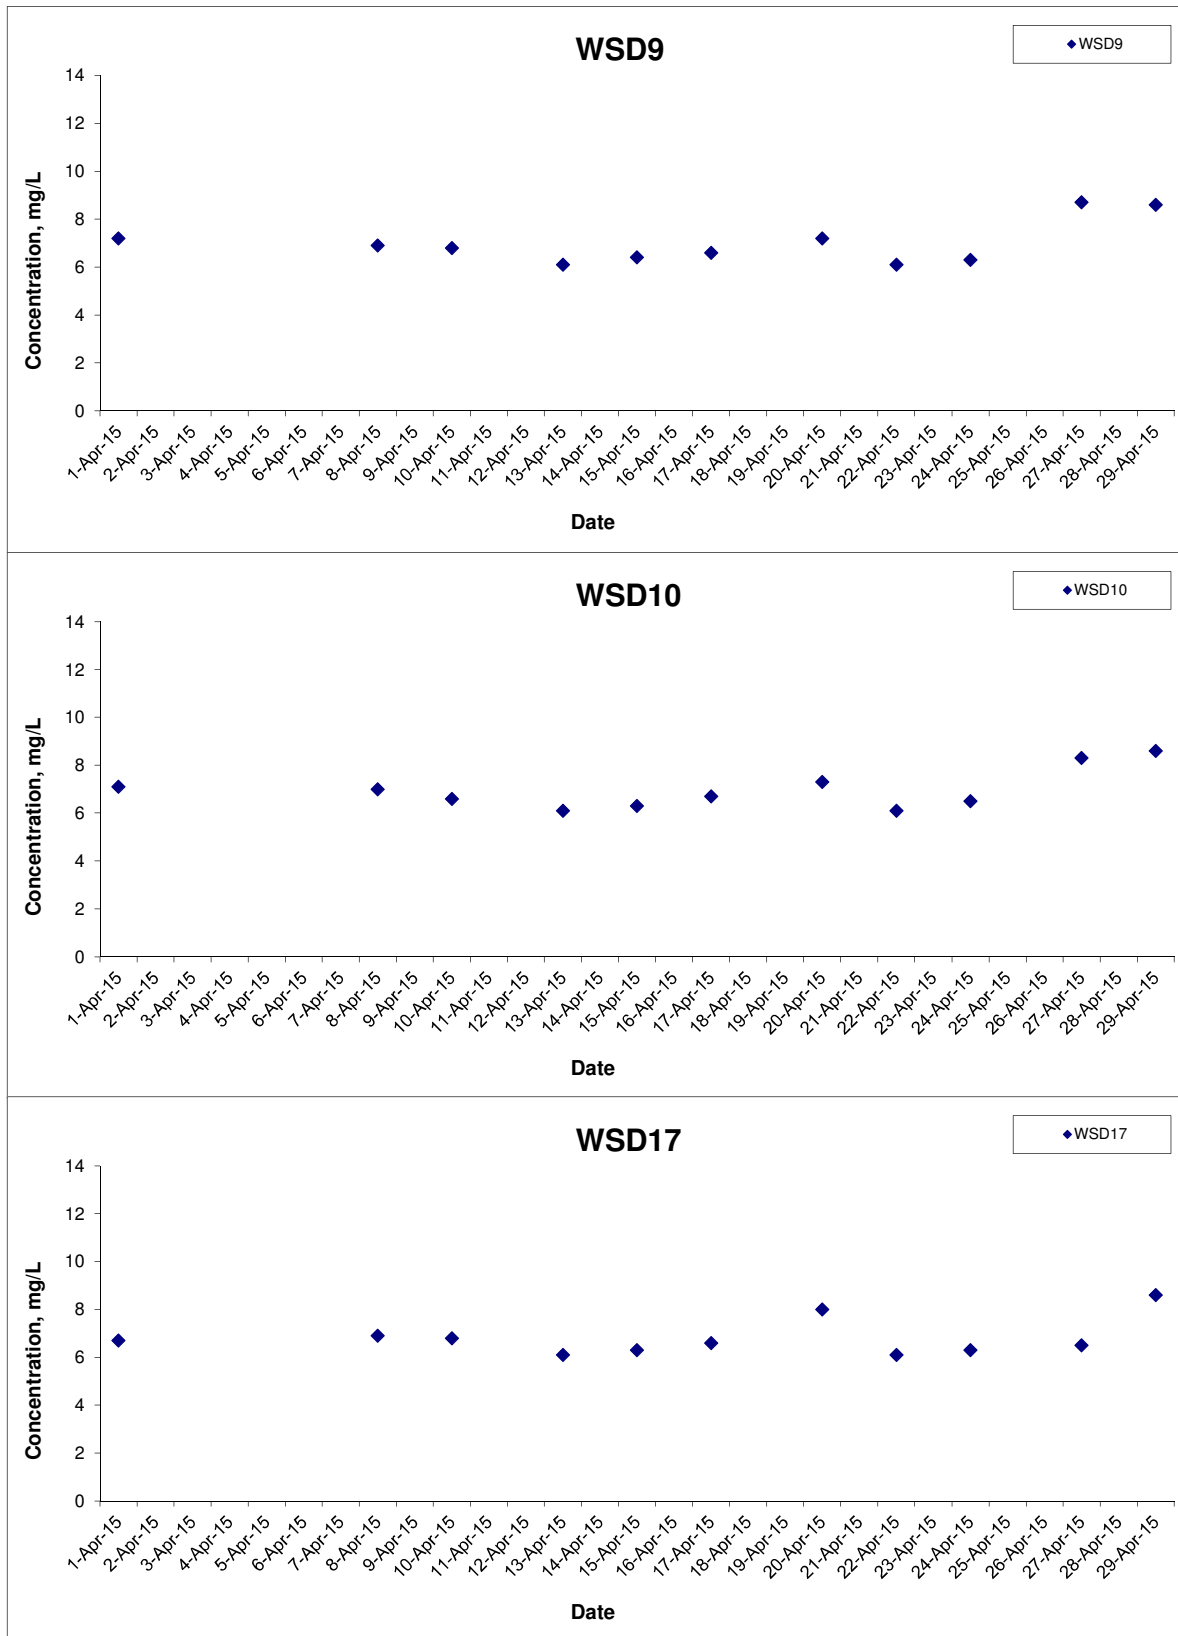
Dissolved Oxygen at Mid-Ebb Tide

Title Contract No. KL/2013/01 -
 Site Formation For Kai Tak Cruise Terminal Development -
 Remaining Works
 Graphical Presentation of Water Quality Monitoring
 Results

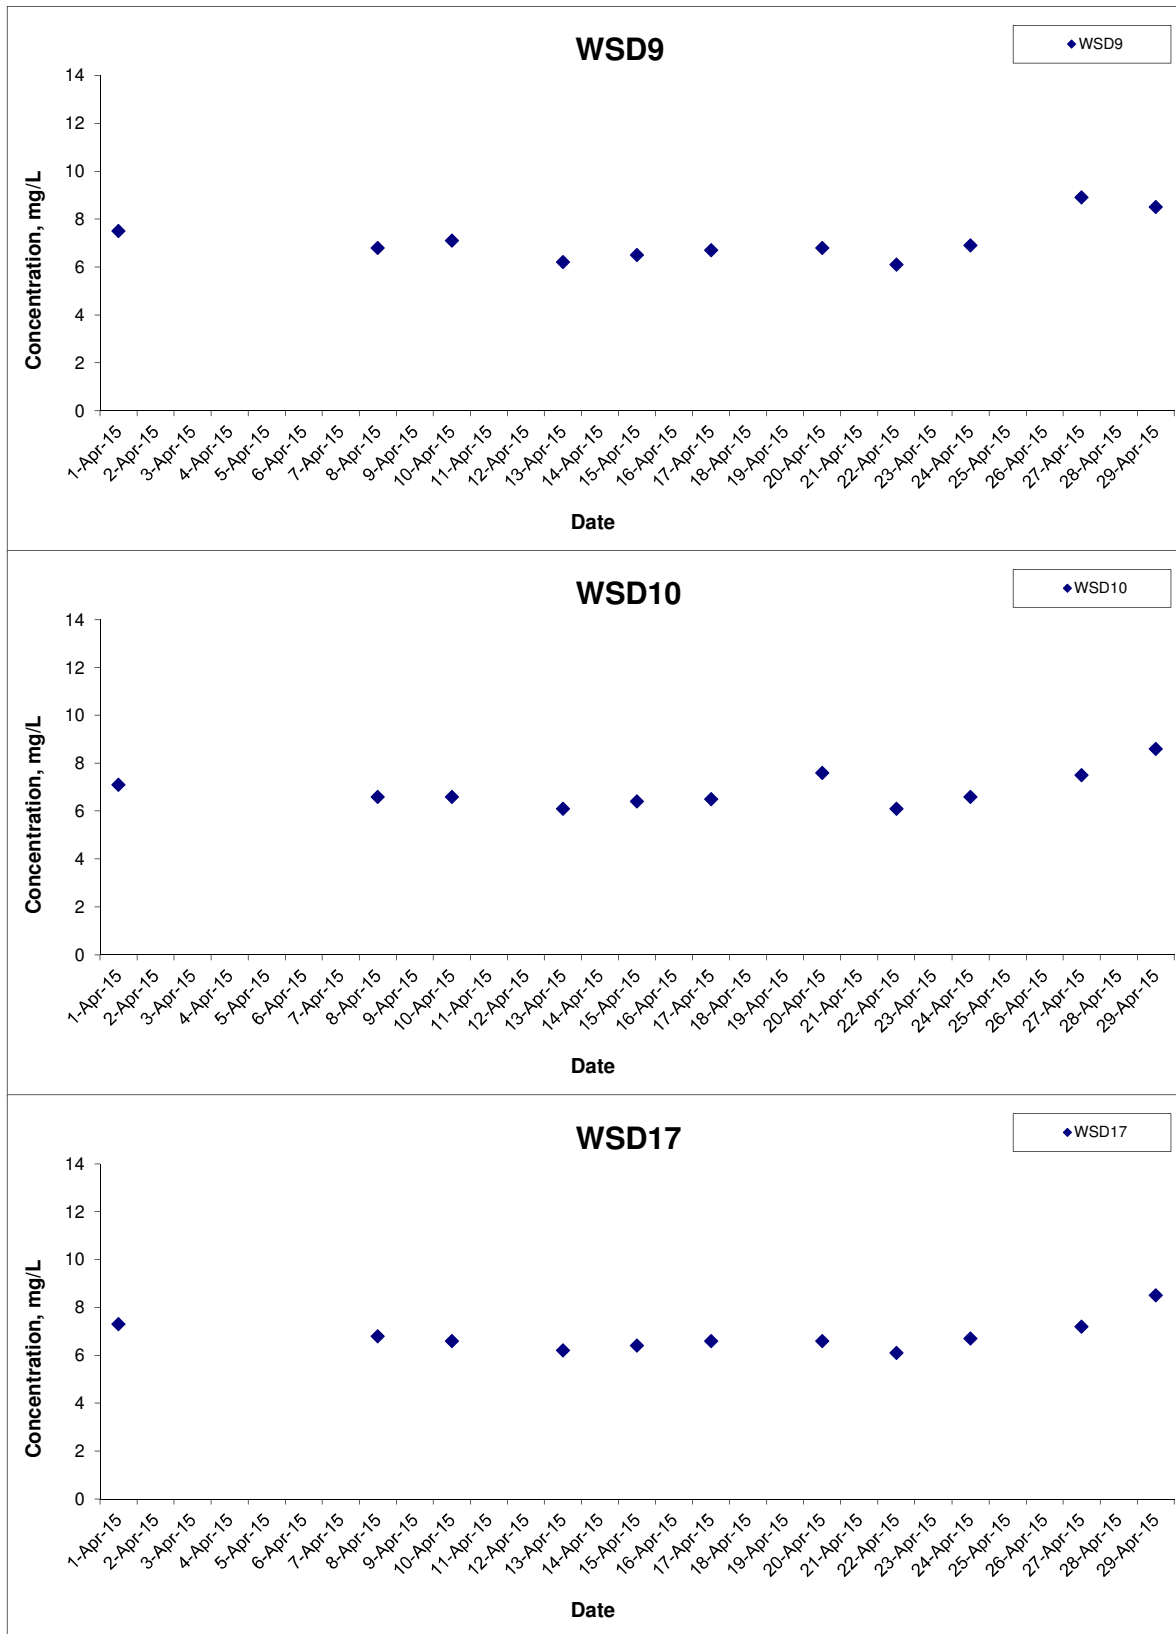
Dissolved Oxygen at Mid-Flood Tide

Title Contract No. KL/2013/01 -
 Site Formation For Kai Tak Cruise Terminal Development -
 Remaining Works
 Graphical Presentation of Water Quality Monitoring
 Results

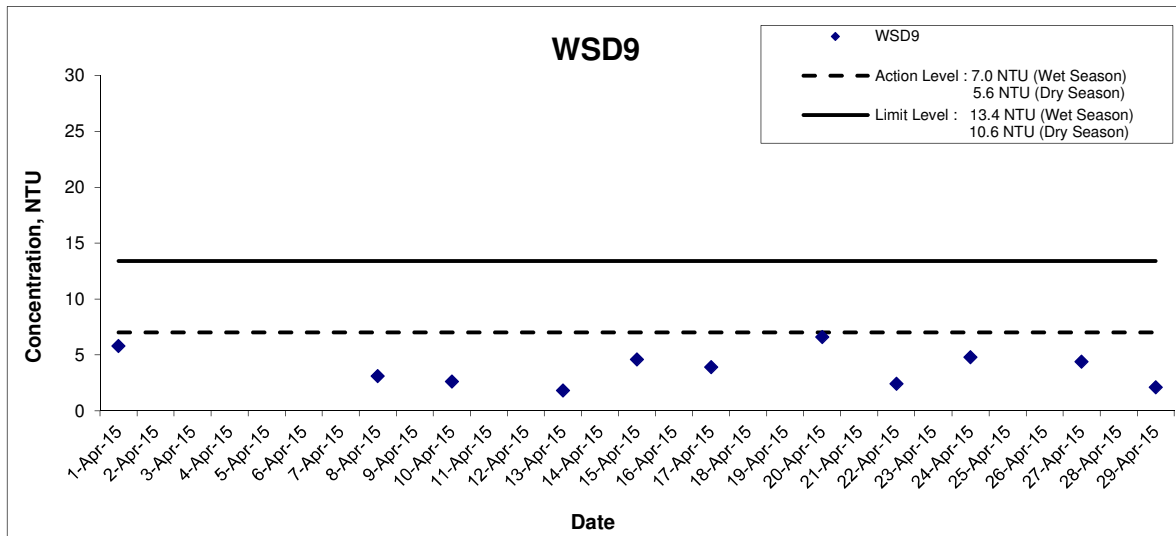
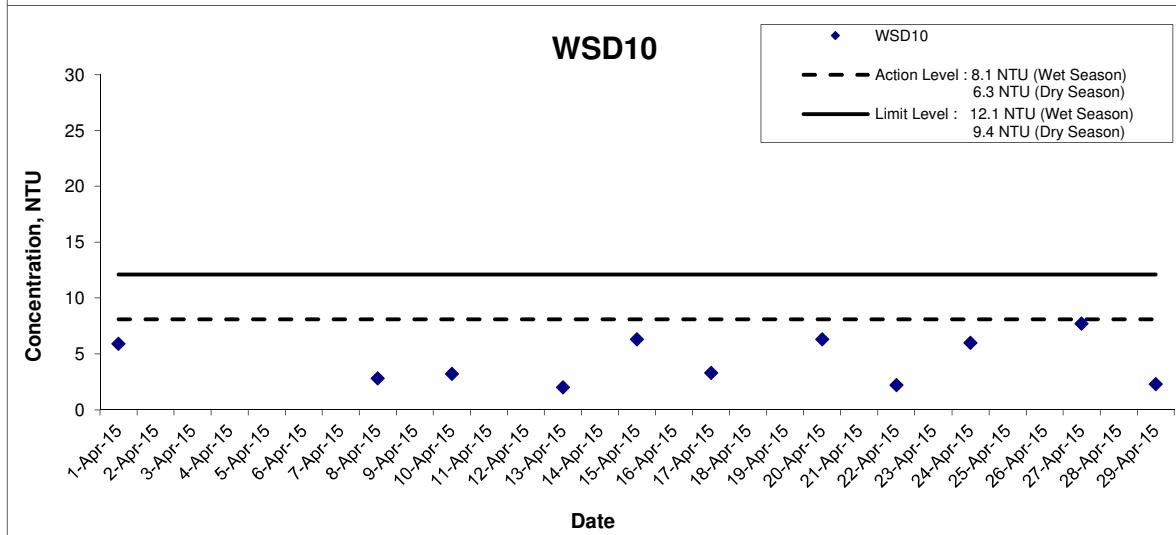
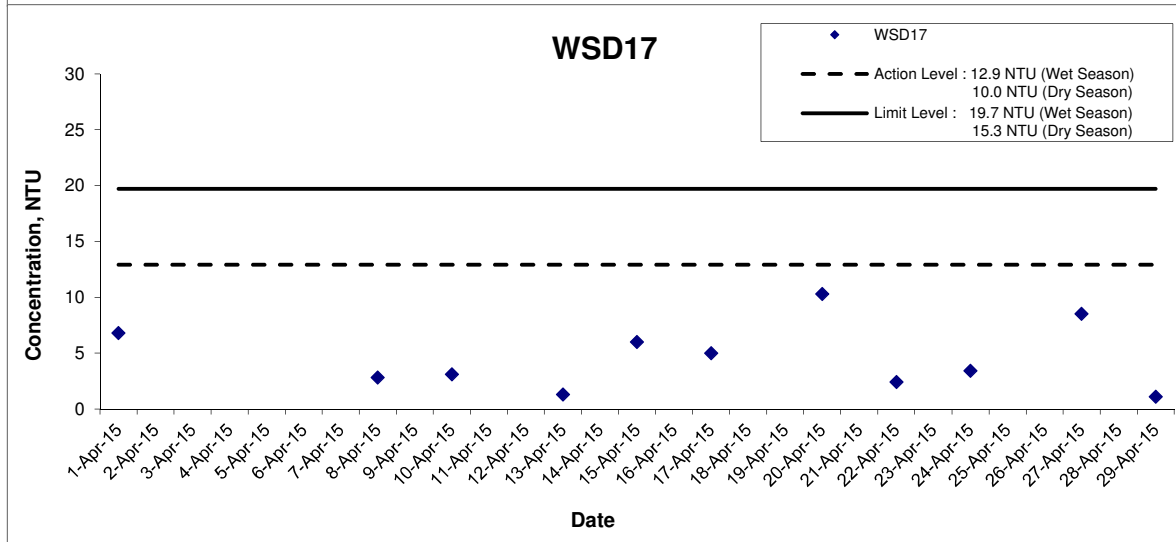
Turbidity at Mid-Ebb Tide

Title Contract No. KL/2013/01 -
 Site Formation For Kai Tak Cruise Terminal Development -
 Remaining Works
 Graphical Presentation of Water Quality Monitoring
 Results

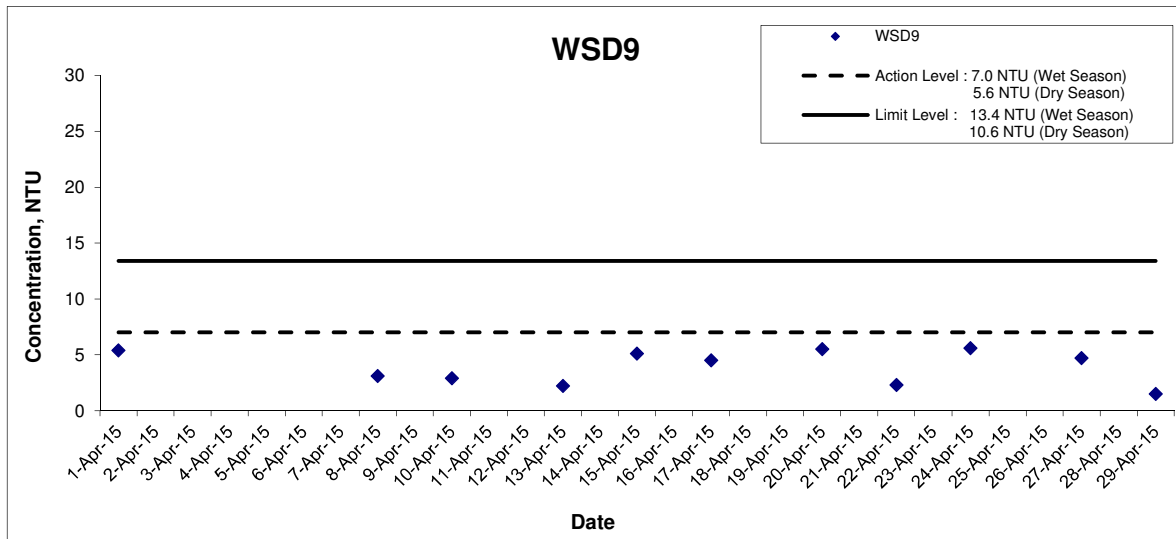
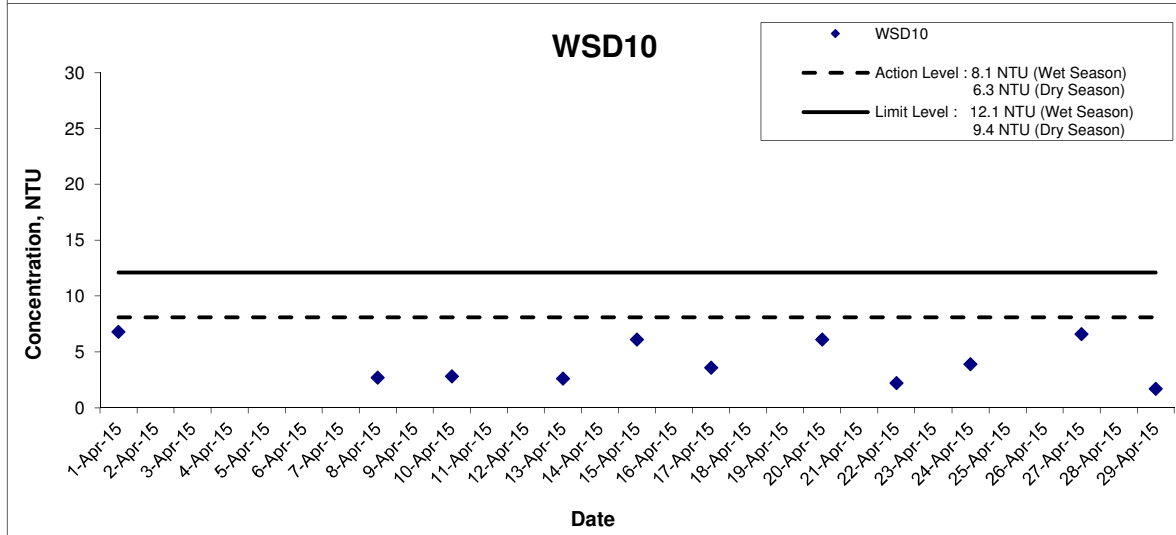
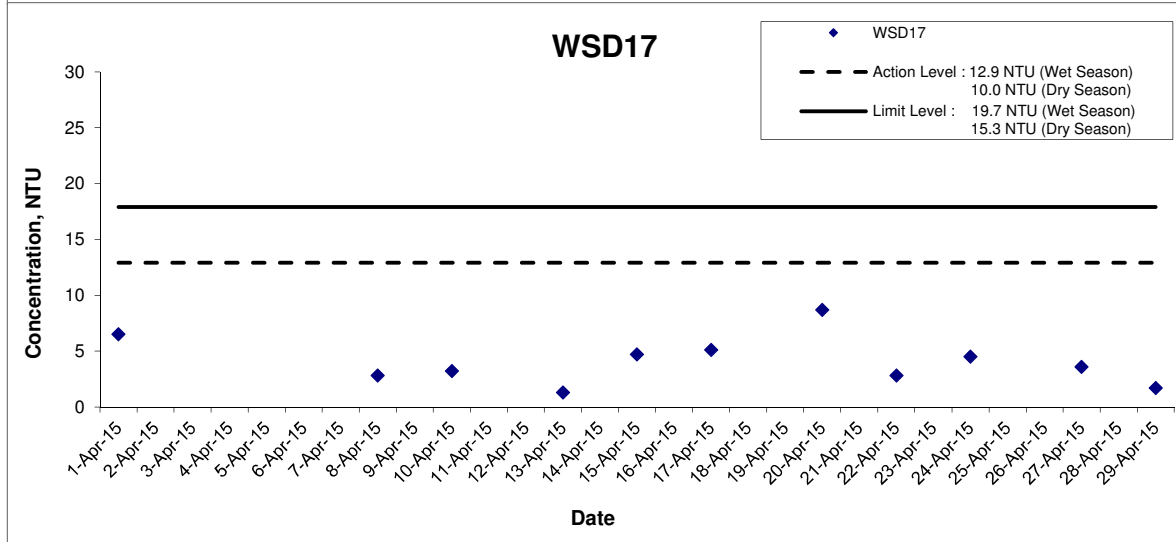
Turbidity at Mid-Flood Tide

Title Contract No. KL/2013/01 -
 Site Formation For Kai Tak Cruise Terminal Development -
 Remaining Works
 Graphical Presentation of Water Quality Monitoring
 Results

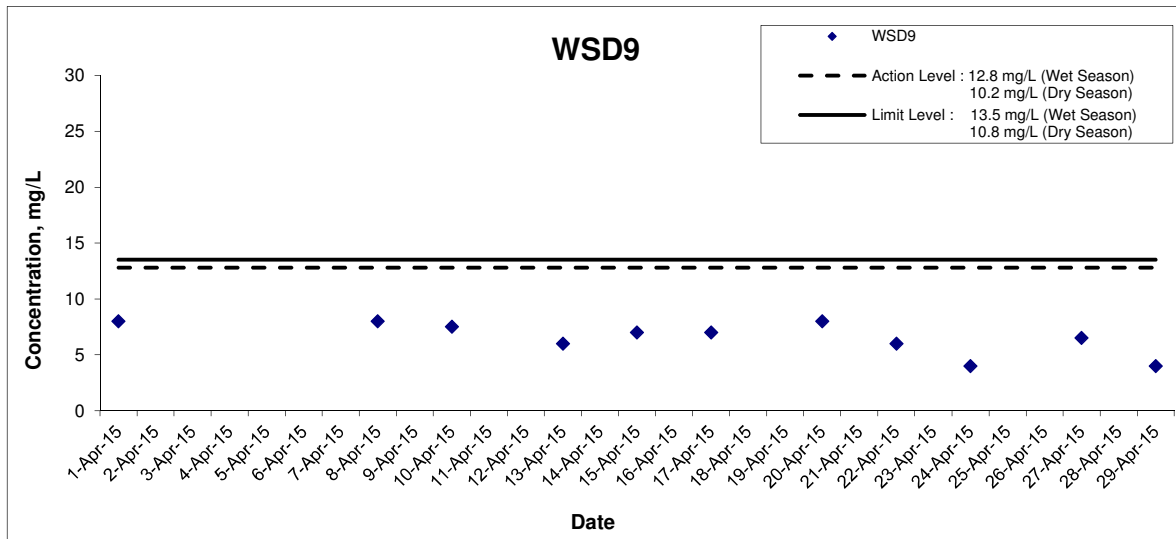
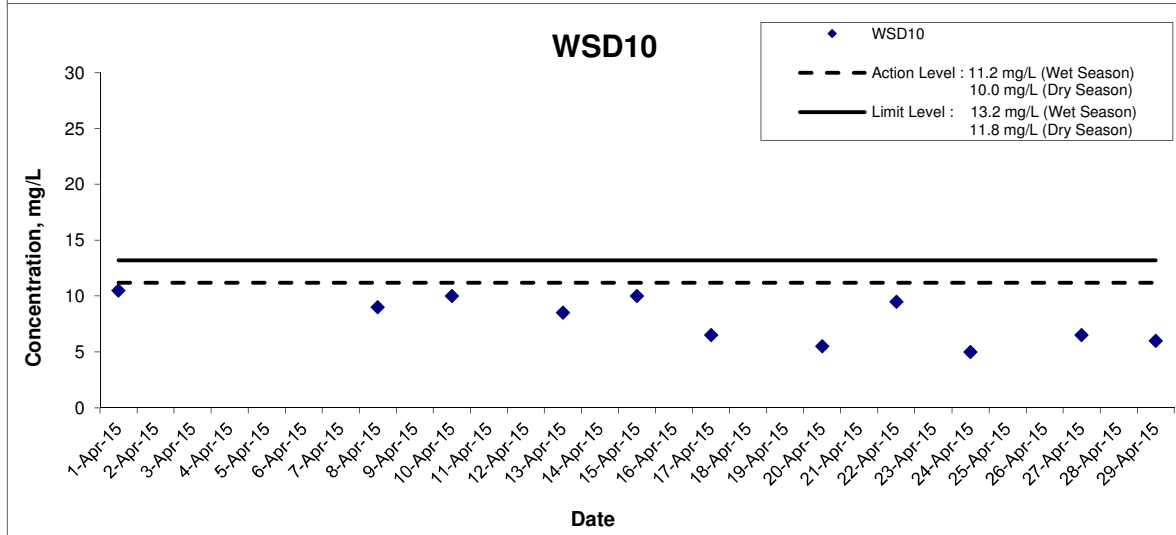
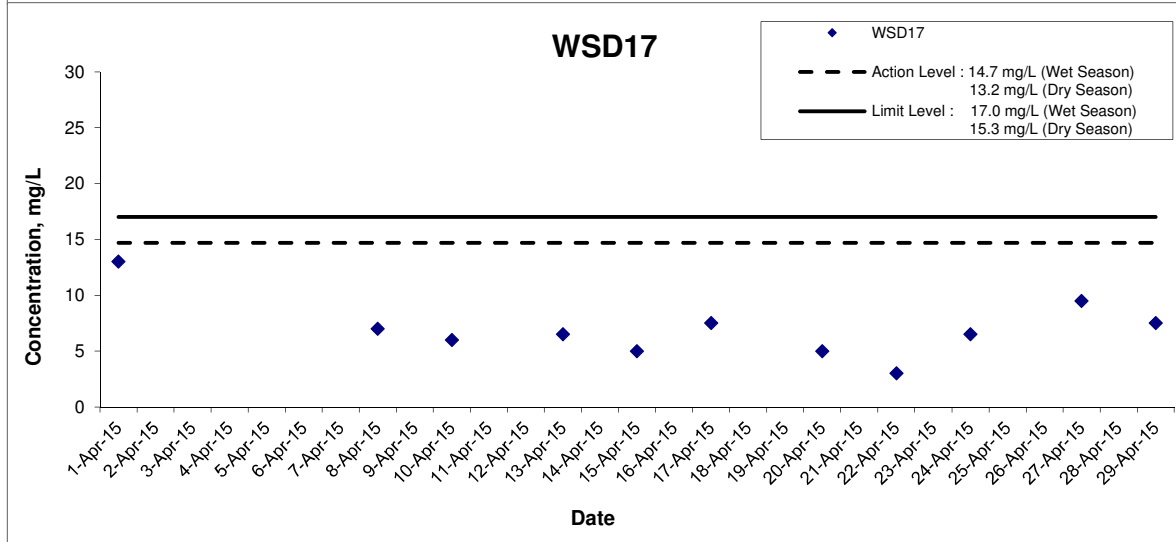
Suspended Solids at Mid-Ebb Tide

Title Contract No. KL/2013/01 -
 Site Formation For Kai Tak Cruise Terminal Development -
 Remaining Works
 Graphical Presentation of Water Quality Monitoring
 Results

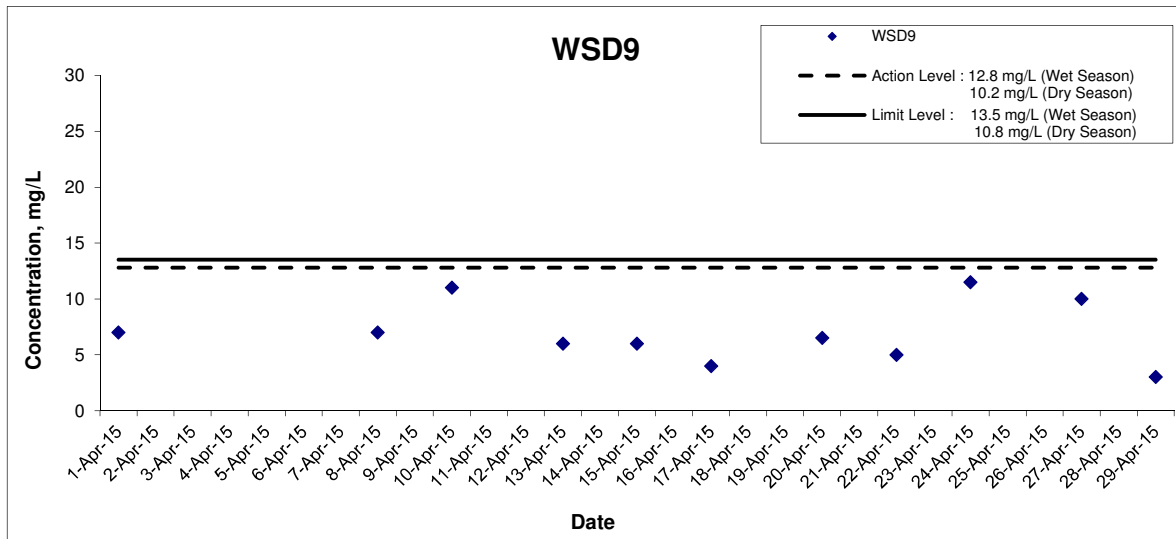
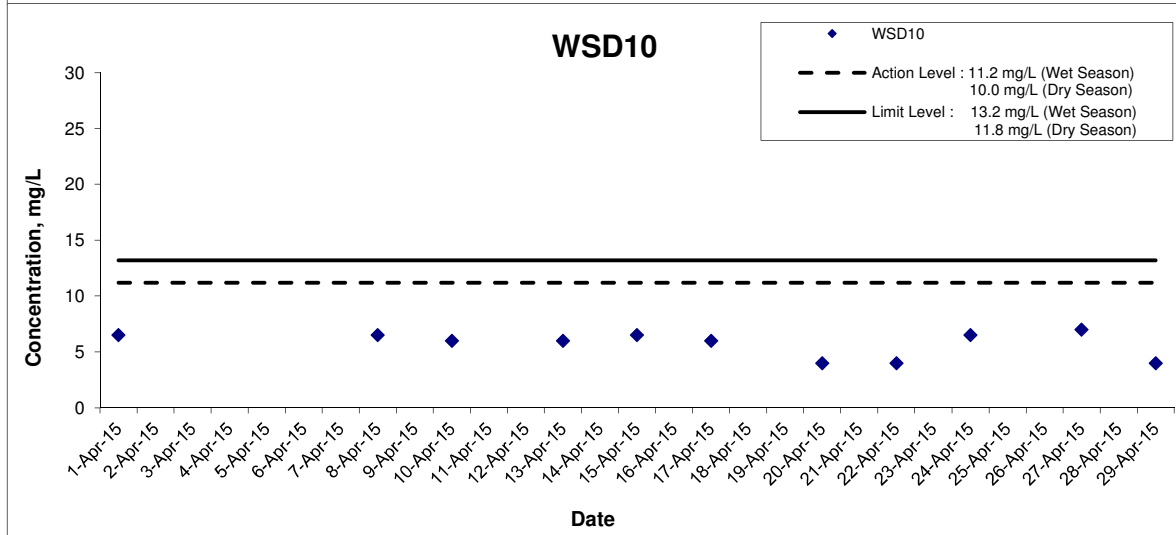
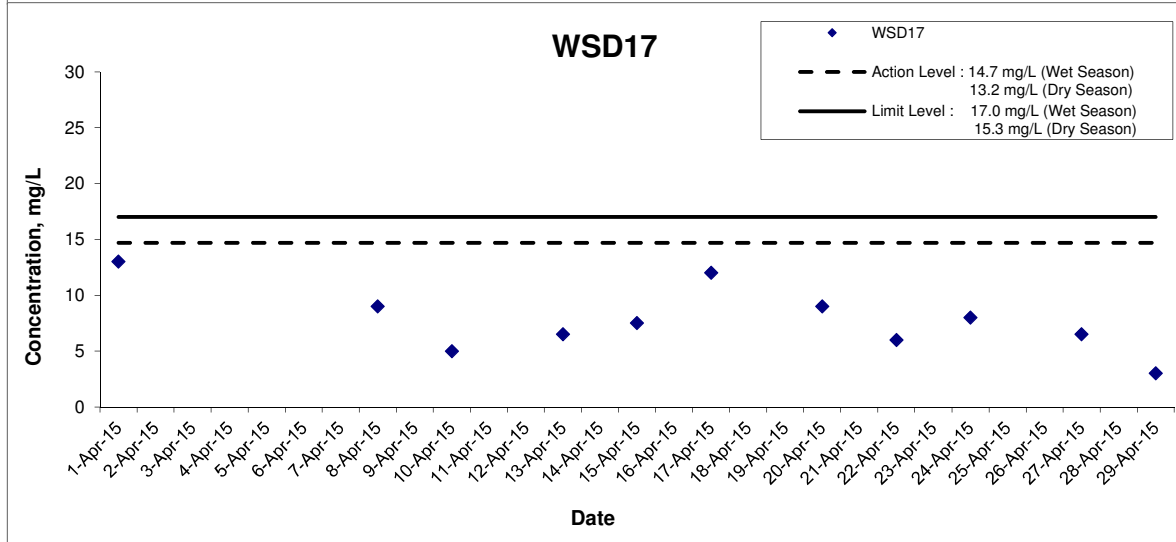
Suspended Solids at Mid-Flood Tide

Title
 Contract No. KL/2013/01 -
 Site Formation For Kai Tak Cruise Terminal Development -
 Remaining Works
 Graphical Presentation of Water Quality Monitoring
 Results
