**Contract No. DC/2007/10**

## **Design and Construction of Hong Kong West Drainage Tunnel**

Quarterly EM&A Report  
(version 1.0)

July to September 2009

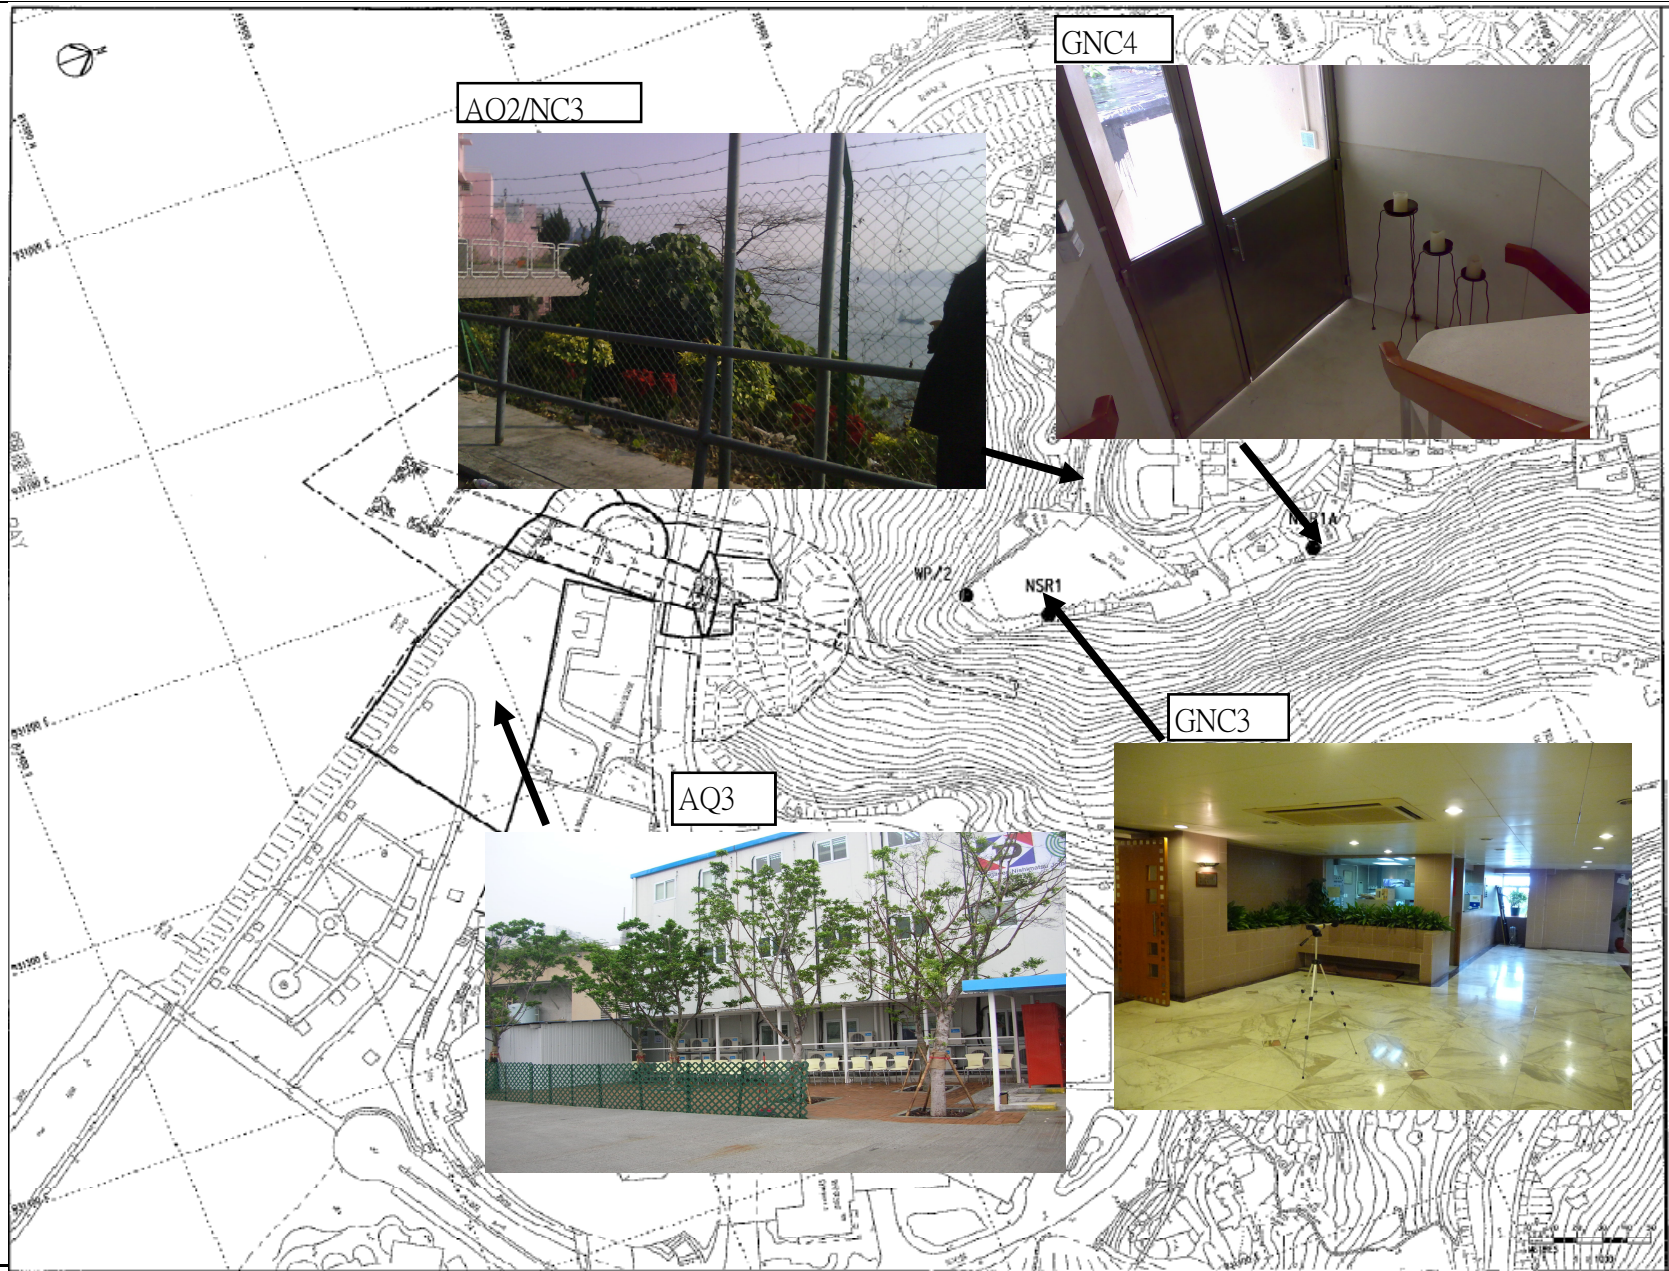
3b

Contract No. DG/2007/10  
 Design and Construction of Hong Kong West Drainage Tunnel  
 (Western Portal)  
 Locations of Air Quality and Noise Monitoring Station

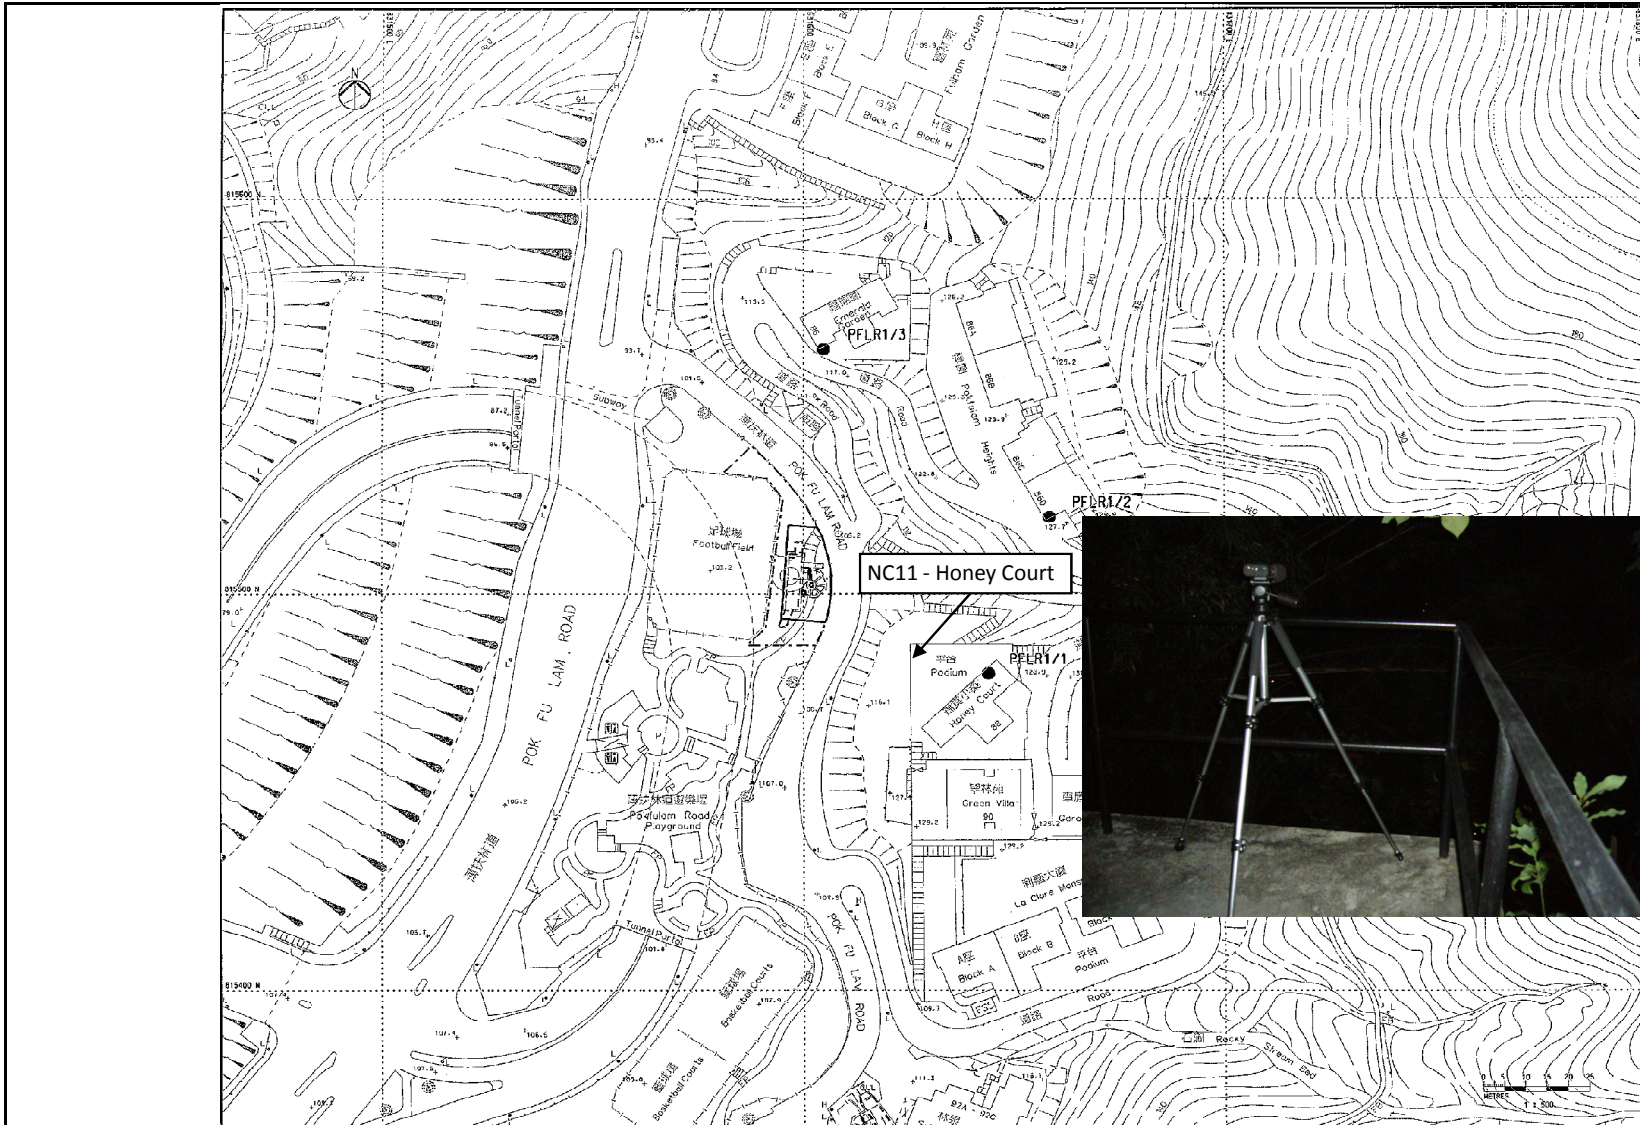
Title	Contract No. DC/2007/10		Scale	Propos
	Design and Construction of Hong Kong West Drainage Tunnel (Intake PFLR1)		N.T.S	No. MA8001
	Locations of Noise Monitoring Stations		Date	Figure
			Sep-09	3.1d

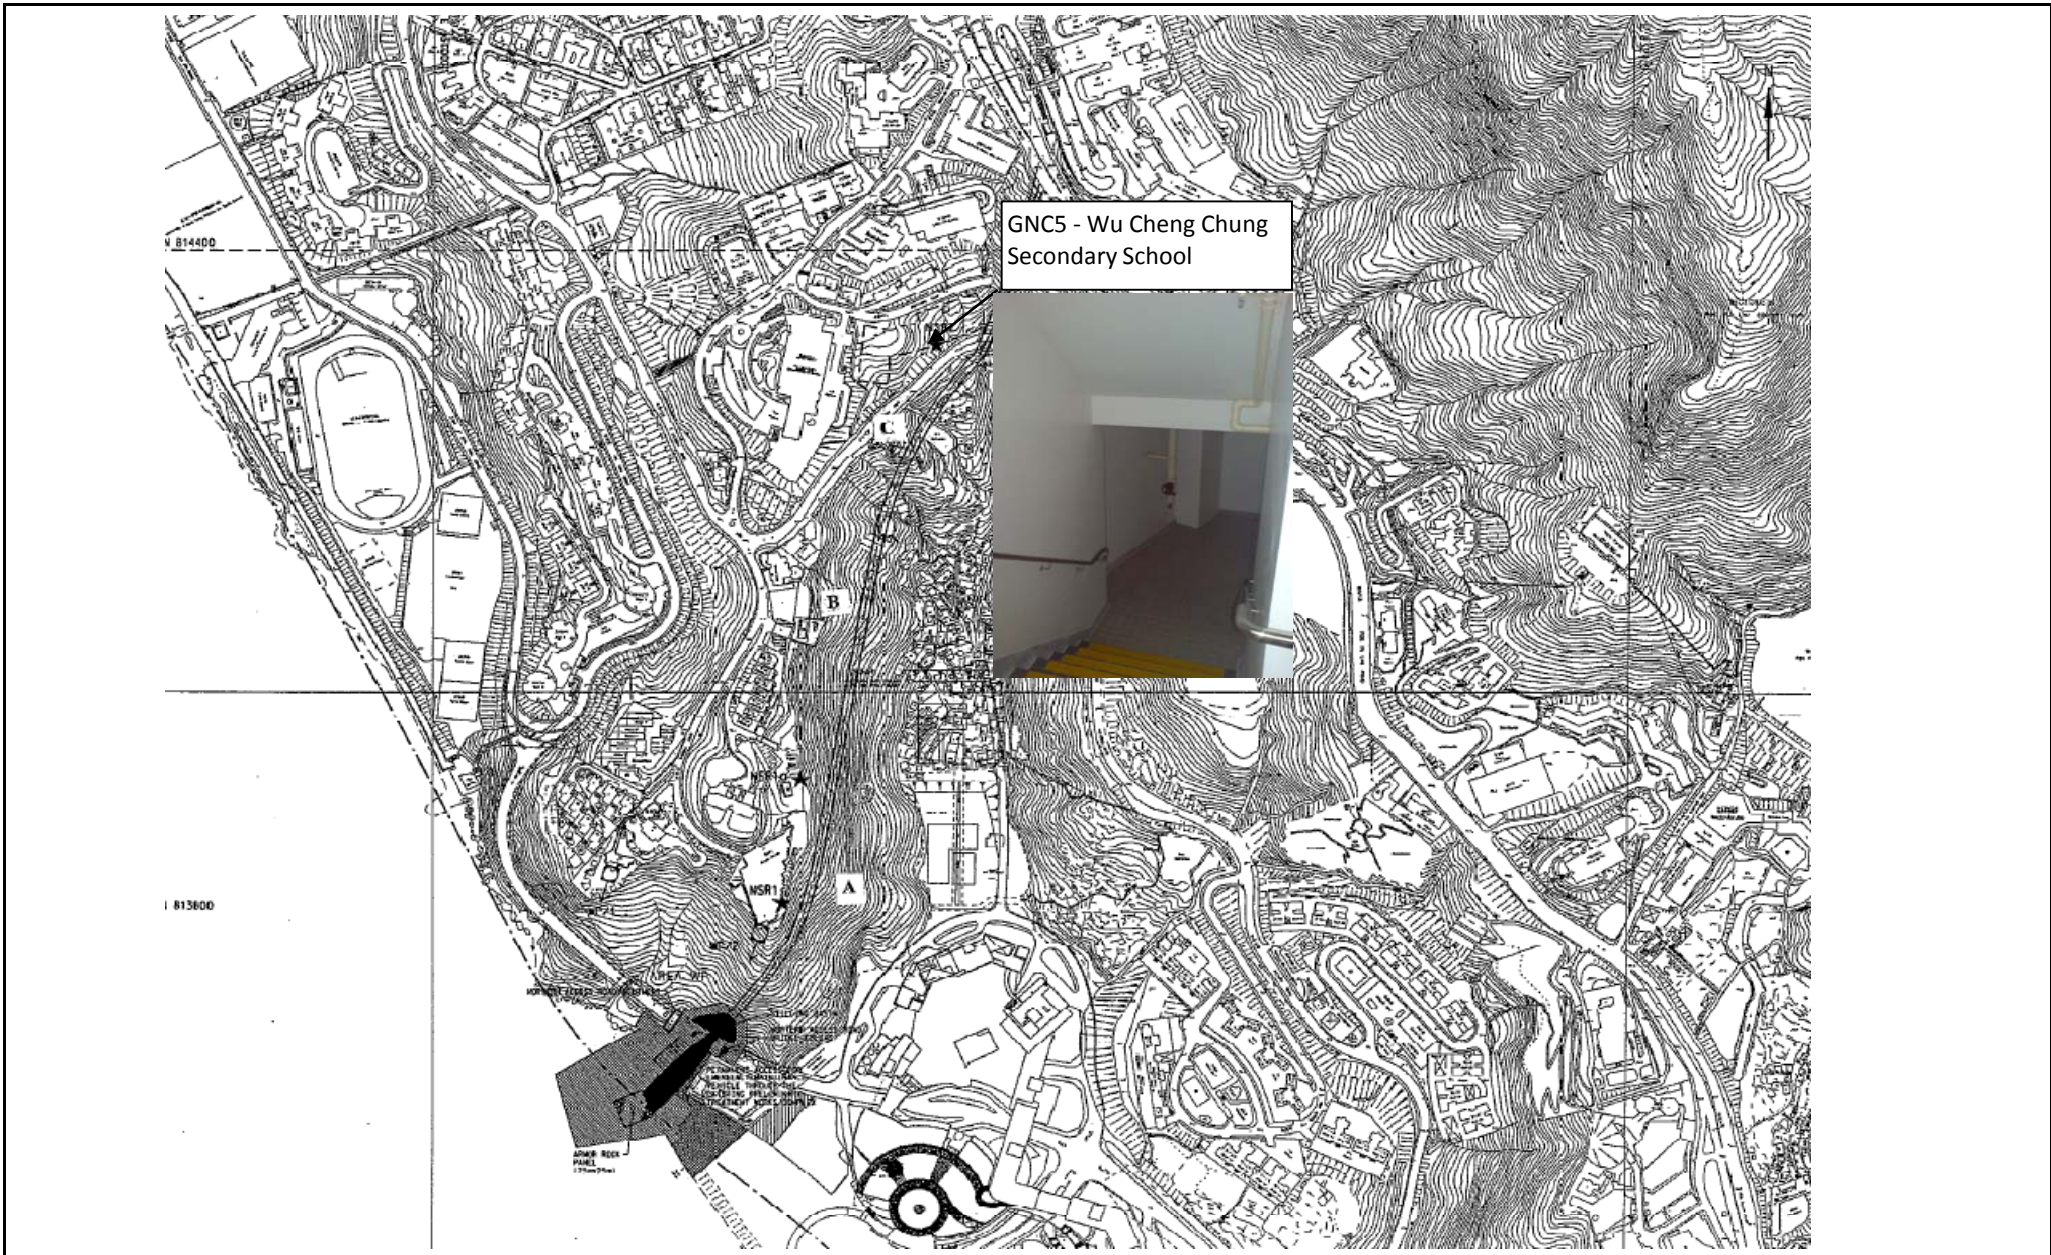
Title	Contract No. DC/2007/10		Scale	Propos
	Design and Construction of Hong Kong West Drainage Tunnel (Near Western Portal)		N.T.S	No. MA8001
	Locations of Groundborne Noise Monitoring Station		Date	Figure
			Sep-09	3.1f
