Contract No. DC/2007/10
Design and Construction of
Hong Kong West Drainage Tunnel

Monthly EM&A Report

October 2010

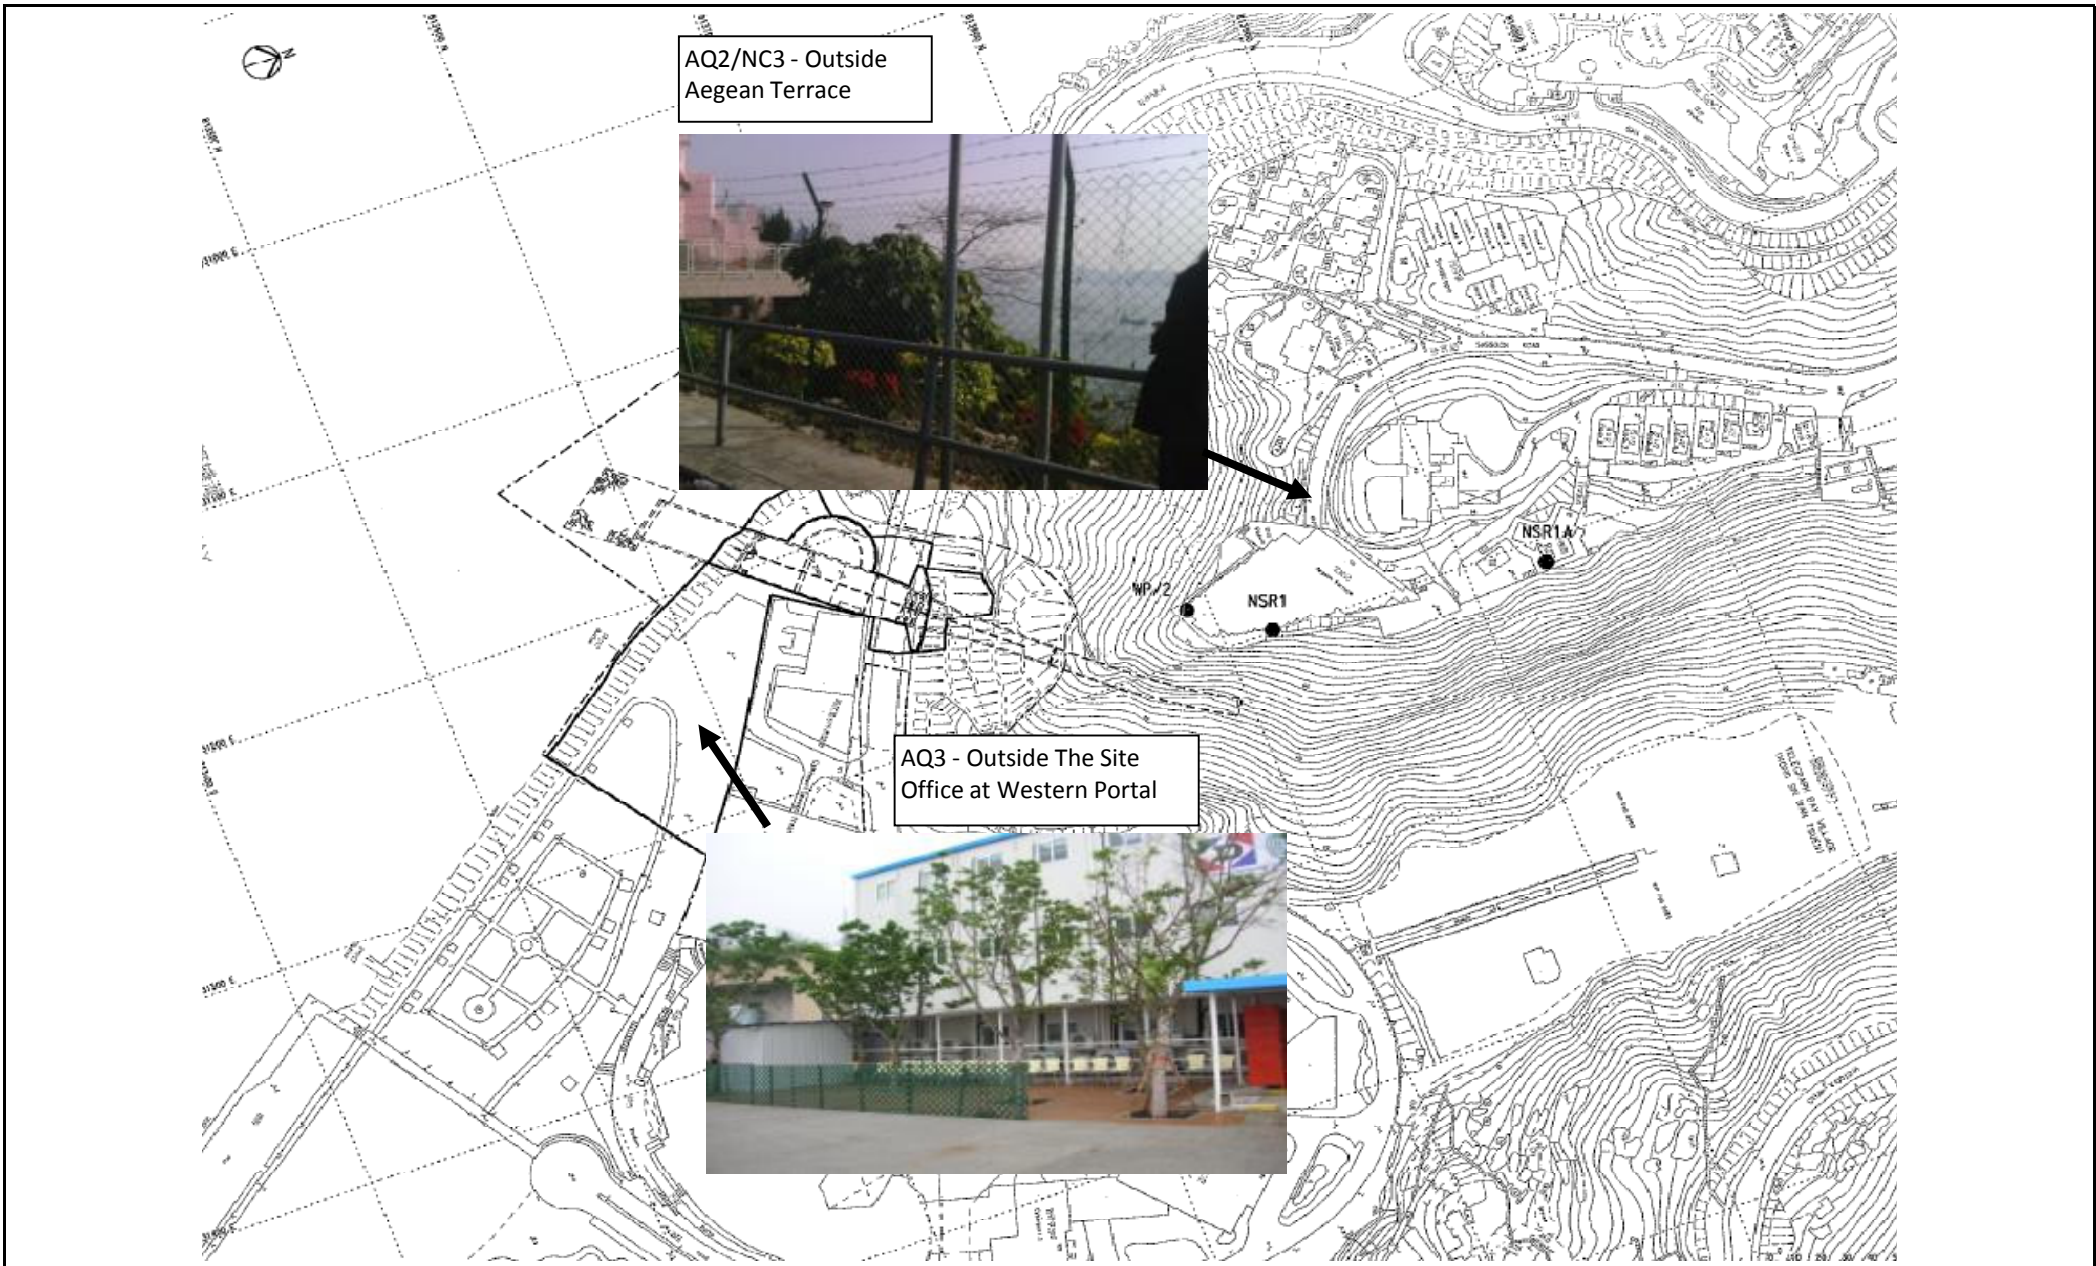
Title	Contract No. DC/2007/10		Scale	Project		CINOTECH
	Design and Construction of Hong Kong West Drainage Tunnel (Western Portal)		N.T.S	No.	MA 8001	
	Locations of Air Quality and Noise Monitoring Station		Date	Sep-09	Figure	3.1b
