Contract No. DC/2007/10
Design and Construction of
Hong Kong West Drainage Tunnel

Monthly EM&A Report

November 2010
(version 1.0)

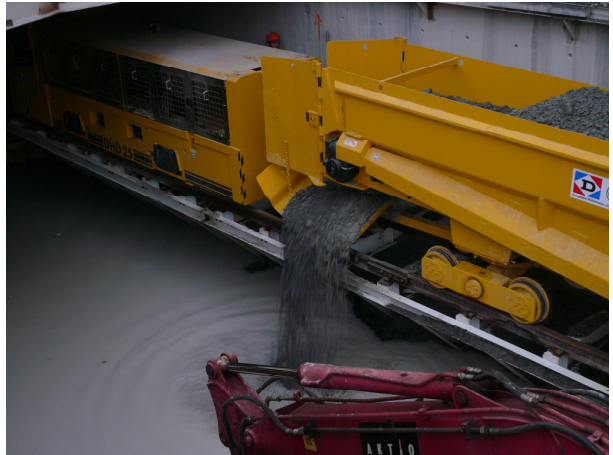
Photo 5: Shuttle car discharging excavated materials at the Adit Spoil Basin

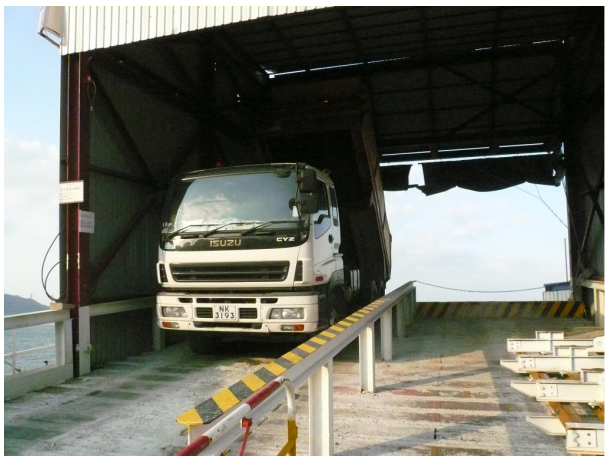
Photo 7: Dump truck discharging excavated materials onto the barge at the ramp jetty
