Contract No. DC/2007/10
Design and Construction of
Hong Kong West Drainage Tunnel

Monthly EM&A Report

February 2011

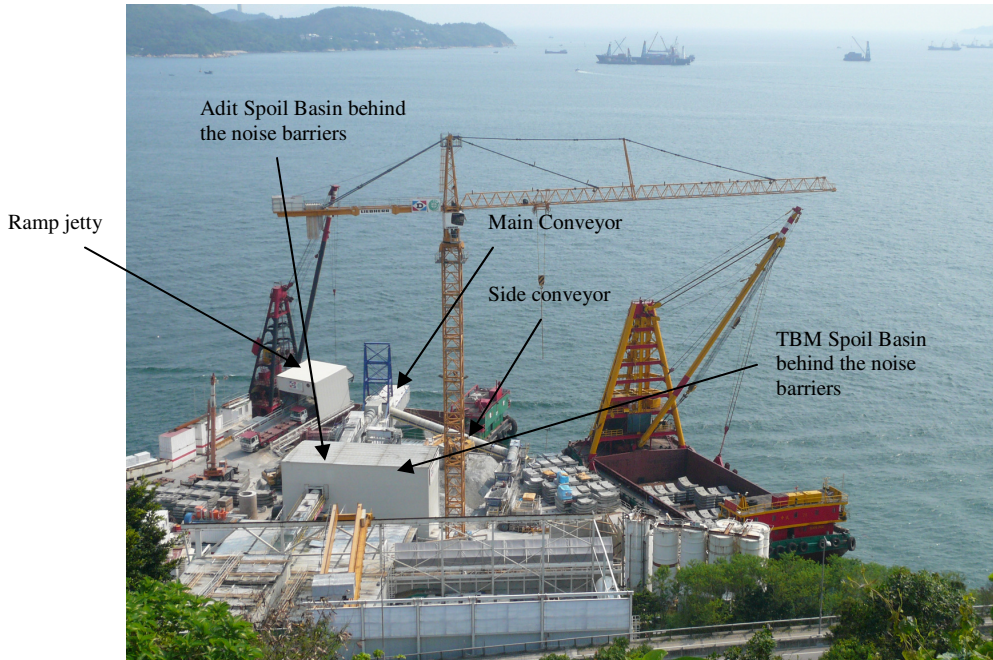
Photo 1: View of the Western Portal

When the next barge comes during daytime, the materials stored in the TBM Spoil Basin will be picked up by a backhoe and are transferred into a side conveyor. The side conveyor carried the materials to the main conveyor for discharge onto the barge (*Photo 1*).

The Main Conveyor and the Side Conveyor are fully enclosed by sound absorptive panels.

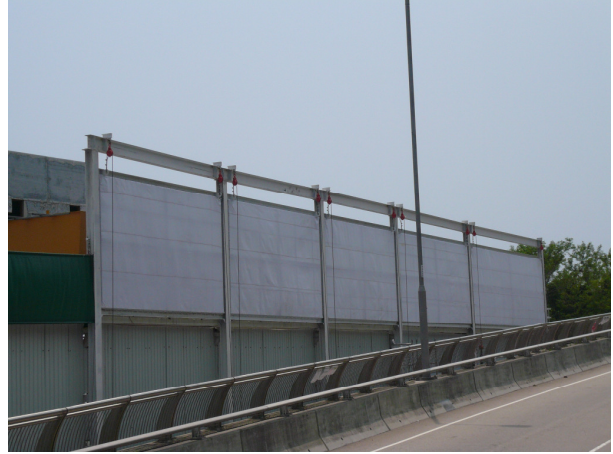
Photo 13: Noise barrier along Cyberport Road
