Contract No. DC/2007/10 Design and Construction of Hong Kong West Drainage Tunnel

Monthly EM&A Report

October 2011

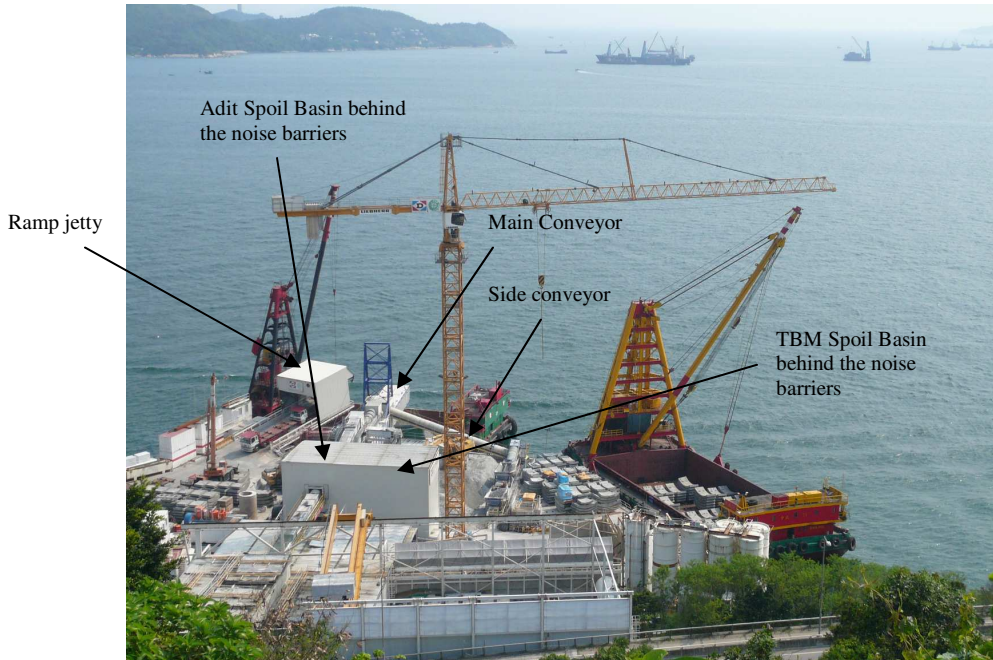
Photo 1: View of the Western Portal

When the next barge comes during daytime, the materials stored in the TBM Spoil Basin will be picked up by a backhoe and are transferred into a side conveyor. The side conveyor carried the materials to the main conveyor for discharge onto the barge (*Photo 1*).

The Main Conveyor and the Side Conveyor are fully enclosed by sound absorptive panels.

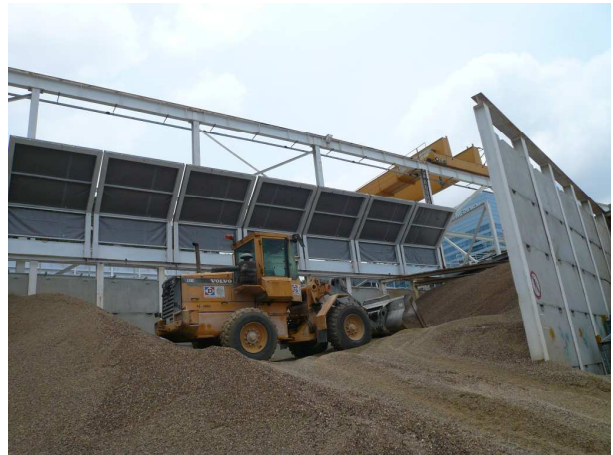
Photo 12: Noise barrier at the pea gravel storage yard at the side facing Aegean Terrace

In addition to the noise enclosure erected at the Western Portal, a row of noise barrier was built in the Western Portal adjacent the pea gravel storage yard (*Photo 12*). The barrier does not only screen the mobile plant at the pea gravel storage yard from the views of the Aegean Terrace residents, but it shields part of the noise generated from the operation of such plant. There is another row of barriers erected at the side abutting the Cyberport Road (*Photo 13*).

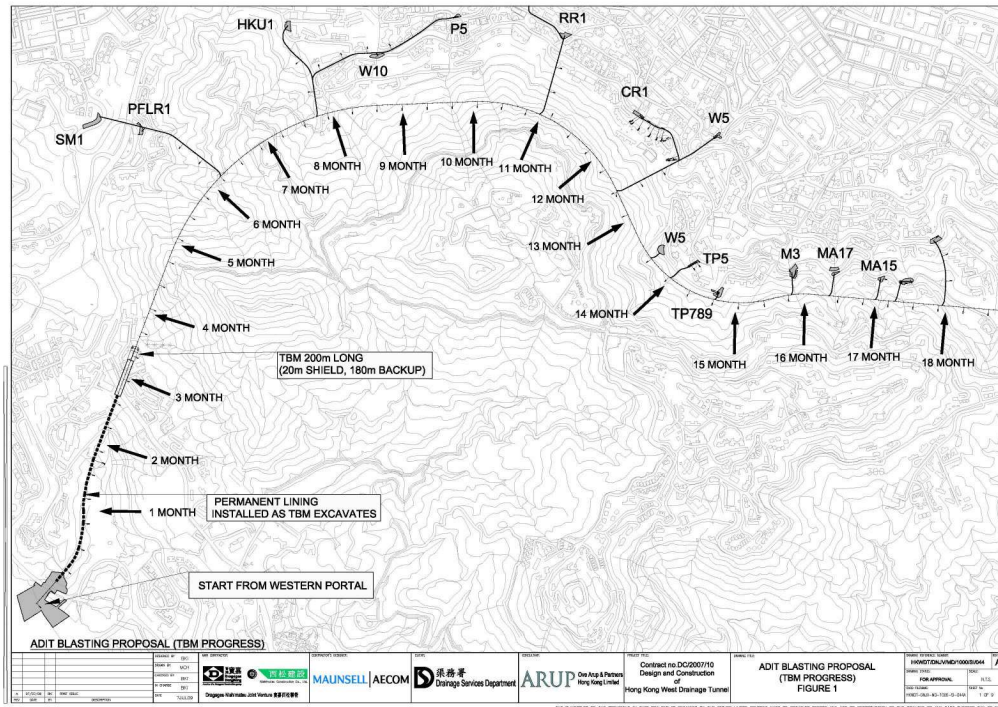
Figure 1: West Tunnel/Adit Alignment and TBM Progress

Figure 1 illustrates the alignment of the West Tunnel and West Adits and the progress of TBM excavation in the West Tunnel.
